April 29, 2025

**RE: Pre-Renovation Preliminary Lead-Containing Paint Inspection of Fire Station  
16, 4111 Kings Highway, Dayton, Ohio, March 10, 2025.  
Helix Project No. 7348.**

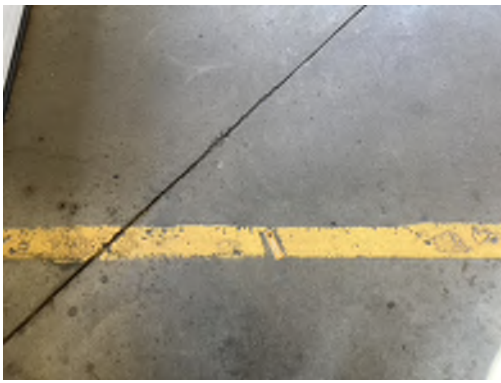
| <b>Helix Sample No.<br/>Lab Sample No.</b> | <b>Sample Location</b> | <b>Description</b> | <b>Lead Concentration<br/>(% Lead)</b> |
|---|---|---|---|
| 7348-03-10-61<br>25016044-1 | 1st Floor, West Vehicle Bay, South Central Area, 0' Ht. | Yellow Paint Stripe on Concrete | <b>0.352</b> |

Sample 7348-03-10-61 with 0.352% lead

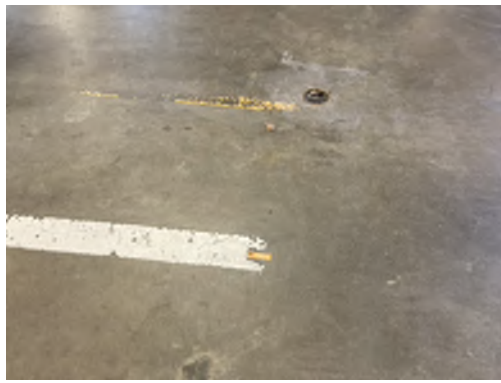
| <b>Helix Sample No.<br/>Lab Sample No.</b> | <b>Sample Location</b> | <b>Description</b> | <b>Lead Concentration<br/>(% Lead)</b> |
|---|---|---|---|
| 7348-03-10-62<br>25016044-2 | 1st Floor, West Vehicle Bay, Central Area, 0' Ht. | White Paint Stripe on Concrete | ND <0.009 |

Sample 7348-03-10-62 with no detectable lead

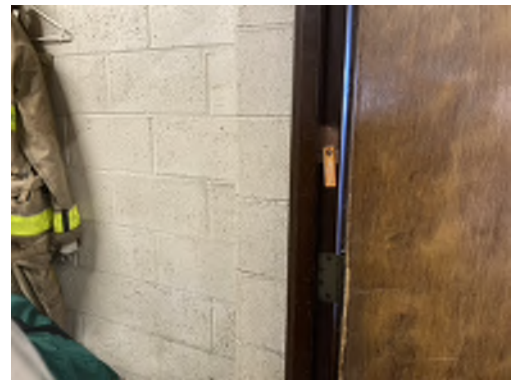
| <b>Helix Sample No.<br/>Lab Sample No.</b> | <b>Sample Location</b> | <b>Description</b> | <b>Lead Concentration<br/>(% Lead)</b> |
|---|---|---|---|
| 7348-03-10-63<br>25016044-3 | 1st Floor, West Vehicle Bay, East Wall, South Central Area, On Doorframe to Turnout Gear Room, 5' Ht. | Brown Paint on Metal Door Frame | <b>1.448</b> |

Sample 7348-03-10-63 with 1.448% lead

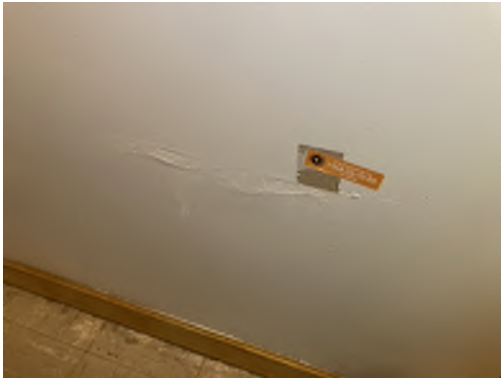
| <b>Helix Sample No.<br/>Lab Sample No.</b> | <b>Sample Location</b> | <b>Description</b> | <b>Lead Concentration<br/>(% Lead)</b> |
|---|---|---|---|
| 7348-03-10-64<br>25016044-4 | 1st Floor, North Central Dormitory, Southwest Cubicle, East Wall, 2' Ht. | Tan Paint on Drywall | ND <0.009 |

Sample 7348-03-10-64 with no detectable lead

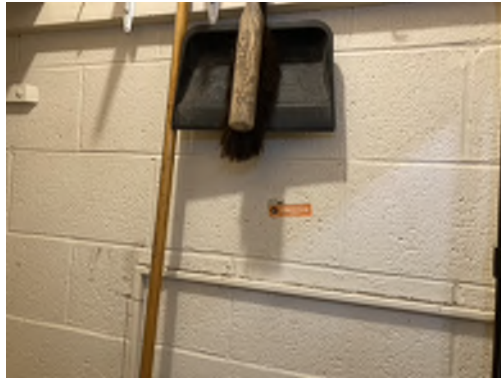
| <b>Helix Sample No.<br/>Lab Sample No.</b> | <b>Sample Location</b> | <b>Description</b> | <b>Lead Concentration<br/>(% Lead)</b> |
|---|---|---|---|
| 7348-03-10-65<br>25016044-5 | 1st Floor, South Central Custodial Room, West Wall, 5' Ht. | Tan and Yellow Paint on Concrete Block Wall | <b>0.014</b> |

Sample 7348-03-10-65 with 0.014% lead

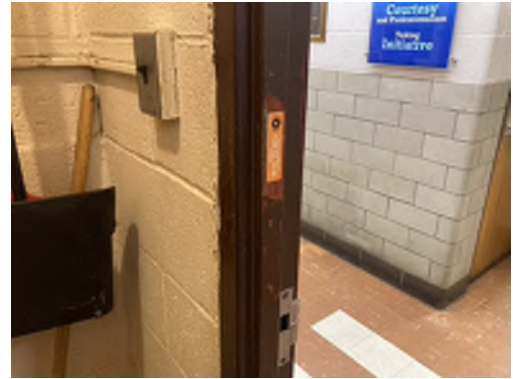
| <b>Helix Sample No.<br/>Lab Sample No.</b> | <b>Sample Location</b> | <b>Description</b> | <b>Lead Concentration<br/>(% Lead)</b> |
|---|---|---|---|
| 7348-03-10-66<br>25016044-6 | 1st Floor, South Central Custodial Room, West Wall, Door Frame, 4' Ht. | Brown and Red Paint on Metal Door Frame | <b>0.704</b> |

Sample 7348-03-10-66 with 0.704% lead

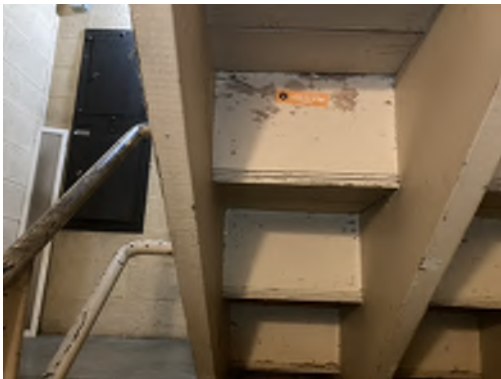
| <b>Helix Sample No.<br/>Lab Sample No.</b> | <b>Sample Location</b> | <b>Description</b> | <b>Lead Concentration<br/>(% Lead)</b> |
|---|---|---|---|
| 7348-03-10-69<br>25016044-9 | 1st Floor, South Central Stairwell, Northwest Central Area, On Underside of Staircase to 2nd Floor | Tan Paint on Wooden Staircase | <b>0.494</b> |

Sample 7348-03-10-69 with 0.494% lead

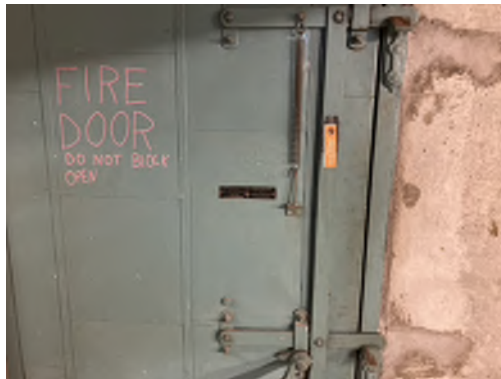
| <b>Helix Sample No.<br/>Lab Sample No.</b> | <b>Sample Location</b> | <b>Description</b> | <b>Lead Concentration<br/>(% Lead)</b> |
|---|---|---|---|
| 7348-03-10-70<br>25016044-10 | Basement, Southwest Central Laundry Room, North Wall, Central Area, Door to Boiler Room, 5' Ht. | Aqua Paint on Fire Door | <b>2.142</b> |

Sample 7348-03-10-70 with 2.142% lead

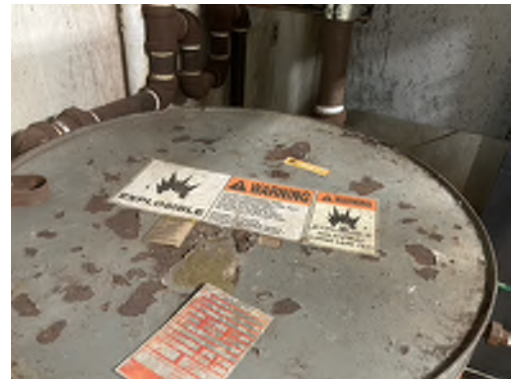
| <b>Helix Sample No.<br/>Lab Sample No.</b> | <b>Sample Location</b> | <b>Description</b> | <b>Lead Concentration<br/>(% Lead)</b> |
|---|---|---|---|
| 7348-03-10-71<br>25016044-11 | Basement, Boiler Room, On Water Tank, On Top, 4' Ht. | Grey Paint on Metal Water Tank | ND <0.009 |

Sample 7348-03-10-71 with no detectable lead

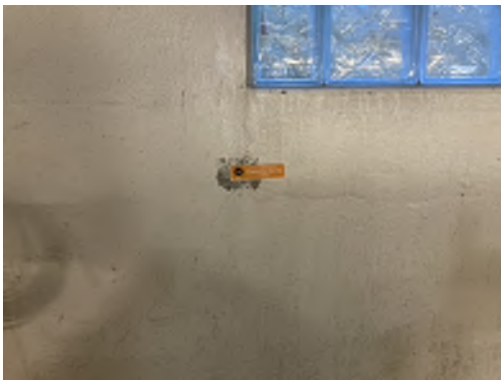
| <b>Helix Sample No.<br/>Lab Sample No.</b> | <b>Sample Location</b> | <b>Description</b> | <b>Lead Concentration<br/>(% Lead)</b> |
|---|---|---|---|
| 7348-03-10-72<br>25016044-12 | Basement, Northwest Exercise Room, North Wall, West Central Area, 5' Ht. | White Paint on Concrete Wall | ND <0.009 |

Sample 7348-03-10-72 with no detectable lead

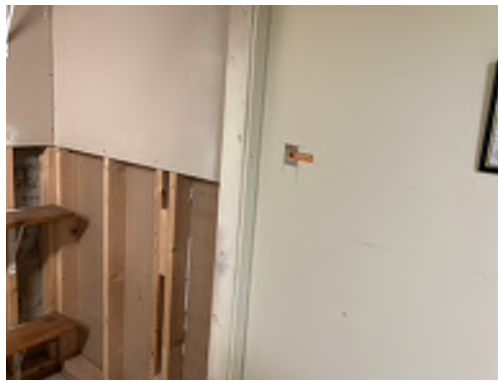
| Helix Sample No.<br>Lab Sample No. | Sample Location | Description | Lead Concentration<br>(% Lead) |
|---|---|---|---|
| 7348-03-10-73<br>25016044-13 | Basement, Southeast Central Office, South Closet, West Wall, 4' Ht. | Beige Paint on Drywall | ND <0.009 |

Sample 7348-03-10-73 with no detectable lead

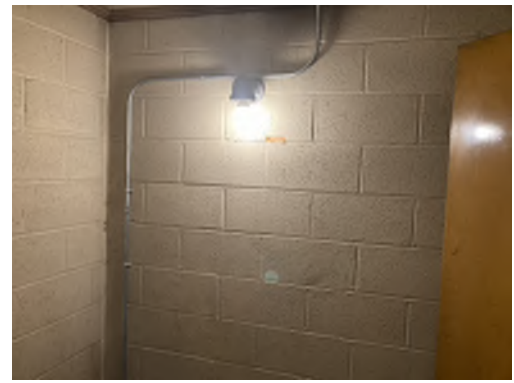
| Helix Sample No.<br>Lab Sample No. | Sample Location | Description | Lead Concentration<br>(% Lead) |
|---|---|---|---|
| 7348-03-10-74<br>25016044-14 | Top Floor, Stairwell, South Wall, Central Area, Under Light, 5' Ht. | Tan Paint on Concrete Block Wall | <b>0.086</b> |

Sample 7348-03-10-74 with 0.086% lead

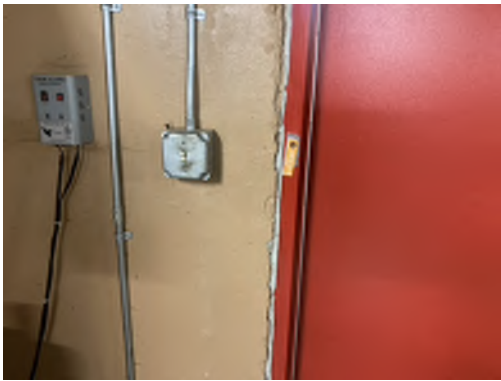
| Helix Sample No.<br>Lab Sample No. | Sample Location | Description | Lead Concentration<br>(% Lead) |
|---|---|---|---|
| 7348-03-10-75<br>25016044-15 | Basement, South Central Maintenance Room, North Wall, West Area, At Double Door Frame, West Side, 4' Ht. | Red Paint on Metal Door Frame | ND <0.010 |

Sample 7348-03-10-75 with no detectable lead

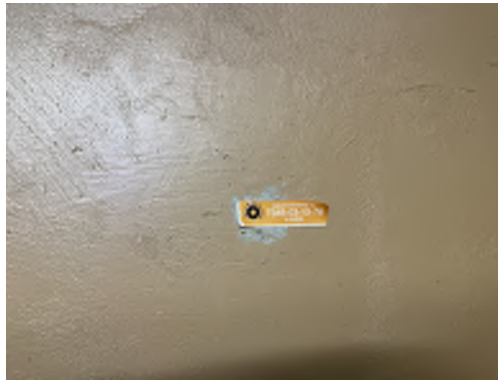
| Helix Sample No.<br>Lab Sample No. | Sample Location | Description | Lead Concentration<br>(% Lead) |
|---|---|---|---|
| 7348-03-10-76<br>25016044-16 | Basement, South Central Maintenance Room, North Wall, East Area, 5' Ht. | Terra Cotta Paint on Concrete Wall | ND <0.009 |

Sample 7348-03-10-76 with no detectable lead

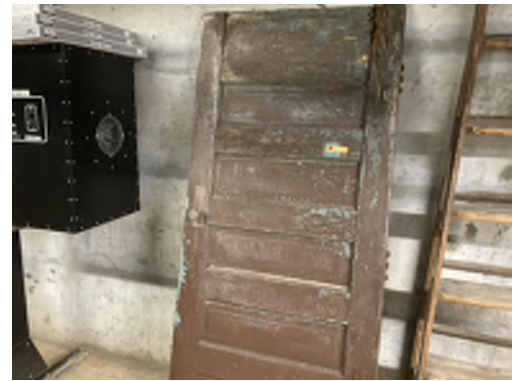
| Helix Sample No.<br>Lab Sample No. | Sample Location | Description | Lead Concentration<br>(% Lead) |
|---|---|---|---|
| 7348-03-10-77<br>25016044-17 | Basement, Southwest Room, North Wall, Central Area, Loose Door, 4' Ht. | Brown Paint over Aqua on Wood Door | <b>1.707</b> |

Sample 7348-03-10-77 with 1.707% lead

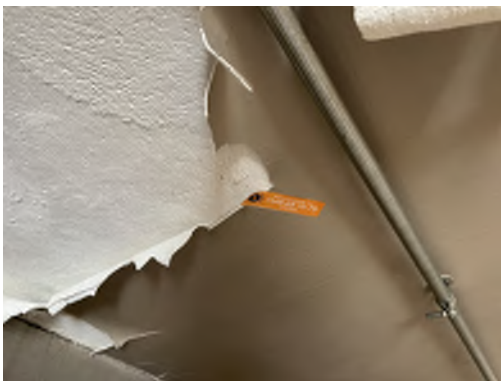
| Helix Sample No.<br>Lab Sample No. | Sample Location | Description | Lead Concentration<br>(% Lead) |
|---|---|---|---|
| 7348-03-10-79<br>25016044-19 | 1st Floor, West Vehicle Bay, North Area, Center of Ceiling, 14' Ht. | Taupe Paint on Plaster | <b>0.026</b> |

Sample 7348-03-10-79 with 0.026% lead
