**ADDENDUM NO. #2**  
**December 4, 2025**  
**Fire Station 16 Renovations**  
**(10% MBE PARTICIPATION GOAL)**

**RE: Pre-Renovation Asbestos Inspection of Fire Station 16, 4111 Kings Highway,  
Dayton, Ohio, March 10 and 31, 2025.  
Helix Project No. 7348.**

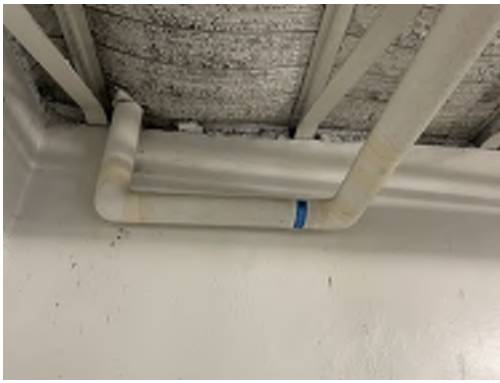
Photo 01- Sample# 7348-03-10-01, No Asbestos Detected in Cream/ Tan Insulation Sealant

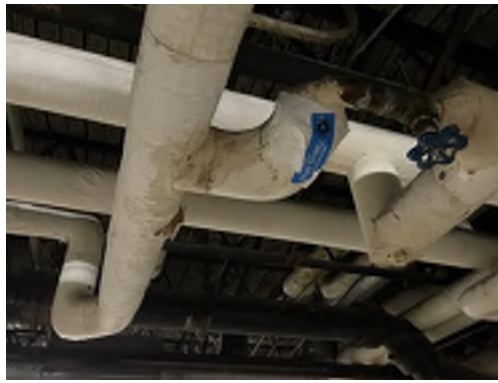
Photo 02- Sample# 7348-03-10-02, No Asbestos Detected in Cream/ Tan Insulation Sealant

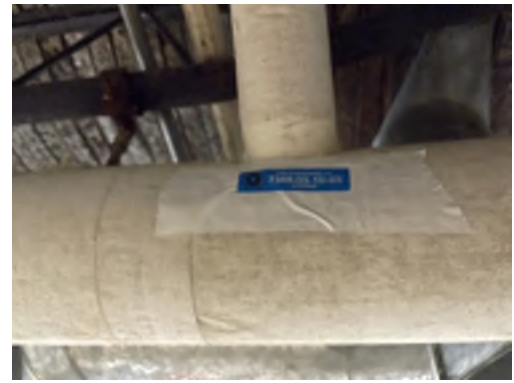
Photo 03- Sample# 7348-03-10-03, No Asbestos Detected in Cream/ Tan Insulation Sealant

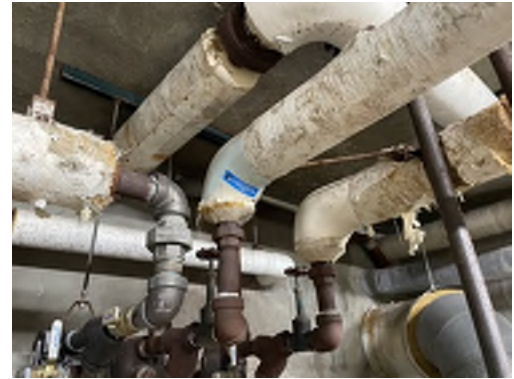
Photo 06- Sample# 7348-03-10-06, No Asbestos Detected in Cream/ Tan Insulation Sealant

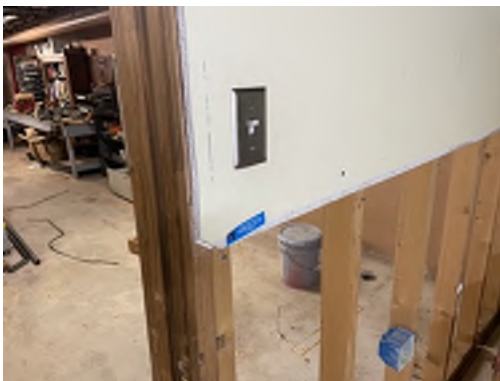
Photo 07- Sample# 7348-03-10-07, No Asbestos Detected in Drywall and Joint Compound

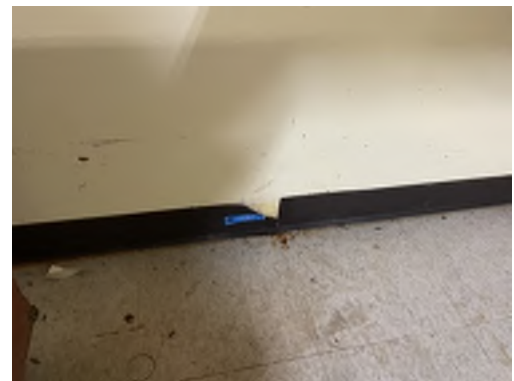
Photo 09- Sample# 7348-03-10-09, No Asbestos Detected in 4" Cove Base and Mastic

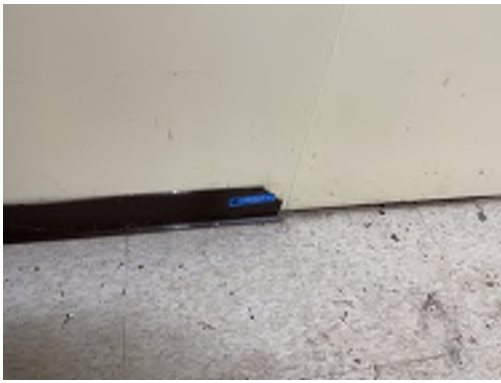
Photo 10- Sample# 7348-03-10-10, No Asbestos Detected in 4" Cove Base and Mastic

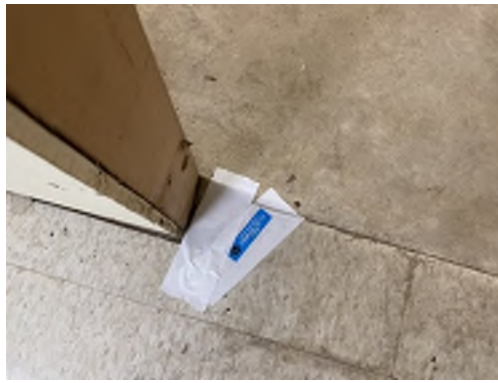
Photo 11- Sample# 7348-03-10-11, No Asbestos Detected in 12" x 12" Tan Mottled Floor Tile and Tan Mastic

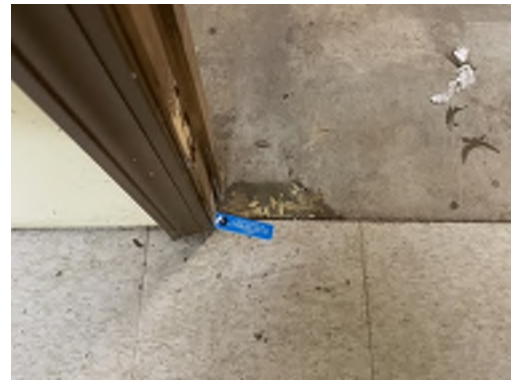
Photo 12- Sample# 7348-03-10-12, No Asbestos Detected in 12" x 12" Tan Mottled Floor Tile and Tan Mastic

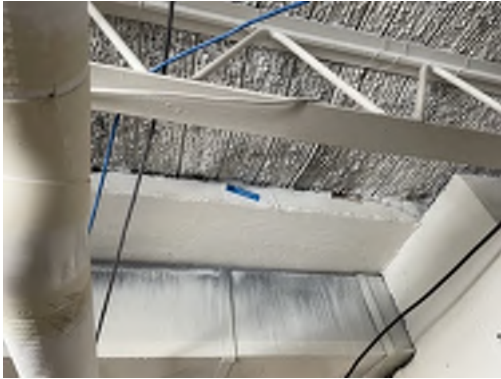
Photo 13- Sample# 7348-03-10-13, No Asbestos Detected in Hard Plaster

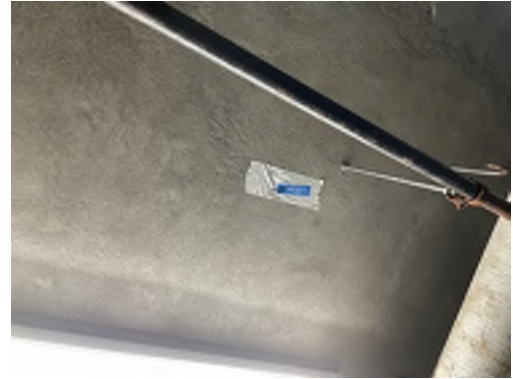
Photo 15- Sample# 7348-03-10-15, No Asbestos Detected in Hard Plaster

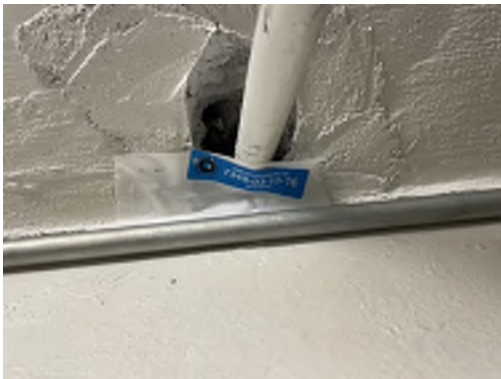
Photo 16- Sample# 7348-03-10-16, No Asbestos Detected in Pipe Penetration Plaster

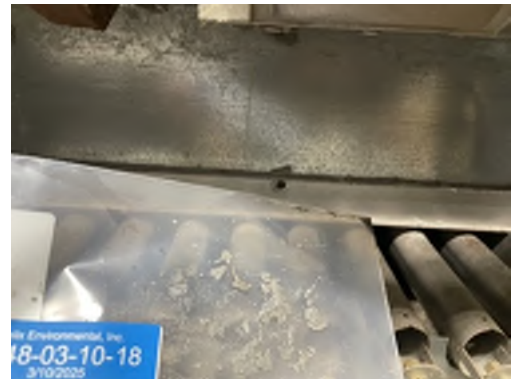
Photo 18- Sample# 7348-03-10-18, No Asbestos Detected in Grey Boiler Sealant

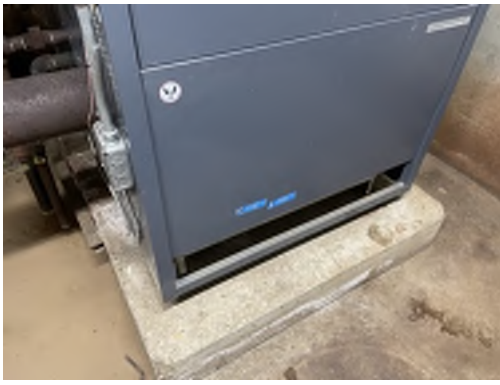
Photo 19- Sample# 7348-03-10-19, No Asbestos Detected in Grey Boiler Sealant

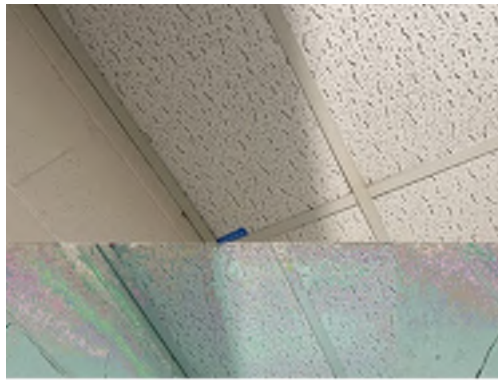
Photo 20- Sample# 7348-03-10-20, No Asbestos Detected in 2' x 4' Ceiling Tile

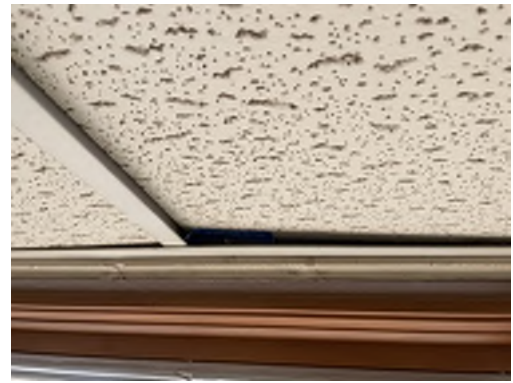
Photo 21- Sample# 7348-03-10-21, No Asbestos Detected in 2' x 4' Ceiling Tile

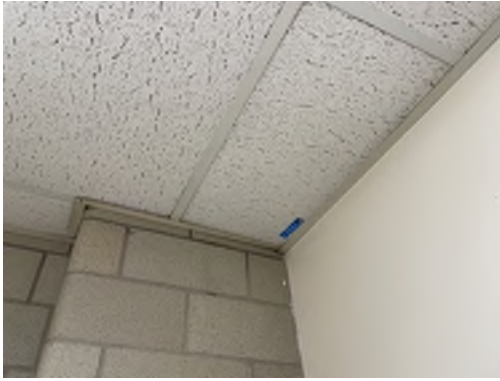
Photo 22- Sample# 7348-03-10-22, No Asbestos Detected in 2' x 2' Ceiling Tile

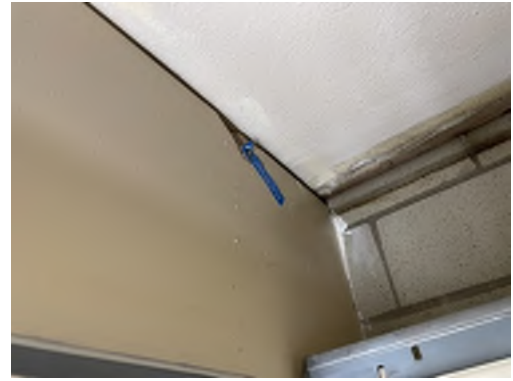
Photo 24- Sample# 7348-03-10-24, No Asbestos Detected in Drywall and Joint Compound

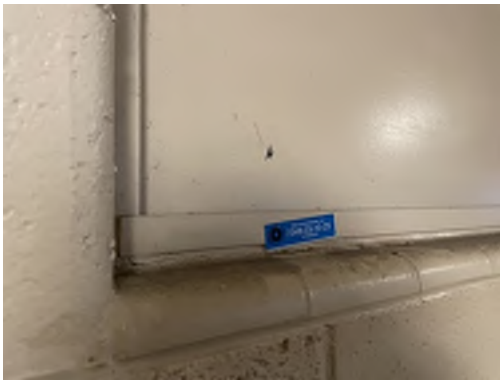
Photo 25- Sample# 7348-03-10-25, 0.3% Chrysotile Asbestos Detected in Grey Interior Caulk

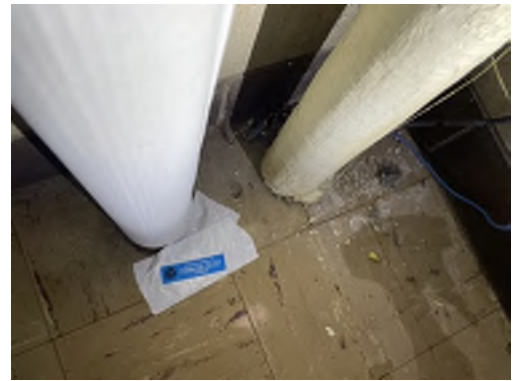
Photo 27- Sample# 7348-03-10-27, 4% Asbestos Detected in 9"x9" Tan Streak Floor Tile, No Asbestos in Black Mastic

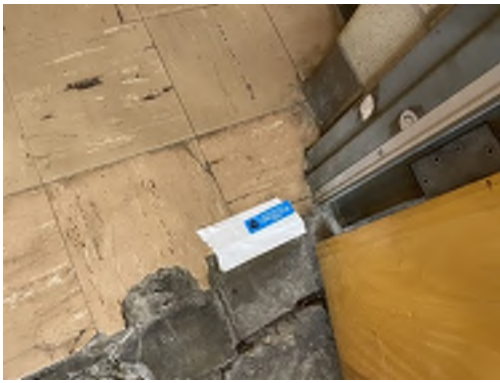
Photo 28- Sample# 7348-03-10-28, 4% Asbestos Detected in 9"x9" Pink Streaked Floor Tile, No Asbestos in Black Mastic

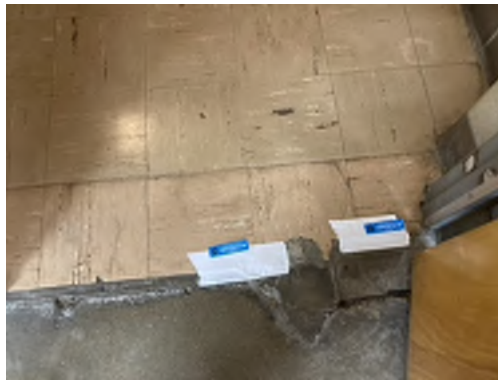
Photo 29- Sample# 7348-03-10-29, 4% Asbestos Detected in 9"x9" Pink Streaked Floor Tile, No Asbestos in Black Mastic

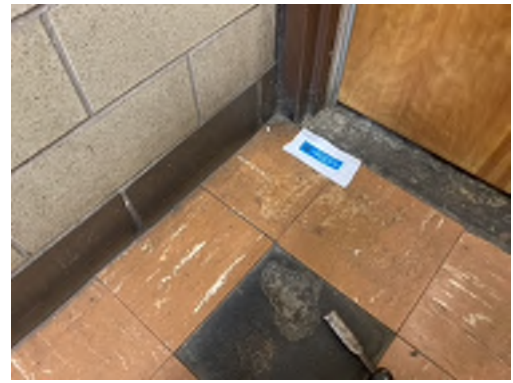
Photo 30- Sample# 7348-03-10-30, 4% Asbestos Detected in 9"x9" Terracotta Streaked Floor Tile, No Asbestos in Black Mastic

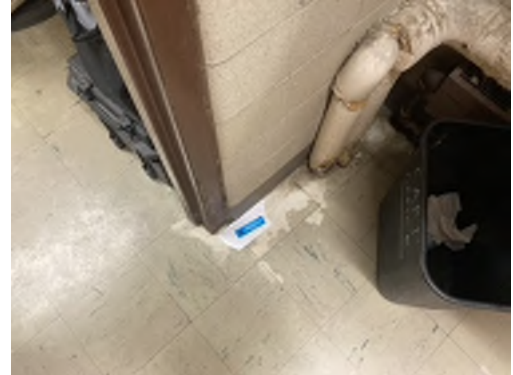
Photo 33- Sample# 7348-03-10-33, 3.5% Asbestos Detected in 9"x9" Grey and Green Streaked Floor Tile, No Asbestos in Black Mastic

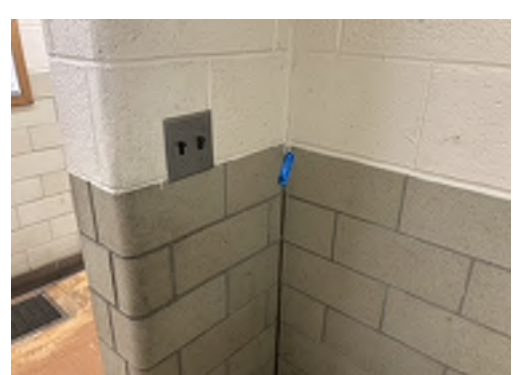
Photo 36- Sample# 7348-03-10-36, 0.9% Chrysotile Asbestos Detected in Grey Interior Caulk

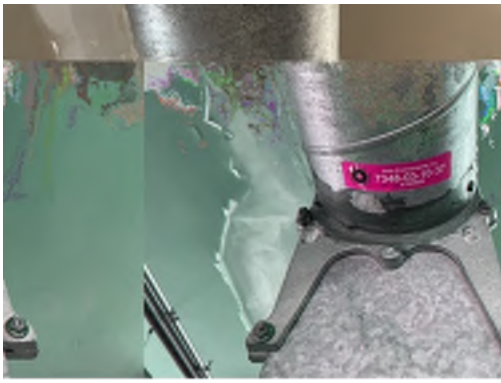
Photo 37- Sample# 7348-03-10-37, No Asbestos Detected in Grey Duct Sealant

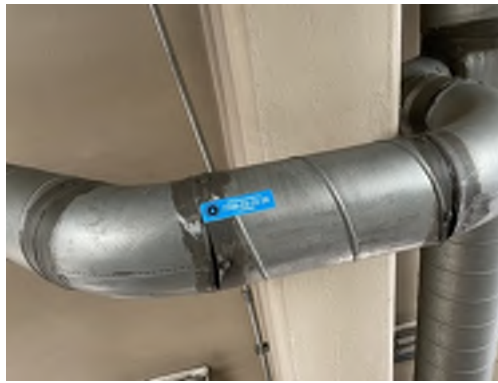
Photo 38- Sample# 7348-03-10-38, No Asbestos Detected in Grey Duct Sealant

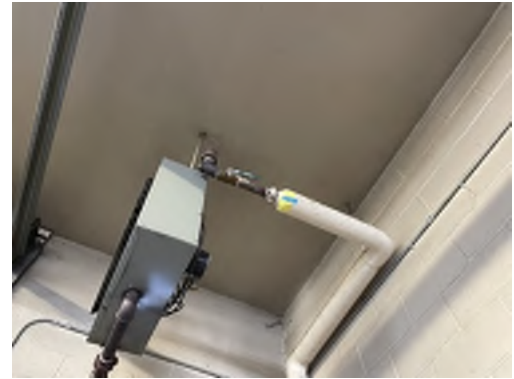
Photo 39- Sample# 7348-03-10-39, No Asbestos Detected in Tan Pipe Insulation Sealant

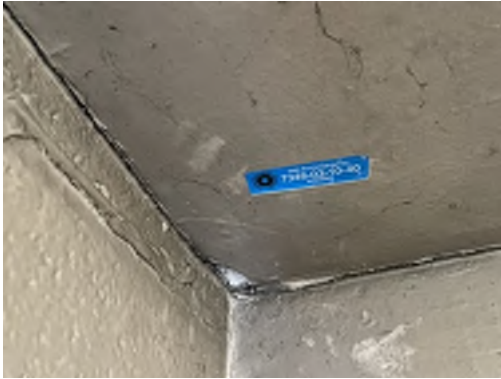
Photo 40- Sample# 7348-03-10-40, No Asbestos Detected in Hard Plaster

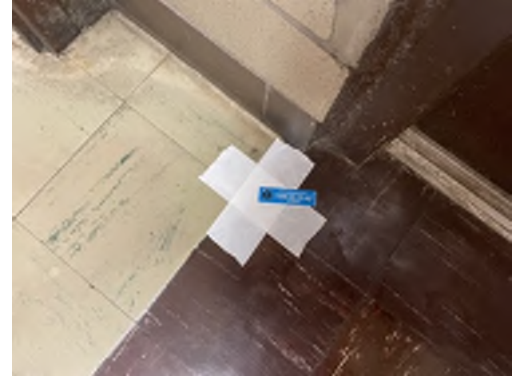
Photo 42- Sample# 7348-03-10-42, 0.5% Asbestos Detected in 9"x9" Maroon Streaked Floor Tile, No Asbestos in Black Mastic

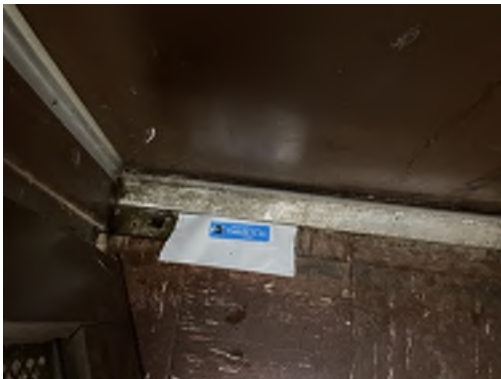
Photo 43- Sample# 7348-03-10-43, 1.3% Asbestos Detected in 9"x9" Maroon Streaked Floor Tile, No Asbestos in Black Mastic

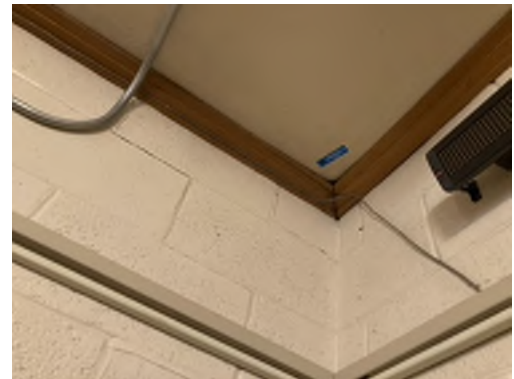
Photo 45- Sample# 7348-03-10-45, No Asbestos Detected in Hard Plaster

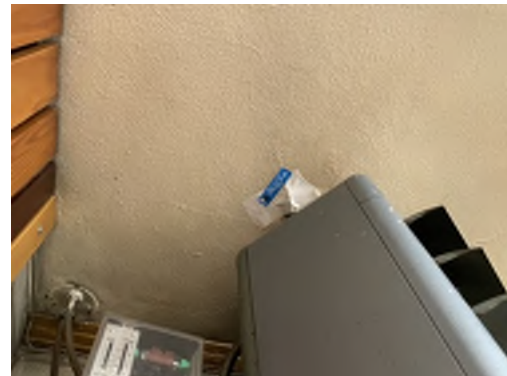
Photo 48- Sample# 7348-03-10-48, No Asbestos Detected in Hard Plaster and Skim Coat

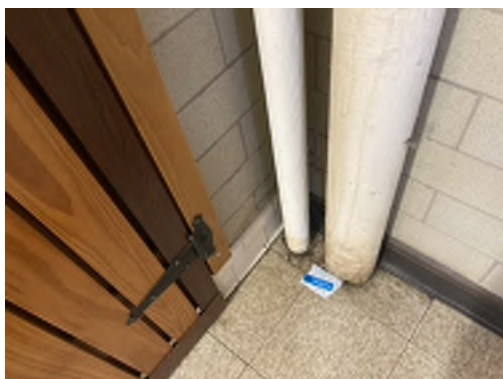
Photo 49- Sample# 7348-03-10-49, No Asbestos Detected in 12"x12" Tan Mottled Floor Tile and Black Mastic

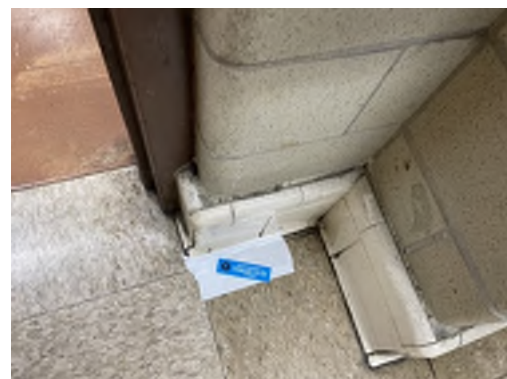
Photo 51- Sample# 7348-03-10-51, No Asbestos Detected in 12"x12" Taupe Mottled Floor Tile and Black Mastic

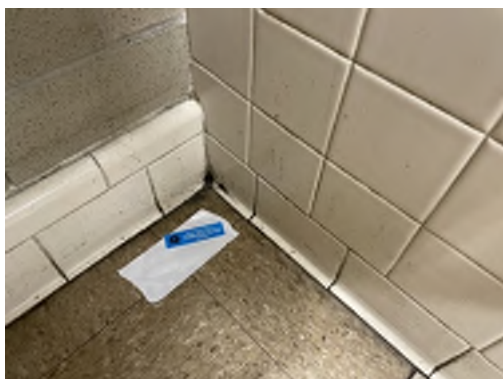
Photo 52- Sample# 7348-03-10-52, No Asbestos Detected in 12"x12" Taupe Mottled Floor Tile and Black Mastic

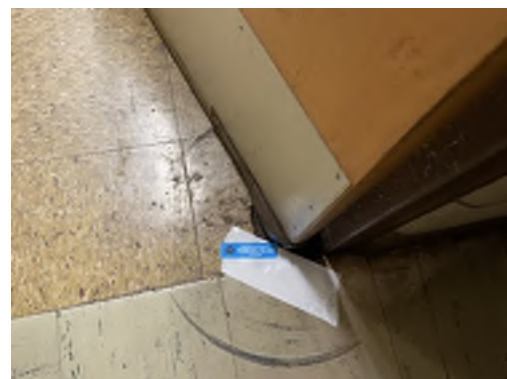
Photo 54- Sample# 7348-03-10-54, No Asbestos Detected in 12"x12" Bronze Mottled Floor Tile and Black Mastic

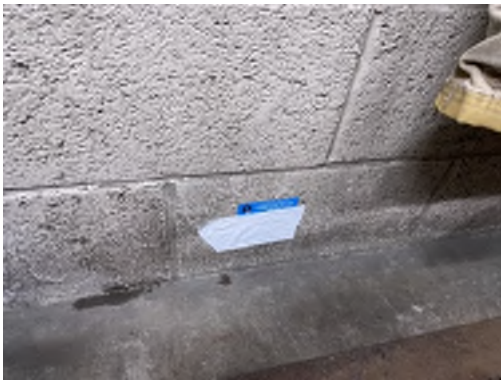
Photo 55- Sample# 7348-03-31-01, No Asbestos Detected in Yellow Block Coating

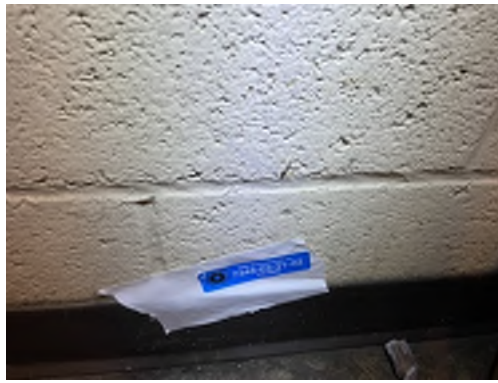
Photo 56- Sample# 7348-03-31-02, No Asbestos Detected in Yellow Block Coating

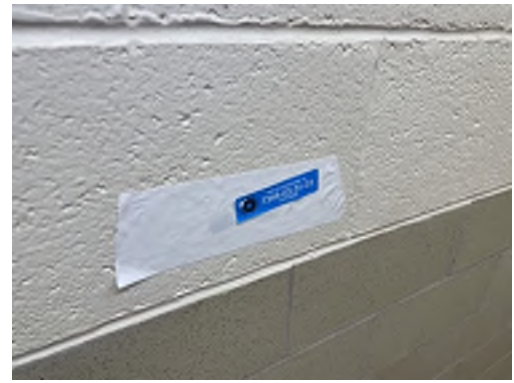
Photo 57- Sample# 7348-03-31-03, No Asbestos Detected in Yellow Block Coating

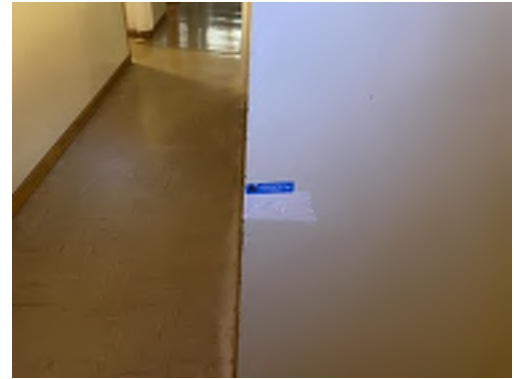
Photo 60- Sample# 7348-03-31-06, No Asbestos Detected in Drywall and Joint Compound

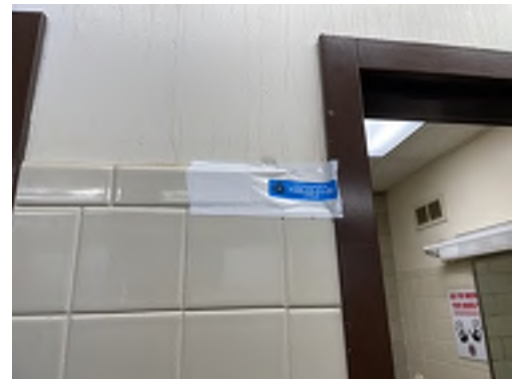
Photo 63- Sample# 7348-03-31-09, No Asbestos Detected in Tan Ceramic Tile Adhesive

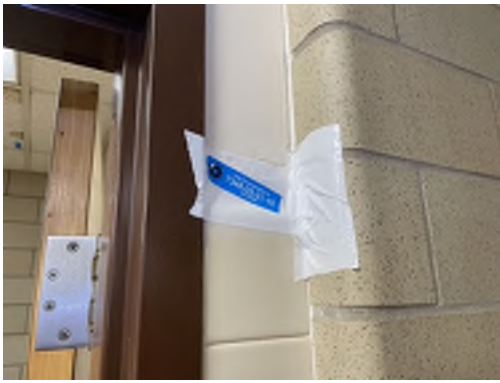
Photo 64- Sample# 7348-03-31-10, No Asbestos Detected in Tan Ceramic Tile Adhesive

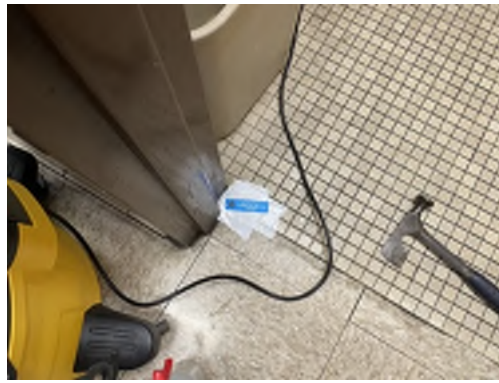
Photo 65- Sample# 7348-03-31-11, <0.25% Asbestos Detected in Mortar, No Asbestos Detected in Ceramic Tile and Adhesive

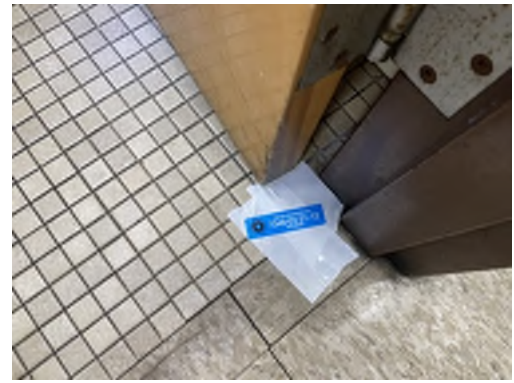
Photo 66- Sample# 7348-03-31-12, <0.25% Asbestos Detected in Mortar, No Asbestos Detected in Ceramic Tile and Adhesive

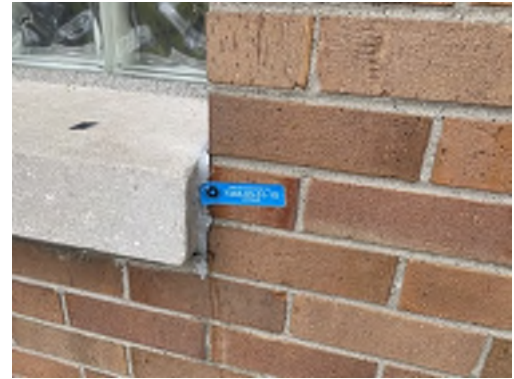
Photo 69- Sample# 7348-03-31-15, No Asbestos Detected in Light Grey Exterior Caulk

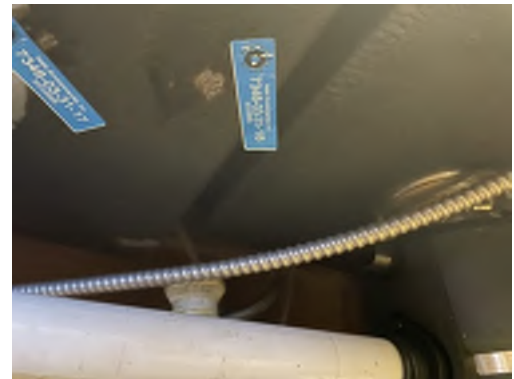
Photo 72- Sample# 7348-03-31-18, No Asbestos Detected in Black Sink Soundproofing

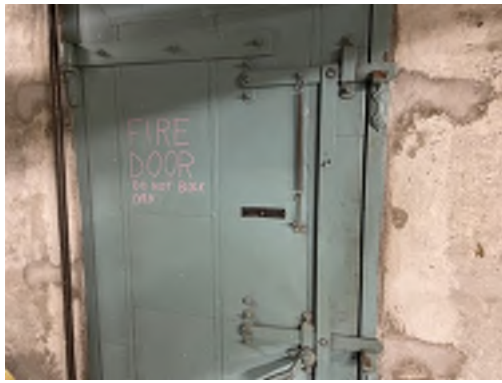
Photo 73- Basement, Boiler Room Entrance Door, All Fire Doors Are Assumed to Contain Asbestos

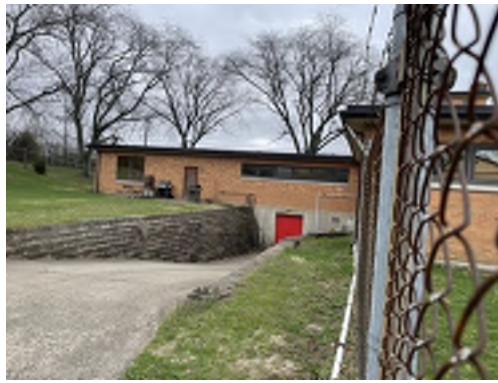
Photo 74- Basement, Maintenance Room Entrance Door, All Fire Doors Are Assumed to Contain Asbestos

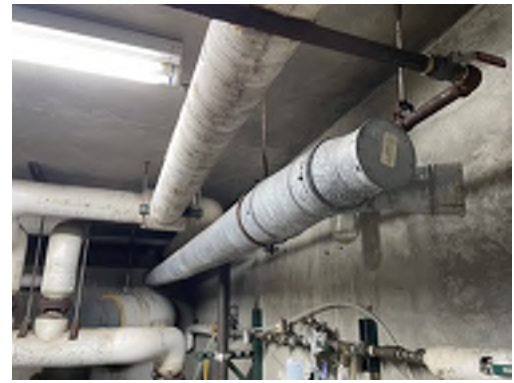
Photo 75- Basement, Boiler Room, Boiler Flue is Assumed to Contain Asbestos, Under the Metal Jacket

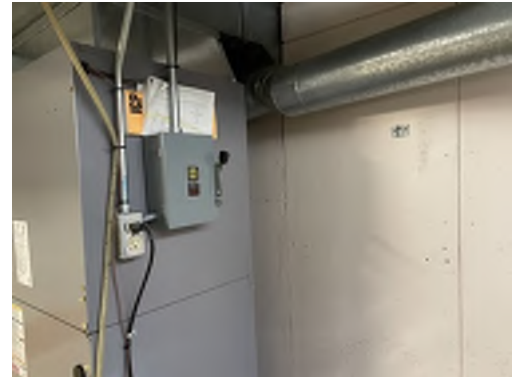
Photo 78- Basement, SW Room, East Area, Electrical Insulators in Safety Switch are Assumed to Contain Asbestos

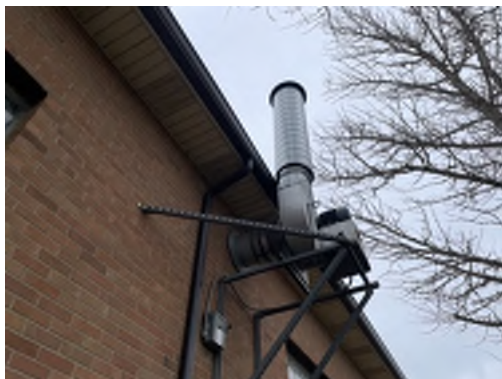
Photo 79- Exterior, West Side, Safety Switch, All Electrical Insulators are Assumed to Contain Asbestos

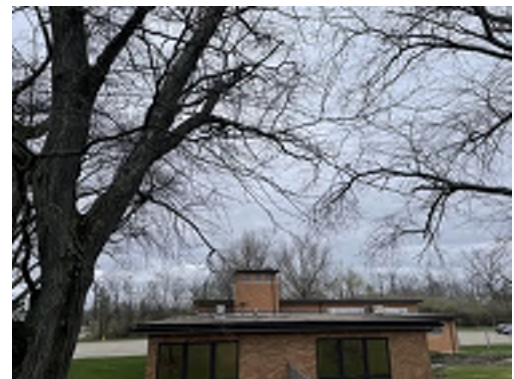
Photo 81- Exterior, Roof, East Side, Safety Switches, All Electrical Insulators are Assumed to Contain Asbestos

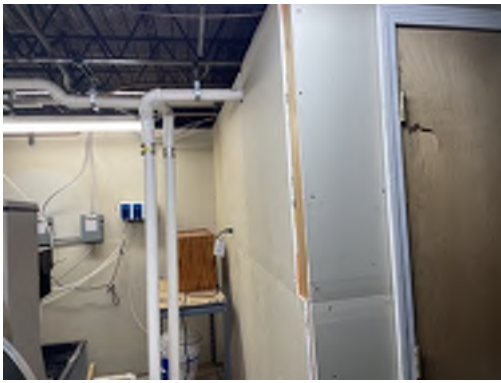
Photo 82- Basement, West Central Hallway, East Wall, Safety Switches, All Assumed to Contain Asbestos

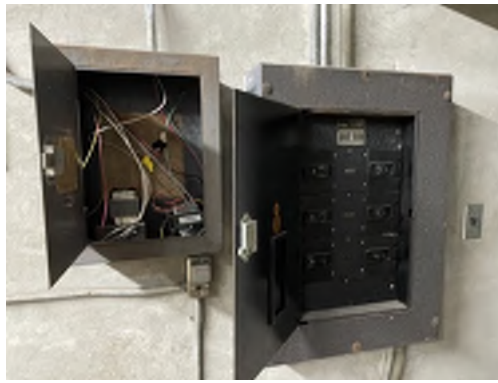
Photo 83- Boiler Room, East Wall, Circuit Breaker, All Electrical Insulators are Assumed to Contain Asbestos

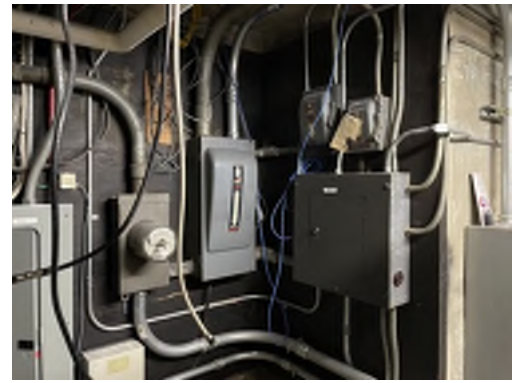
Photo 84- Basement, SW Room, West Wall, All Electrical Insulators are Assumed to Contain Asbestos

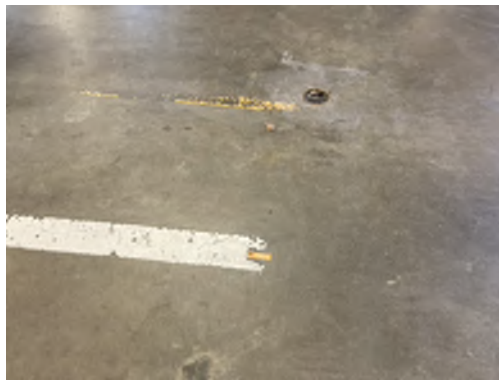
Sample 7348-03-10-62 with no  
detectable lead

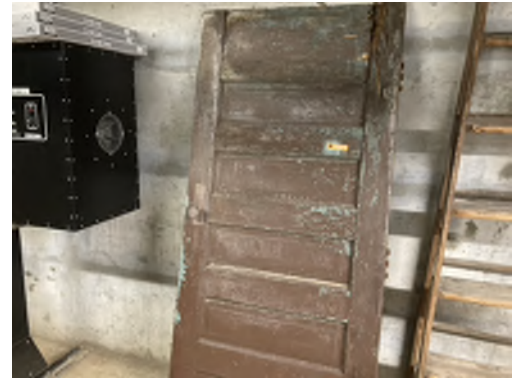
Sample 7348-03-10-77 with 1.707% lead
