ADDENDUM NO. #2
December 4, 2025
Fire Station 15 Renovations
(10% MBE PARTICIPATION GOAL)

Answer: *Pre-Renovation Asbestos Inspection* report is attached. Additionally, the *Pre-Renovation Preliminary Lead-Containing Paint Inspection* report is attached as well.

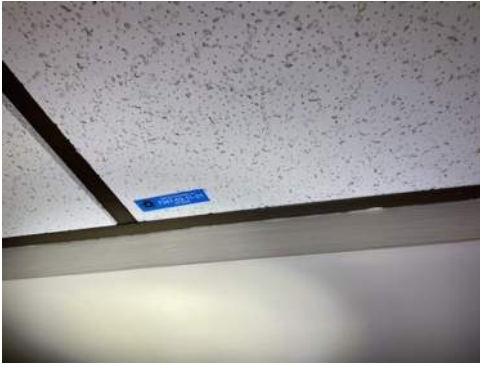
Photo 01- Sample# 7347-03-11-01, No Asbestos Detected in 2' x 2' Ceiling Tile

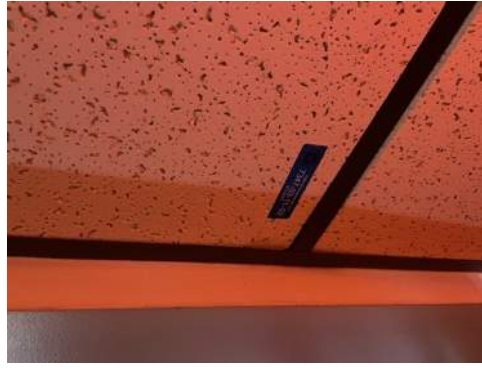
Photo 02- Sample# 7347-03-11-02, No Asbestos Detected in 2' x 2' Ceiling Tile

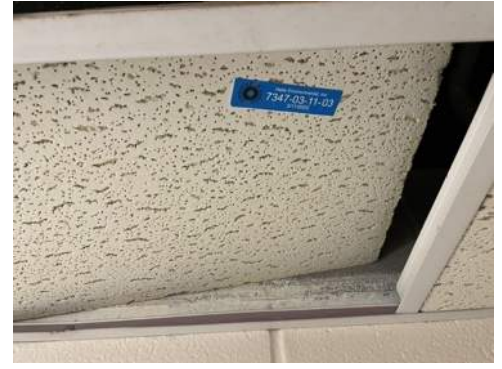
Photo 03- Sample# 7347-03-11-03, No Asbestos Detected in 2' x 2' Ceiling Tile

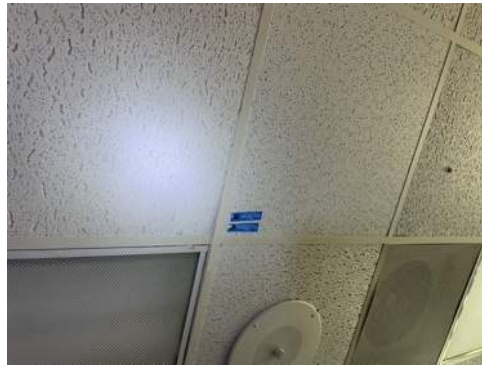
Photo 05- Sample# 7347-03-11-05, No Asbestos Detected in 2' x 2' Ceiling Tile

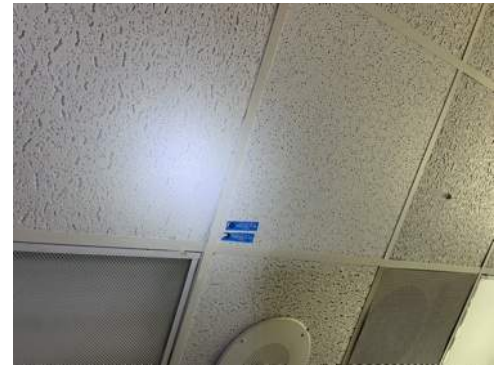
Photo 06- Sample# 7347-03-11-06, No Asbestos Detected in 2' x 2' Ceiling Tile

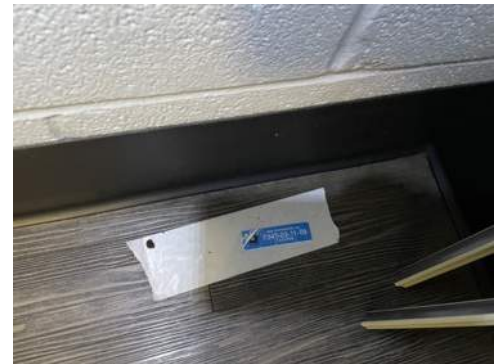
Photo 09- Sample# 7347-03-11-09, No Asbestos Detected in Sheet Flooring and Green Mastic

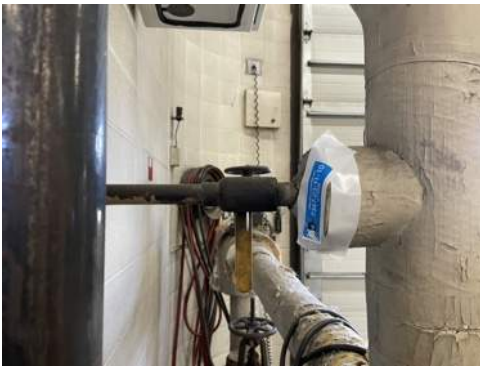
Photo 10- Sample# 7347-03-11-10, 1.1% Chrysotie Asbestos Detected in Grey Pipe Insulation Sealant

Trained workers and supervisors certified by OEPA must be used to remove the identified asbestos-containing building materials using special procedures and protective equipment to ensure that the workers are not overexposed to airborne asbestos. Advance notification may need to be provided to both the Regional Air Pollution Control Agency (RAPCA) and OEPA at least ten working days in advance of the start of abatement on site, depending on the quantity of materials removed. The fact that asbestos-containing materials were observed in or on the building should be noted on the demolition notification form along with the name and certification number of the

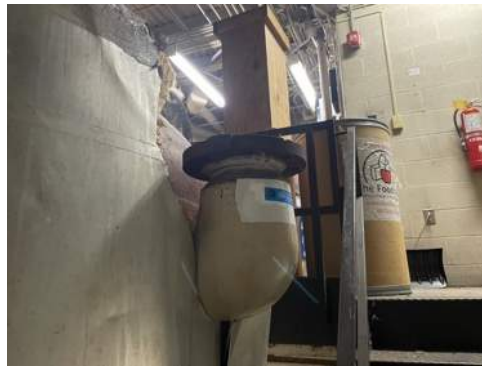
Photo 11- Sample# 7347-03-11-11, 2.7% Chrysotie Asbestos Detected in Tan Pipe Insulation Sealant

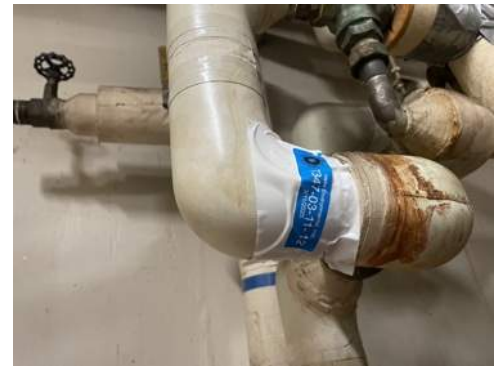
Photo 12- Sample# 7347-03-11-12, 1.6% Chrysotie Asbestos Detected in Tan Pipe Insulation Sealant

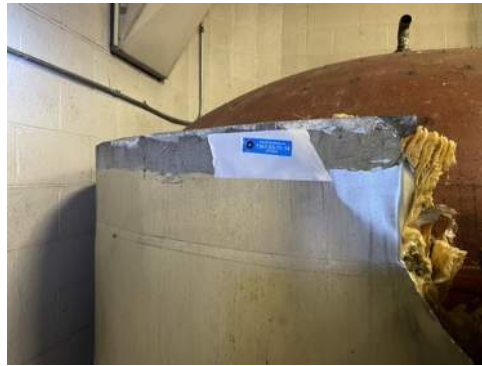
Photo 14- Sample# 7347-03-11-14, 10% Chrysotie Asbestos Detected in Grey Tank Insulation Sealant

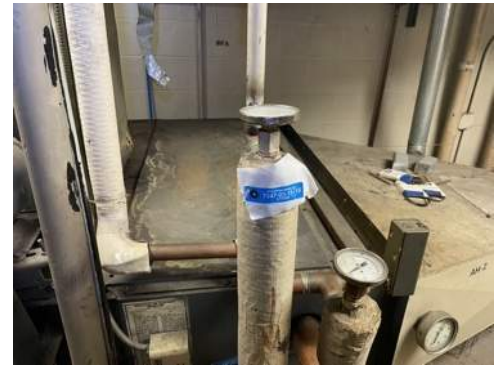
Photo 15- Sample# 7347-03-11-15, No Asbestos Detected in Tan Pipe Insulation Sealant

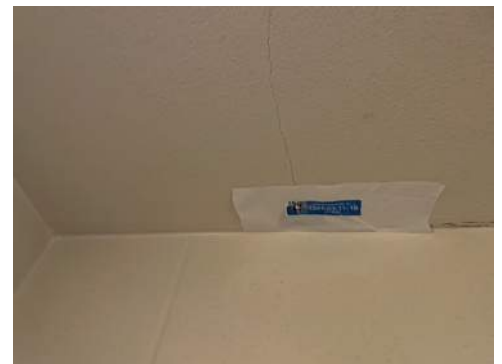
Photo 18- Sample# 7347-03-11-18, No Asbestos Detected in Stucco and Base Layer

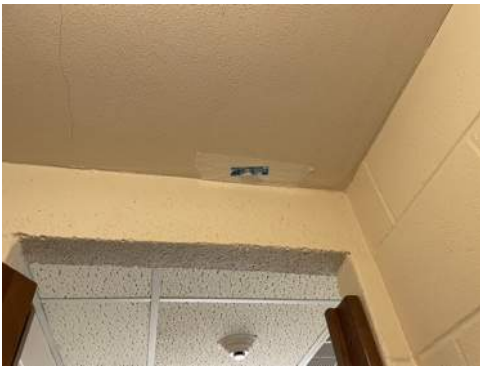
Photo 19- Sample# 7347-03-11-19, No Asbestos Detected in Stucco and Base Layer

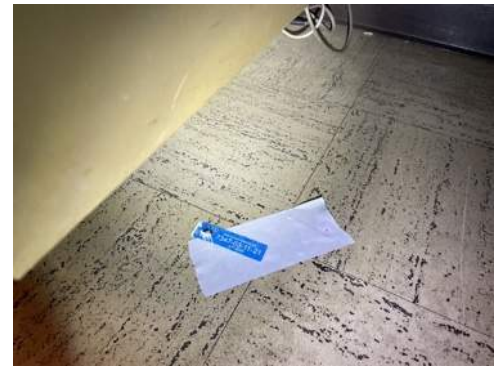
Photo 21- Sample# 7347-03-11-21, 0.6% Chrysotile Asbestos Detected in 12"x12" Grey Streaked Floor Tile, No Asbestos in Black Mastic

OSHA has interpreted its regulations to require wet methods for the removal of materials containing less than 1% asbestos, with prompt cleanup of debris in leak tight containers. Helix Environmental, Inc. recommends the use of a licensed asbestos abatement company to perform this work since they have the equipment, experience, and knowledge to safely remove materials containing trace amounts of asbestos without creating a potential hazard.

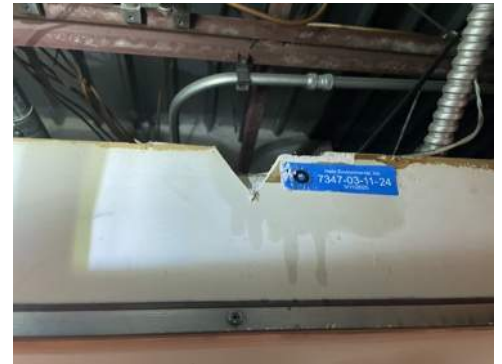
Photo 24- Sample# 7347-03-11-24, No Asbestos Detected in Drywall and Joint Compound

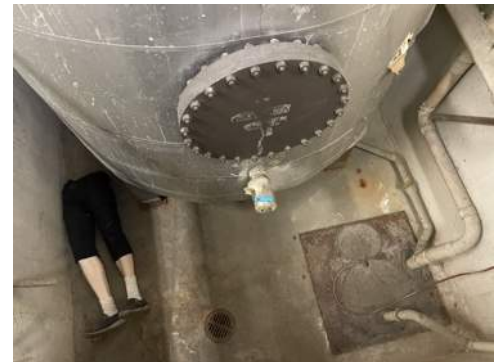
Photo 27- Sample# 7347-03-11-27, No Asbestos Detected in Tan Pipe Insulation Sealant

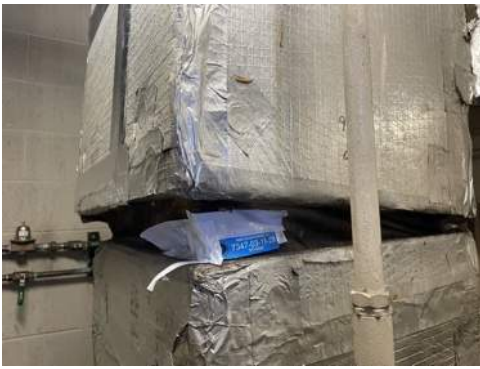
Photo 28- Sample# 7347-03-11-28, No Asbestos Detected in Vibration Isolator Cloth

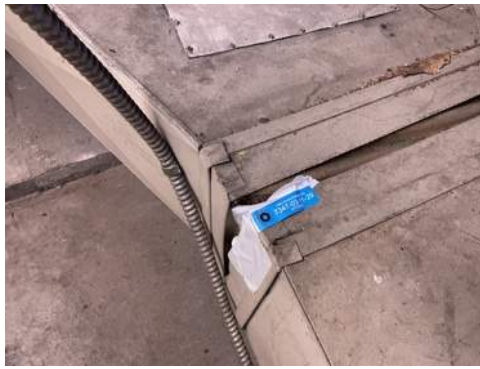
Photo 29- Sample# 7347-03-11-29, No Asbestos Detected in Vibration Isolator Cloth

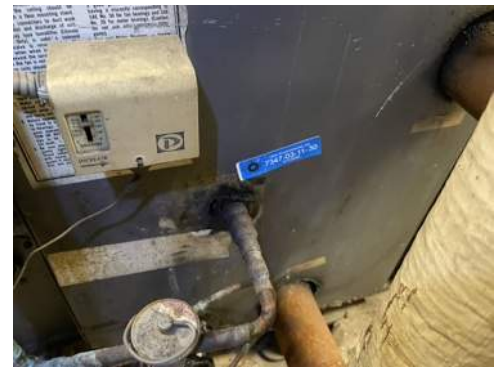
Photo 30- Sample# 7347-03-11-30, No Asbestos Detected in Black Sweat Wrap

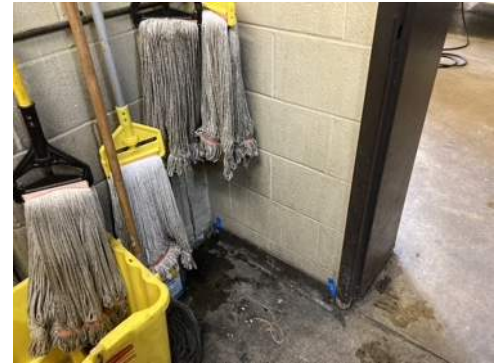
Photo 33- Sample# 7347-03-11-33, No Asbestos Detected in Brown Cove Base Mastic

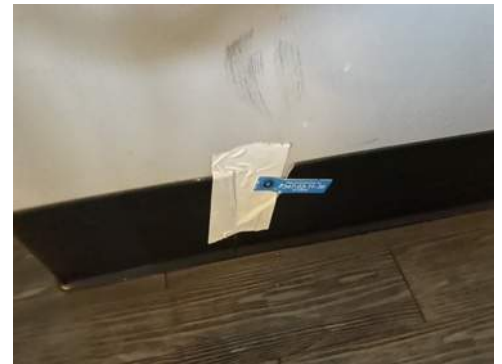
Photo 36- Sample# 7347-03-11-36, No Asbestos Detected in 6" Cove Base and Mastic

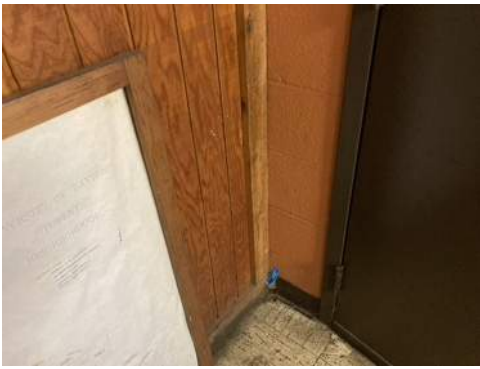
Photo 37- Sample# 7347-03-11-37, No Asbestos Detected in 4" Cove Base and Mastic

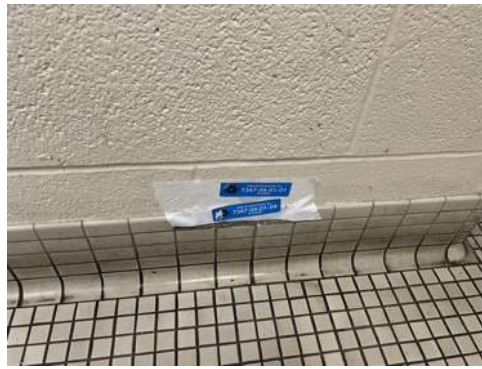
Photo 38- Sample# 7347-04-01-01, No Asbestos Detected in White Concrete Block Coating

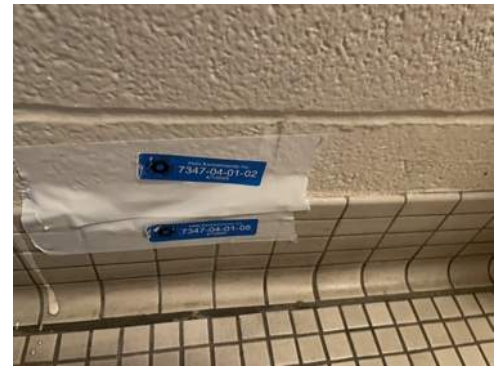
Photo 39- Sample# 7347-04-01-02, No Asbestos Detected in White Concrete Block Coating

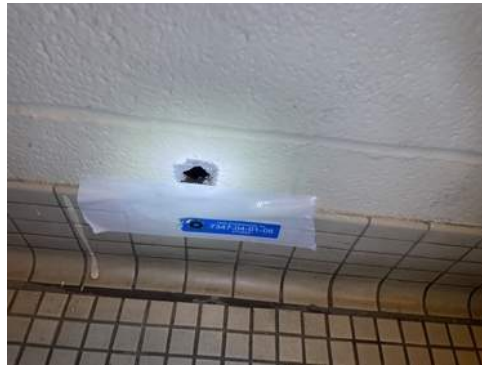
Photo 41- Sample# 7347-04-01-05, No Asbestos Detected in Ceramic Tile, Tan Adhesive, and Grout

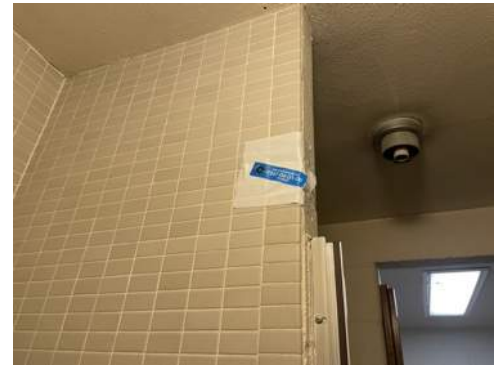
Photo 42- Sample# 7347-04-01-06, No Asbestos Detected in Ceramic Tile, Tan Adhesive, and Grout

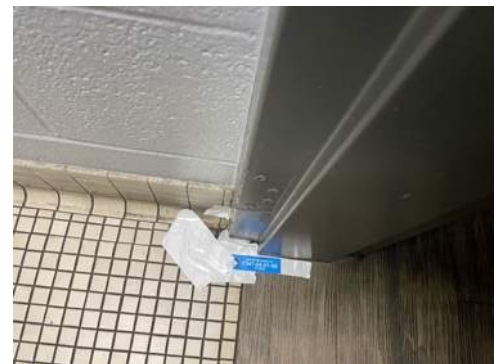
Photo 45- Sample# 7347-04-01-09, No Asbestos Detected in Ceramic Tile, Tan Adhesive, and Grout

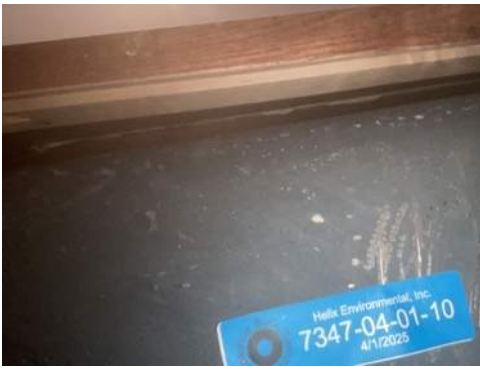
Photo 46- Sample# 7347-04-01-10, No Asbestos Detected in Sink Soundproofing

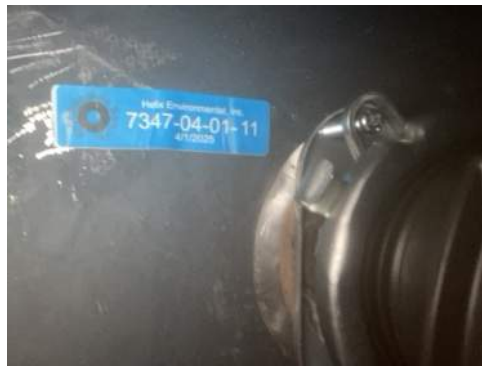
Photo 47- Sample# 7347-04-01-11, No Asbestos Detected in Sink Soundproofing

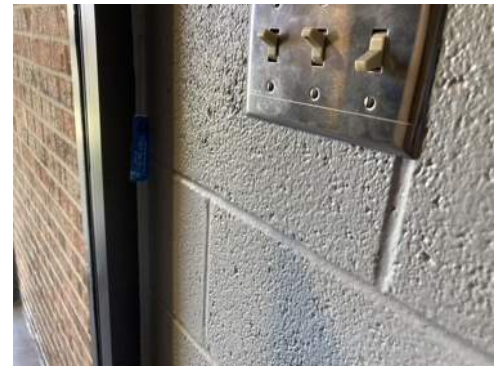
Photo 48- Sample# 7347-04-01-12, No Asbestos Detected in Brown Interior Caulk

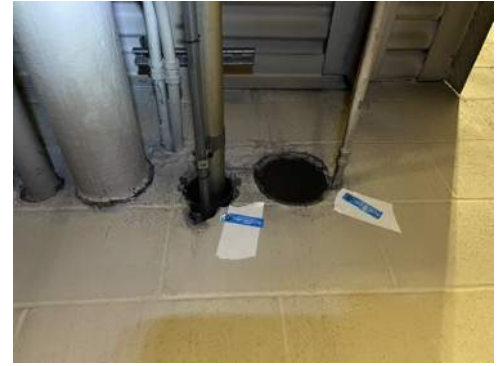
Photo 51- Sample# 7347-04-01-15, 2% Chrysotile Asbestos Detected in Pipe Penetration Caulk

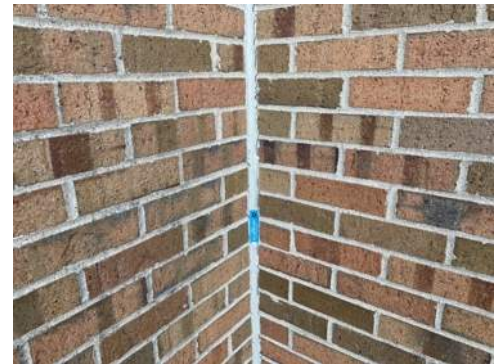
Photo 54- Sample# 7347-04-01-18, No Asbestos Detected in Grey Exterior Caulk

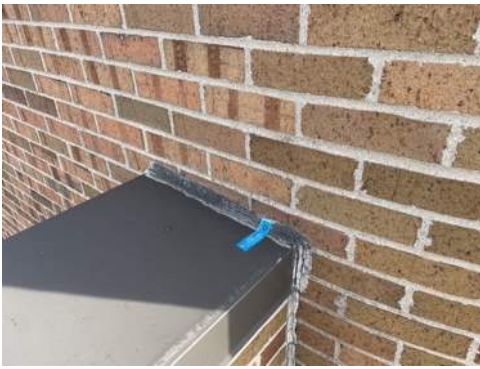
Photo 55- Sample# 7347-04-01-19, No Asbestos Detected in Grey Exterior Caulk

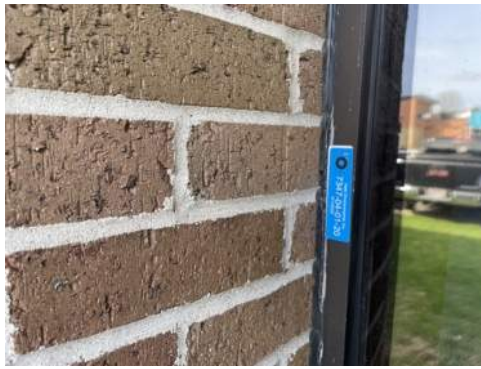
Photo 56- Sample# 7347-04-01-20, No Asbestos Detected in Black Exterior Caulk

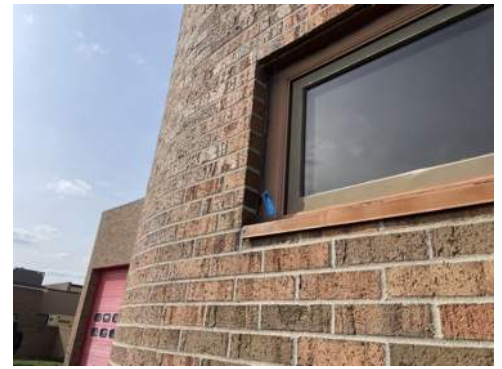
Photo 57- Sample# 7347-04-01-21, No Asbestos Detected in Grey Exterior Caulk

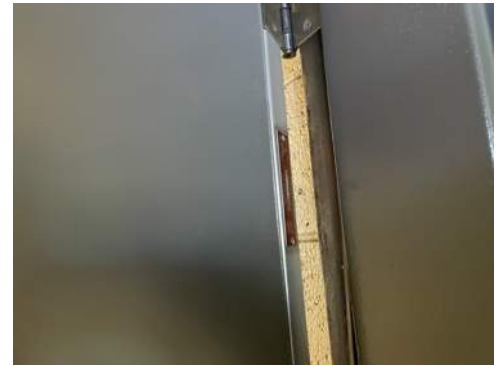
Photo 60- 1st Floor, West Vehicle Bay, Southeast Door, All Fire Doors are Assumed to Contain Asbestos

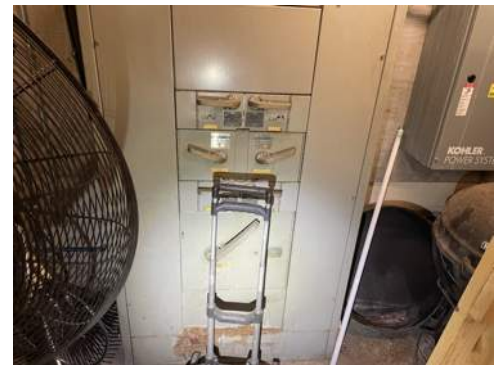
Photo 63- 1st Floor, Central Tower, East Wall, Switch Gear, All Electrical Insulators are Assumed to Contain Asbestos

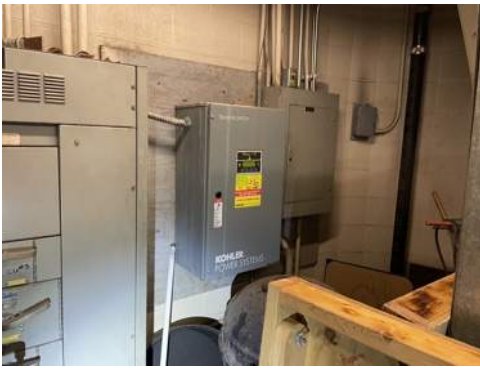
Photo 64- 1st Floor, Central Tower, East Wall, Switch and Circuit Breaker, All Electrical Insulators are Assumed to Contain Asbestos

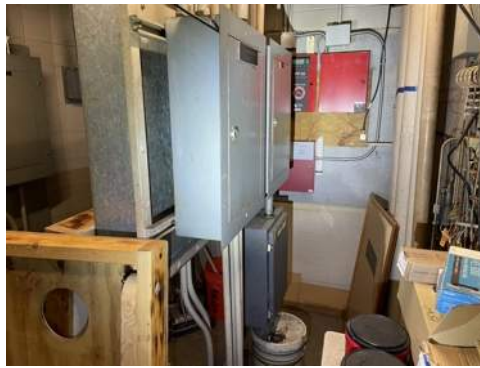
Photo 65- 1st Floor, Central Tower, SE Area, Circuit Breakers, All Electrical Insulators are Assumed to Contain Asbestos

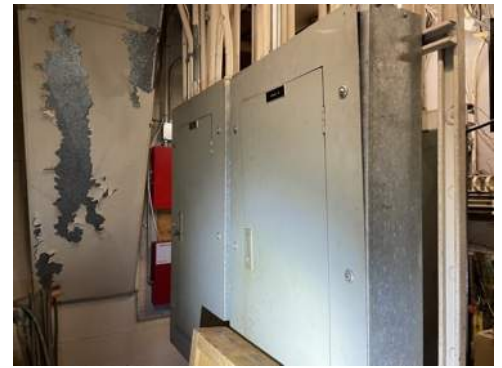
Photo 66- 1st Floor, Central Tower, SE Area, Circuit Breakers, All Electrical Insulators are Assumed to Contain Asbestos

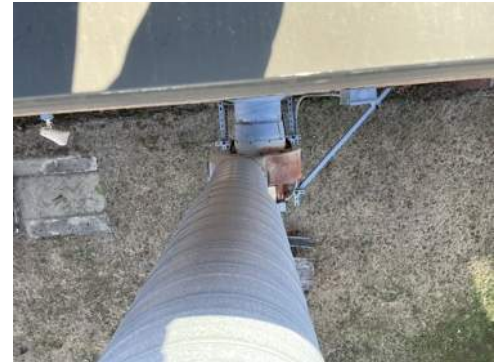
Photo 69- Exterior, West Side, Central Area, Safety Switch, All Electrical Insulators are Assumed to Contain Asbestos

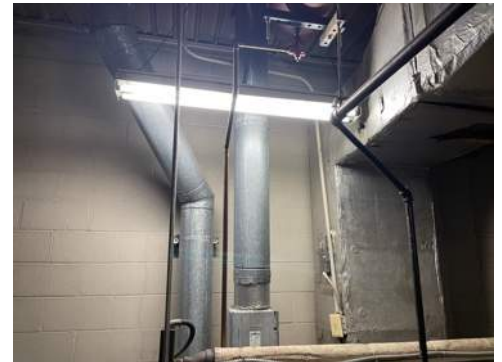
Photo 72- Boiler, Boiler Exhaust Flue is Assumed to Contain Asbestos

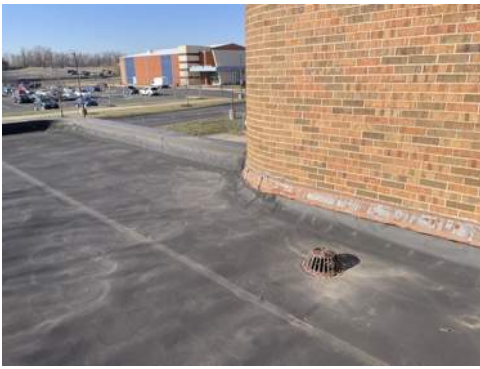
Photo 73- 2nd Floor, Rooftop, All Bituminous Roofing is Assumed to Contain Asbestos

inspectors (Mr. Benjamin Froehlich, Ohio Certification Cert. No. ES34739). In addition, approximately 4,000 SF of bituminous roofing materials on the Main Building and 800 SF of bituminous roofing materials on the East Addition were also observed by the inspectors, and were Category I Non-Friable materials. Under current EPA regulations, Category I Non-Friable materials, including bituminous roofing materials, resilient flooring material, and non-friable gaskets, do not need to be removed from buildings prior to their demolition. The quantities of these Category I Non-Friable materials must be noted on the demolition/renovation notification form which must be sent to the Ohio EPA at least 10-working days prior to the start of demolition or asbestos abatement.

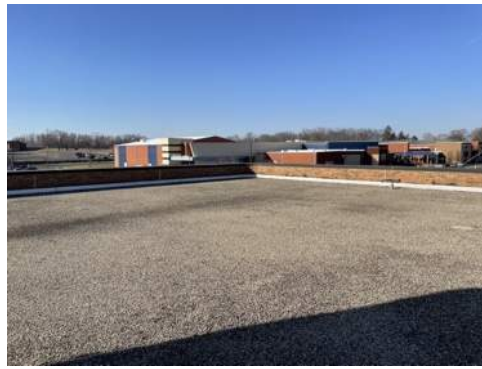
Photo 74- 3rd Floor, Rooftop, All Bituminous Roofing is Assumed to Contain Asbestos

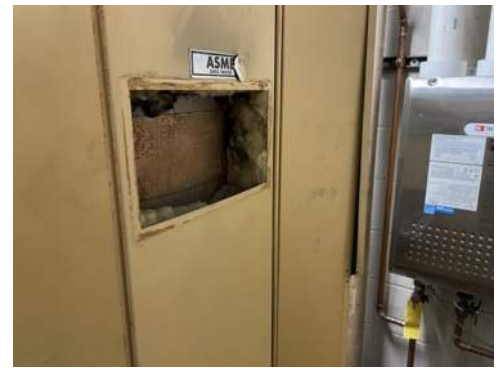
Photo 75- 3rd Floor, Hot Water Heater, Fiberglass Insulation

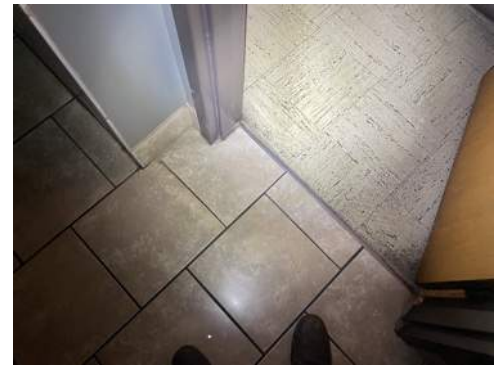
Photo 78- 1st Floor, NE Bathroom, Ceramic Tile over <1% Grey 12" x 12" Floor Tile

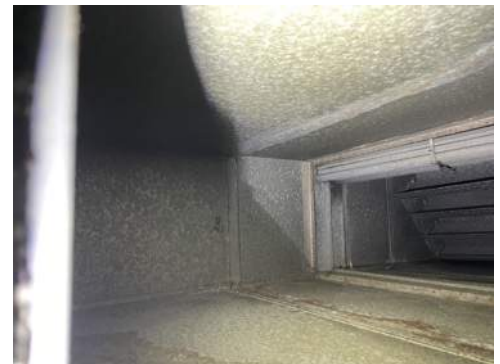
Photo 81- Inside of AHU 2, No Suspect Material

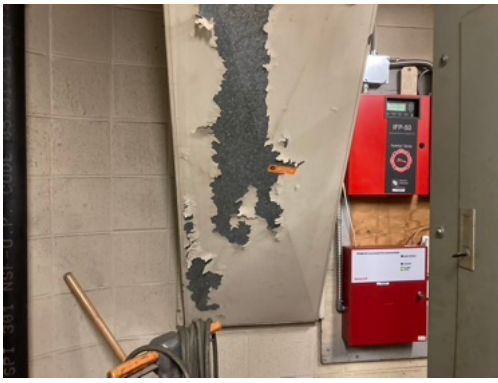
Paint Film Sample 7347-03-11-61 with no detectable lead

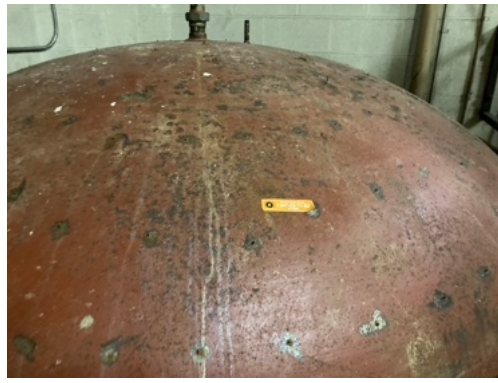
Paint Film Sample 7347-03-11-62 with 0.648% lead

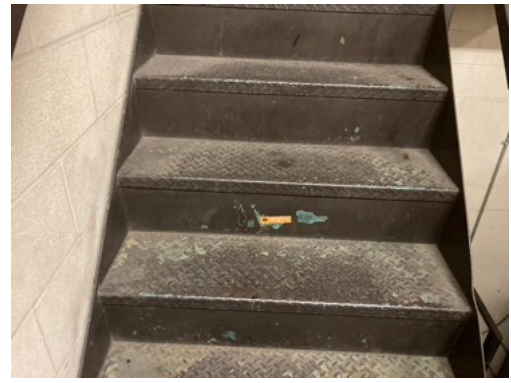
Paint Film Sample 7347-03-11-63 with 0.062% lead

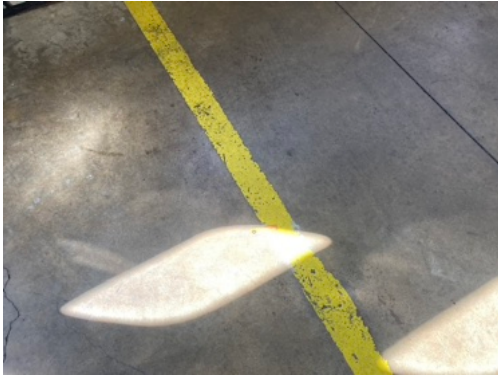
Paint Film Sample 7347-03-11-64 with 0.138% lead

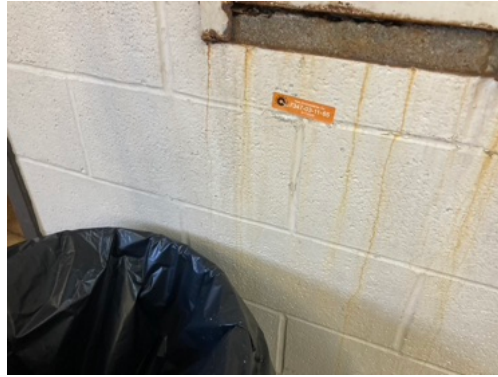
Paint Film Sample 7347-03-11-65 with no detectable lead

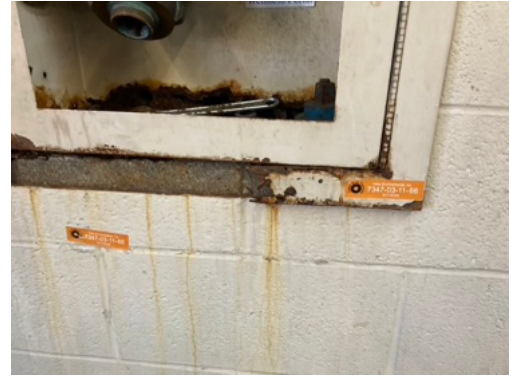
Paint Film Samples 7347-03-11-65 & 66 with no detectable lead

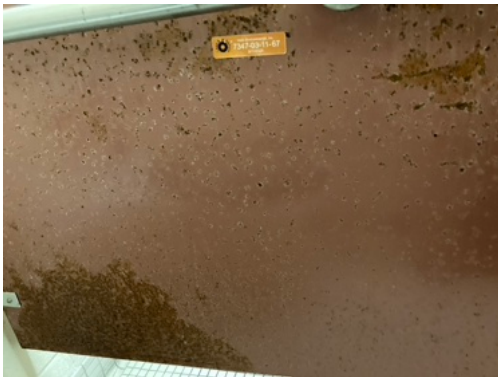
Paint Film Sample 7347-03-11-67 with 1.049% lead

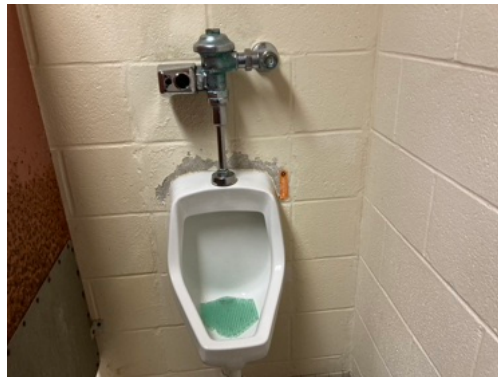
Paint Film Sample 7347-03-11-68 with no detectable lead

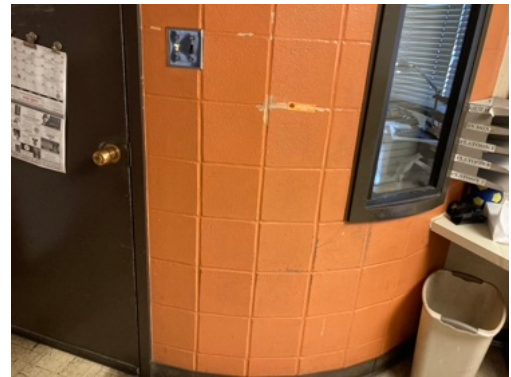
Paint Film Sample 7347-03-11-69 with no detectable lead

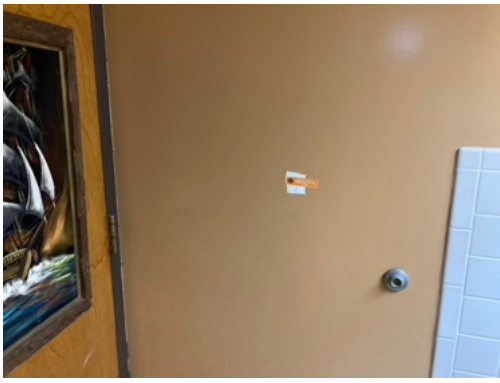
Paint Film Sample 7347-03-11-79 with
0.010% lead

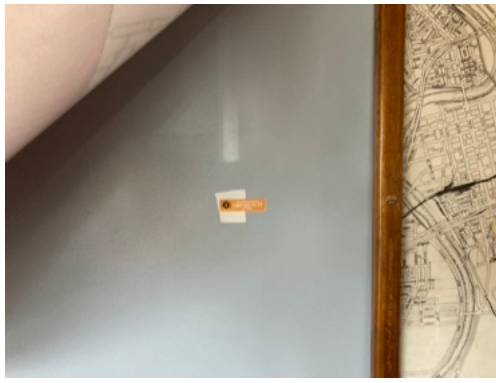
Paint Film Sample 7347-03-11-71 with
no detectable lead

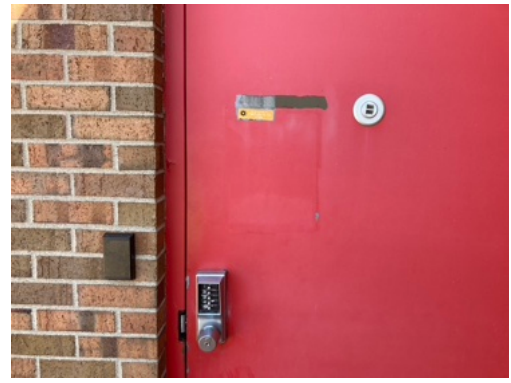
Paint Film Sample 7347-03-11-72 with
no detectable lead

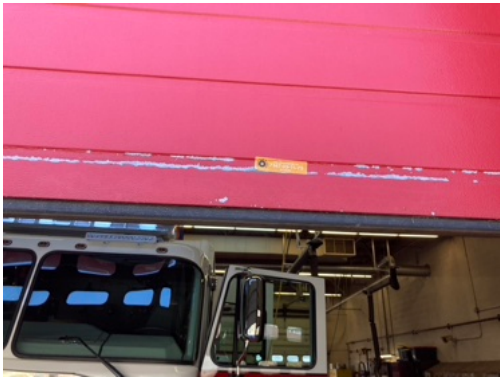
Paint Film Sample 7347-03-11-73 with
no detectable lead

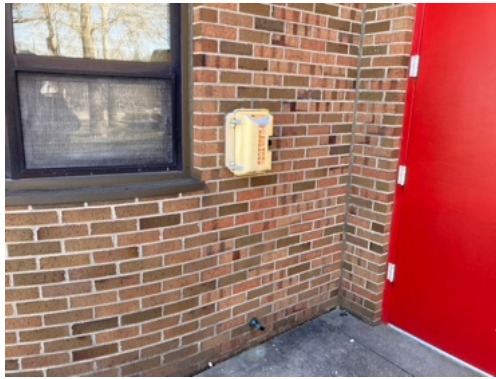
Paint Film Sample 7347-03-11-74 with
no detectable lead
