DATE: February 16, 2026
PROJECT: Harrison Township District 10
Sheriff Substation Renovation

ADDENDUM NO. 1

Analysis Report
prepared for
Helix Environmental Inc

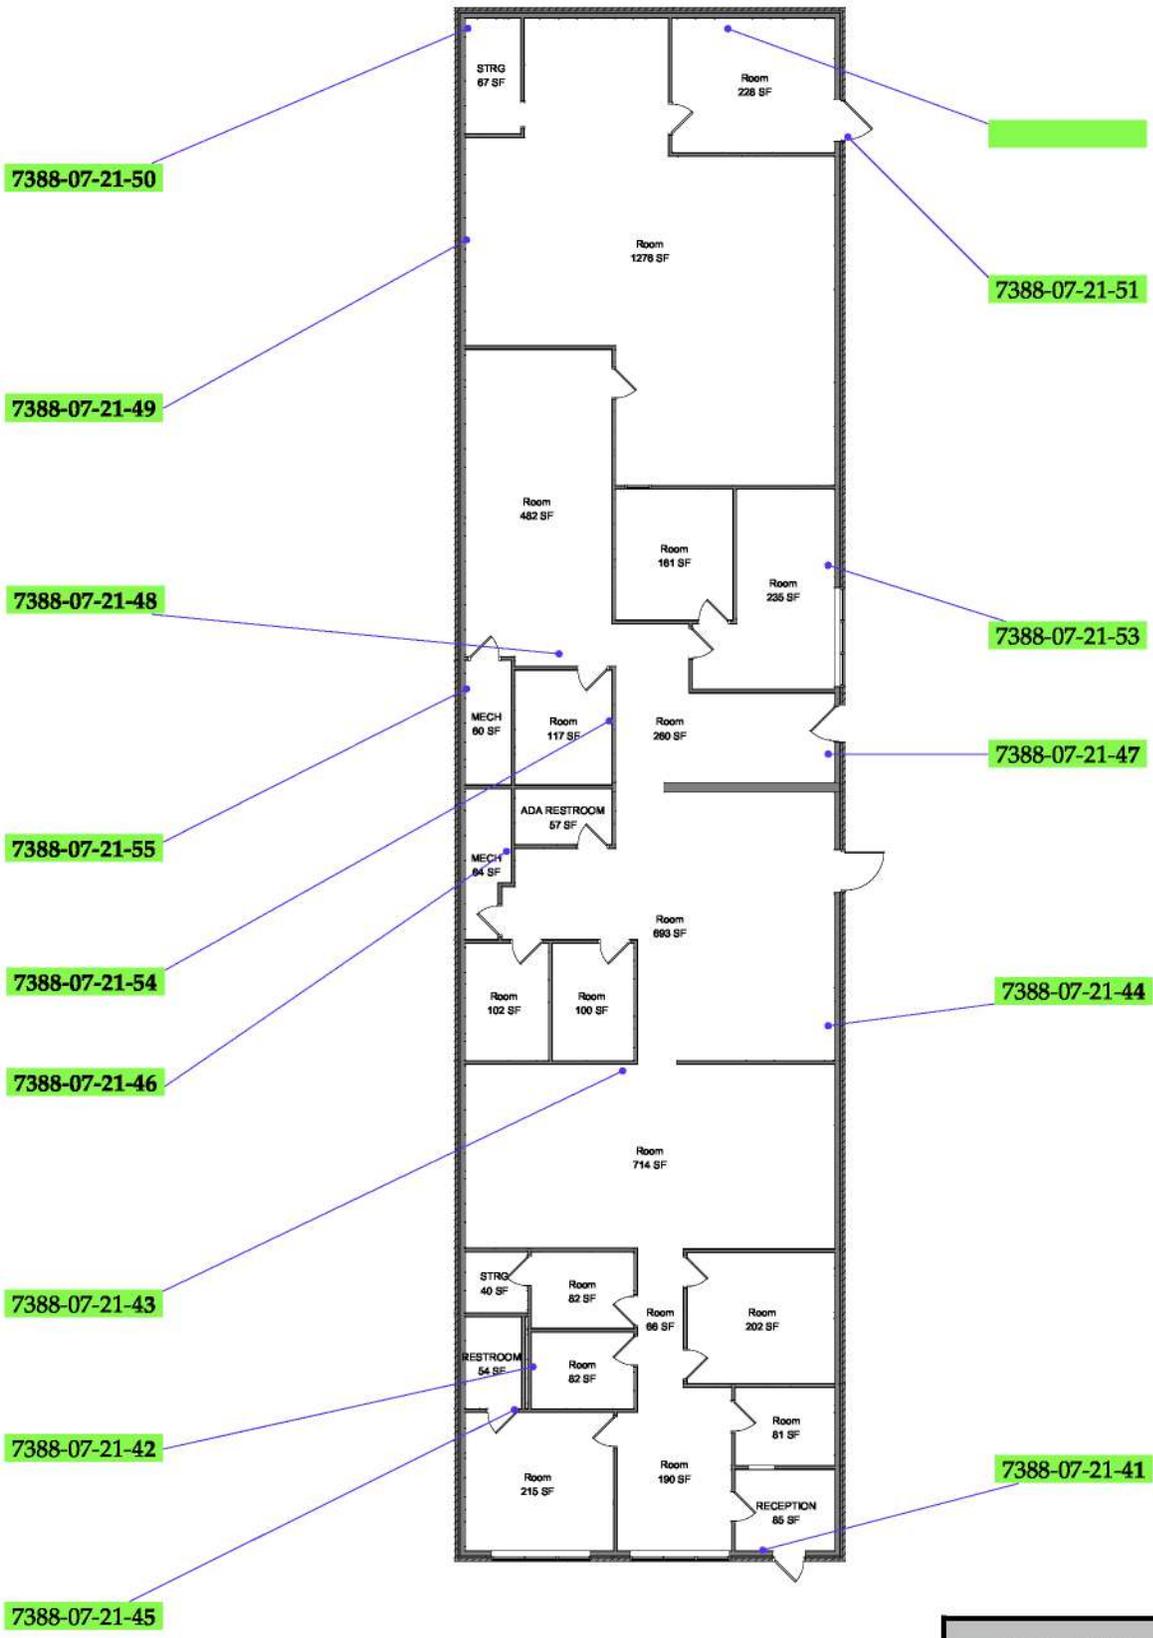
LEGEND

- Lead-Containing Paint
- Non Lead-Containing Paint

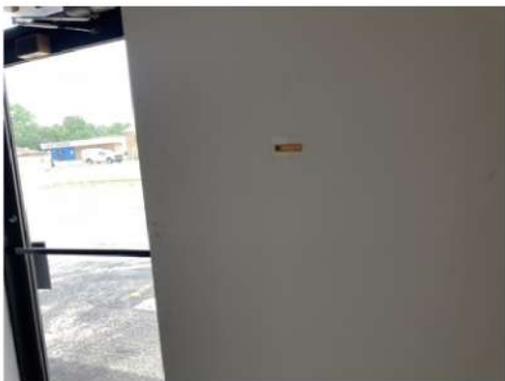
Sample 7388-07-25-41 with no detectable lead

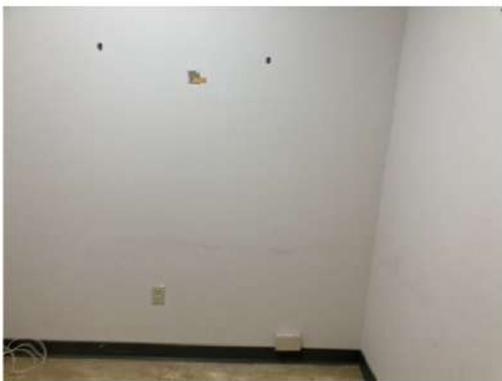
Sample 7388-07-25-42 with no detectable lead

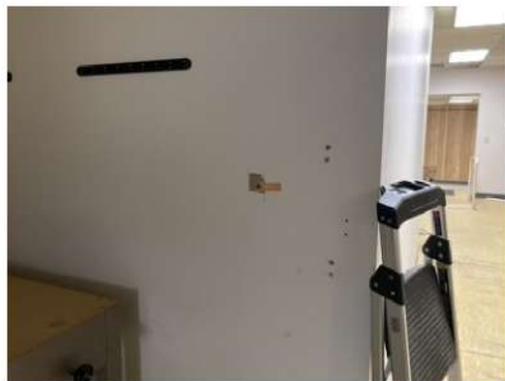
Sample 7388-07-25-43 with no detectable lead

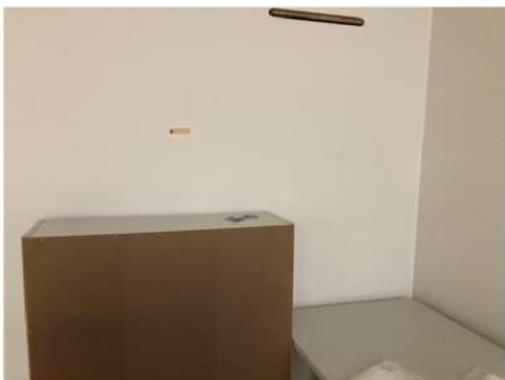
Sample 7388-07-25-44 with no detectable lead

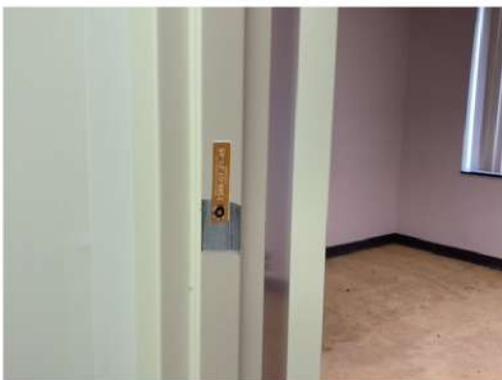
Sample 7388-07-25-45 with no detectable lead

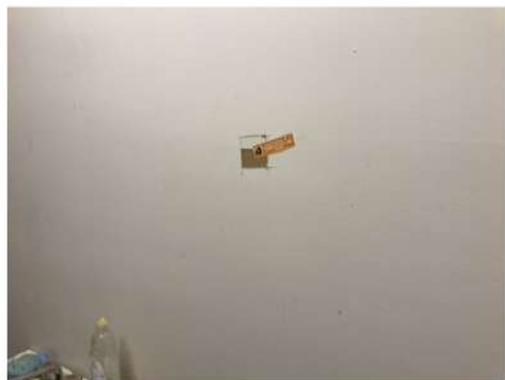
Sample 7388-07-25-46 with no detectable lead

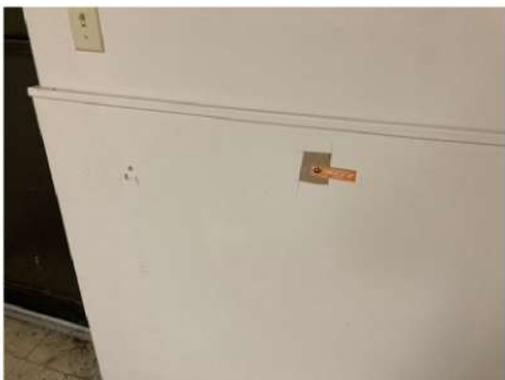
Sample 7388-07-25-47 with no detectable lead

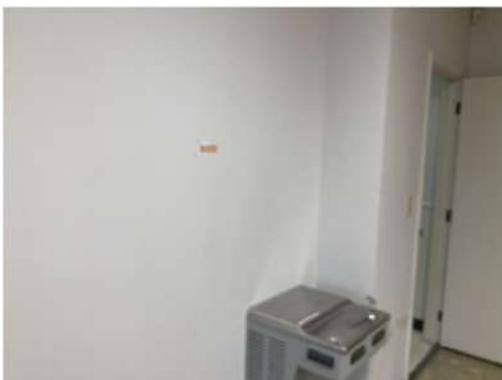
Sample 7388-07-25-48 with no detectable lead

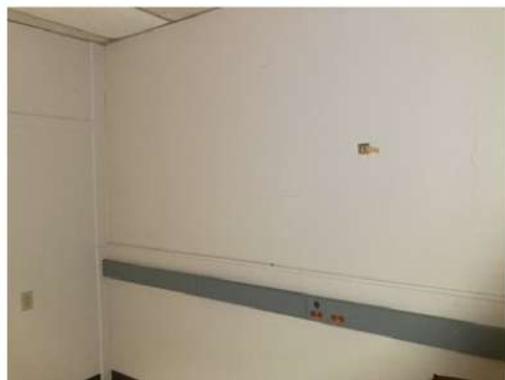
Sample 7388-07-25-49 with no detectable lead

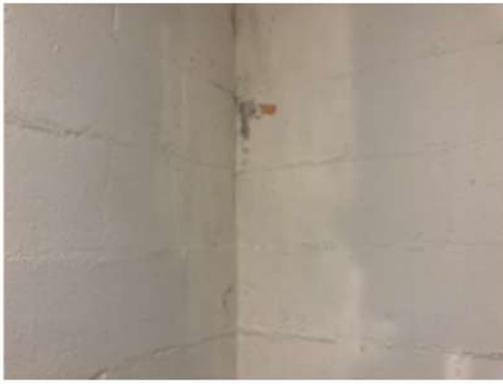
Sample 7388-07-25-50 with no detectable lead

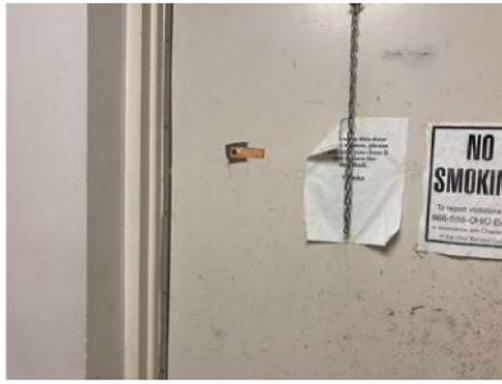
Sample 7388-07-25-51 with no detectable lead

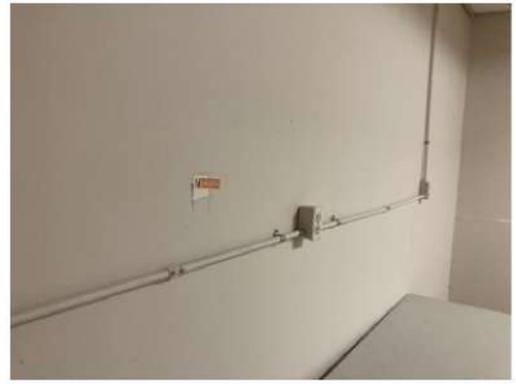
Sample 7388-07-25-52 with no detectable lead

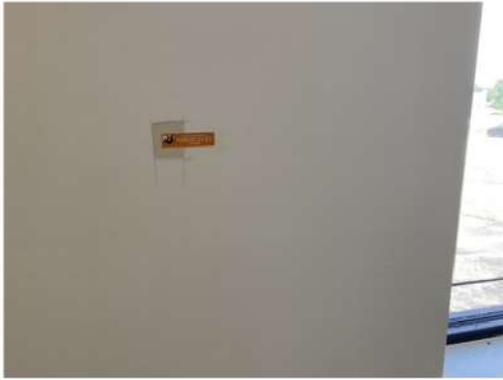
Sample 7388-07-25-53 with no detectable lead

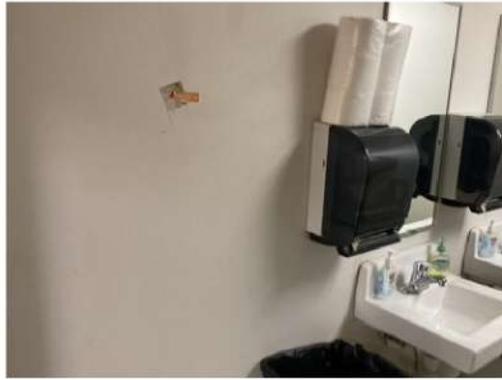
Sample 7388-07-25-54 with no detectable lead

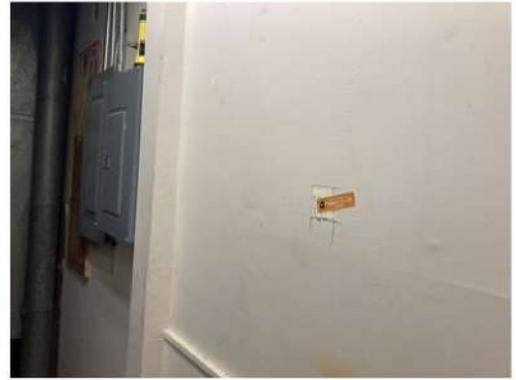
Sample 7388-07-25-55 with no detectable lead

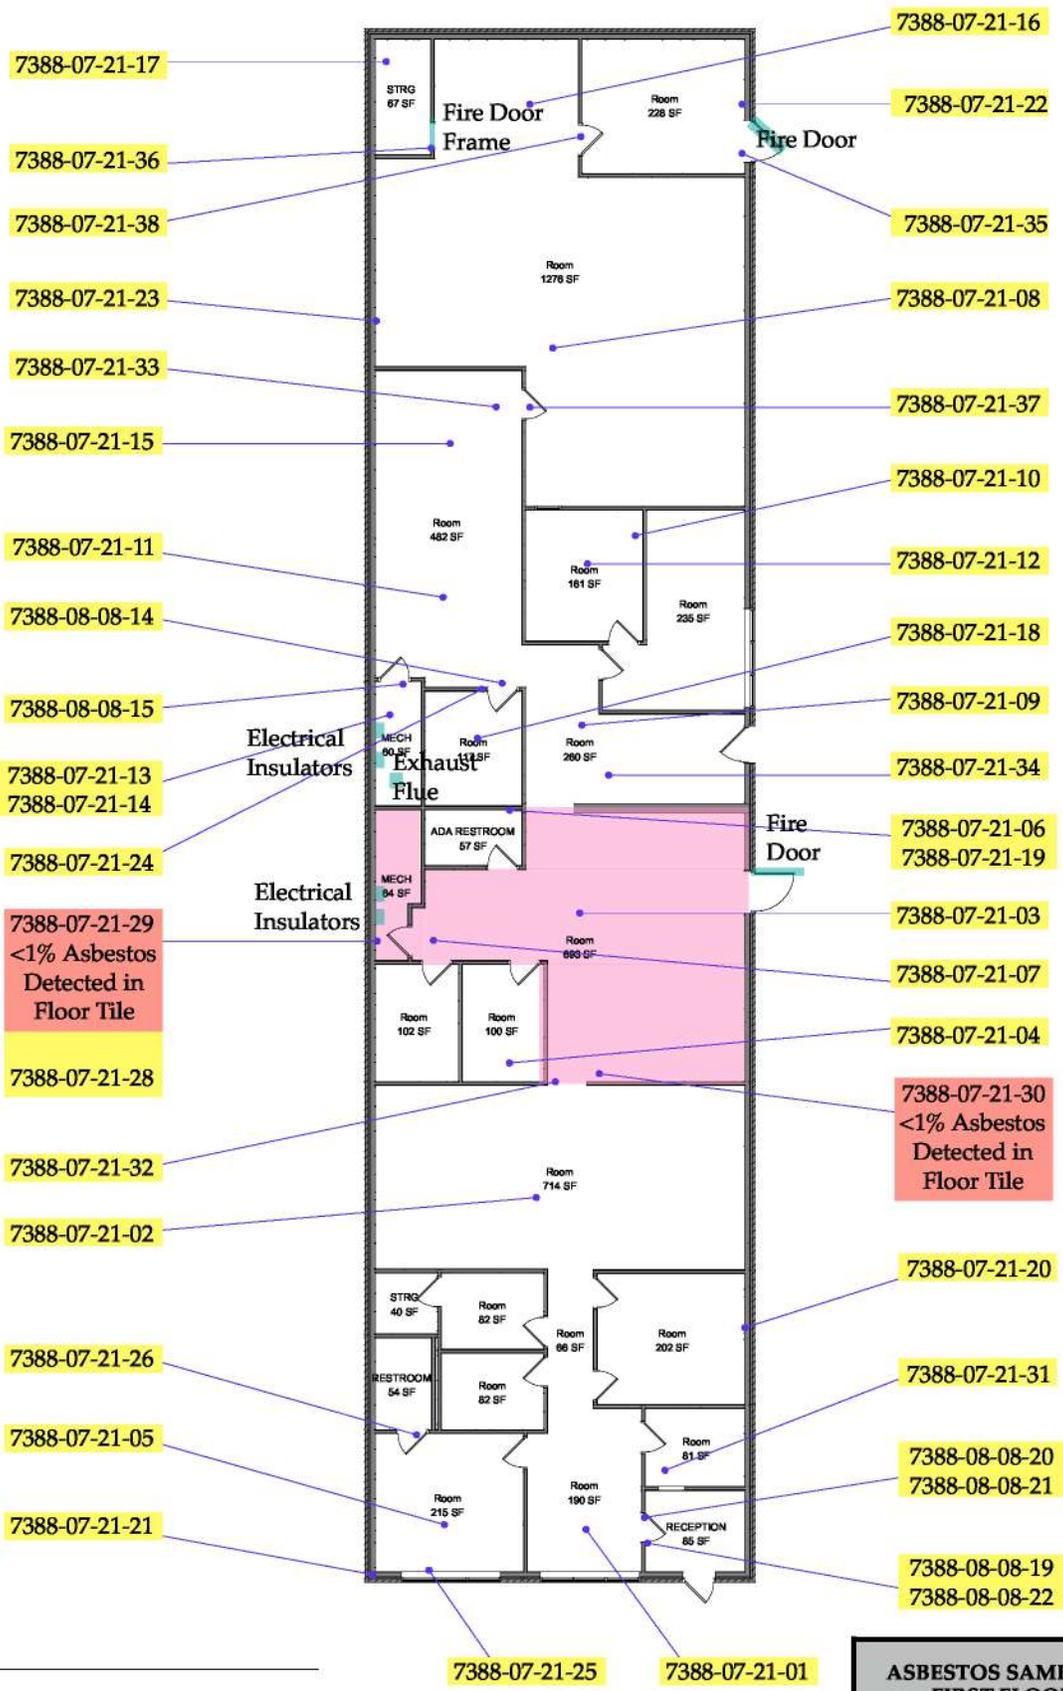
LEGEND

- Asbestos-Containing Material
- Non Asbestos-Containing Material
- Asbestos-Containing Material (Insulation, Flooring Etc.)
- Assumed Asbestos-Containing Material Present (Electrical Insulators, Fire Doors, Etc.)

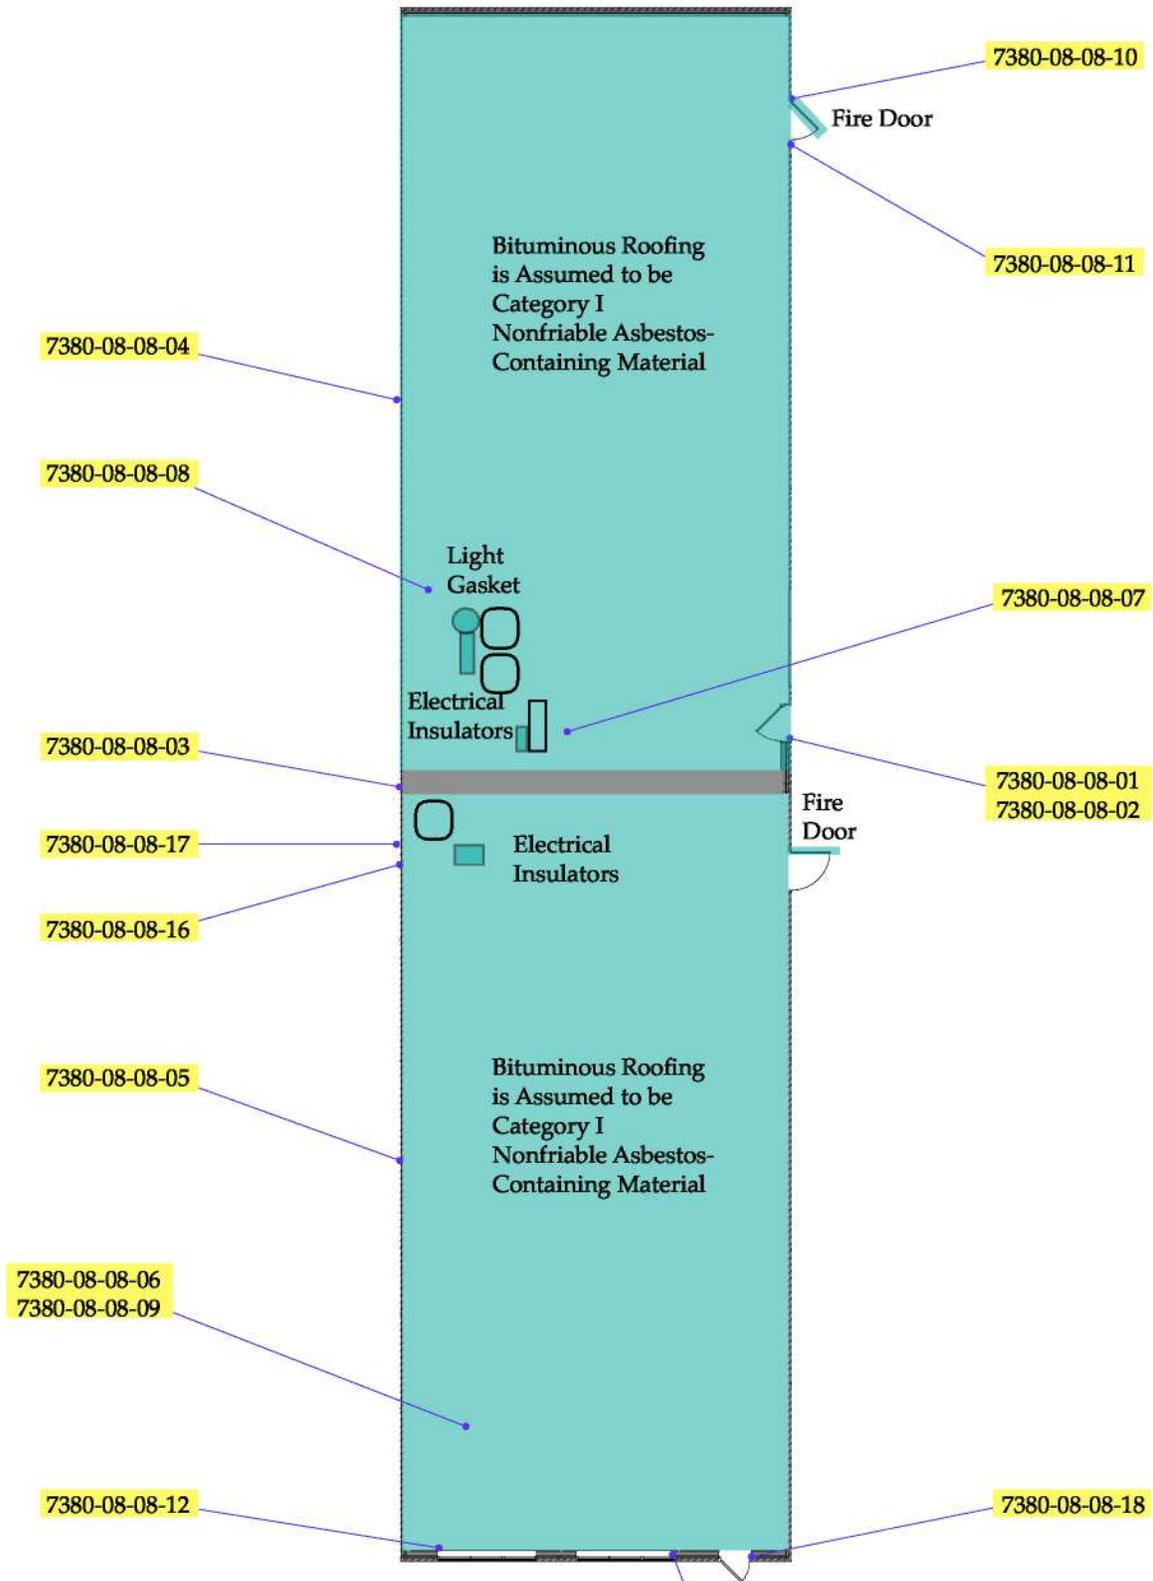
LEGEND

- Asbestos-Containing Material
- Non Asbestos-Containing Material
- Asbestos-Containing Material (Insulation, Flooring Etc.)
- Assumed Asbestos-Containing Material Present (Electrical Insulators, Roofing, Fire Doors, Etc.)

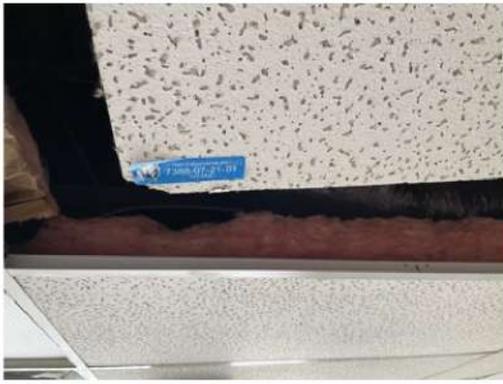
Photo 01- Sample# 7388-07-21-01, No Asbestos Detected in Ceiling Tile

Helix Sample No. Lab Sample No.	Amount	Layer	Description/Sample Location	Friable or Non-Friable	PLM Result (% Asbestos)
7388-07-21-01 25047487-001	1150 SF	1	2' x 4' Ceiling Tile, Random Short Fissures and Holes, Dense Pattern/ 1st Floor, East Building, East Central Hallway, East Central Area, On Ceiling, 9' Ht.	Friable	No Asbestos Detected
7388-07-21-02 25047487-002	-	1	2' x 4' Ceiling Tile, Random Short Fissures and Holes, Dense Pattern/ 1st Floor, East Building, Central Room, Central Area, On Ceiling, 9' Ht.	Friable	No Asbestos Detected
7388-07-21-15 25047487-015	1500 SF	1	2' x 4' Ceiling Tile, Random Short Fissures and Holes, Dense Pattern/ 1st Floor, West Addition, Large South Central Room, West Central Area, On Ceiling, 8.5' Ht.	Friable	No Asbestos Detected
7388-07-21-16 25047487-016	-	1	2' x 4' Ceiling Tile, Random Short Fissures and Holes, Dense Pattern/ 1st Floor, West Addition, Large West Room, West Central Area, On Ceiling, 8.5' Ht.	Friable	No Asbestos Detected

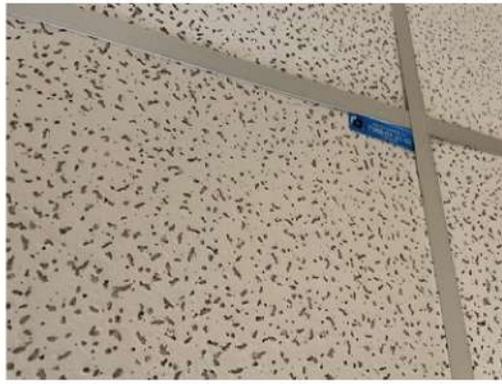
Photo 02- Sample# 7388-07-21-02, No Asbestos Detected in Ceiling Tile

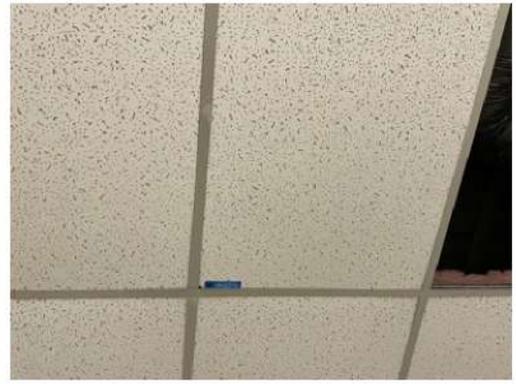
Photo 03- Sample# 7388-07-21-03, No Asbestos Detected in Ceiling Tile

7388-07-21-03 25047487-003	400 SF	1	2' x 4' Ceiling Tile, Random Short Fissures and Holes/ 1st Floor, East Building, Northwest Room, Central Area, On Ceiling, 9' Ht.	Friable	No Asbestos Detected
7388-07-21-04 25047487-004	-	1	2' x 4' Ceiling Tile, Random Short Fissures and Holes/ 1st Floor, East Building, Southwest Central Office, East Central Area, On Ceiling, 9' Ht.	Friable	No Asbestos Detected

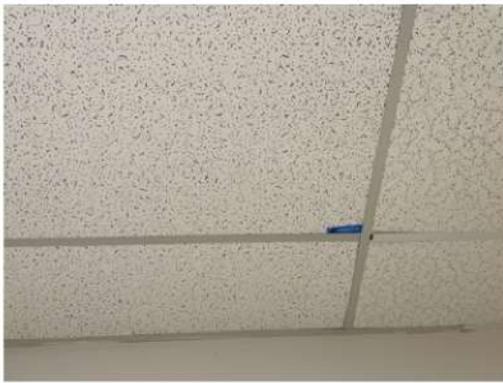
Photo 04- Sample# 7388-07-21-04, No Asbestos Detected in Ceiling Tile

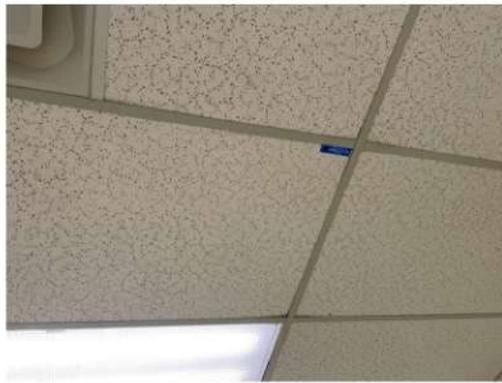
Photo 05- Sample# 7388-07-21-05, No Asbestos Detected in Ceiling Tile

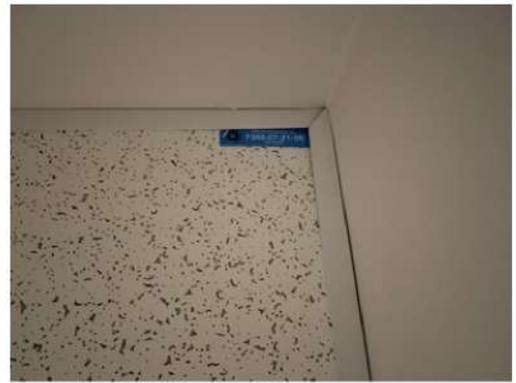
Photo 06- Sample# 7388-07-21-06, No Asbestos Detected in Ceiling Tile

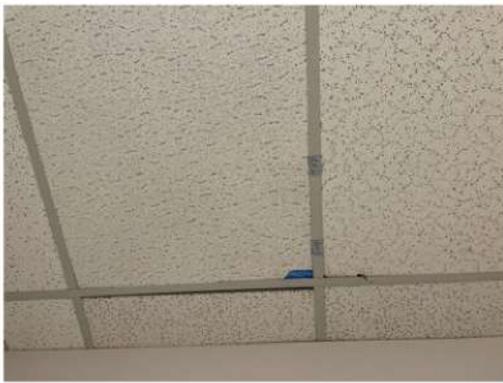
Photo 07- Sample# 7388-07-21-07, No Asbestos Detected in Ceiling Tile

7388-07-21-07 25047487-007	112 SF	1	2' x 4' Ceiling Tile, Horizontal Fissures and Holes / 1st Floor, East Building, Northwest Room, South Central Area, On Ceiling, 9' Ht.	Friable	No Asbestos Detected
7388-07-21-08 25047487-008	-	1	2' x 4' Ceiling Tile, Horizontal Fissures and Holes / 1st Floor, West Addition, Large West Room, East Central Area, On Ceiling, 9' Ht.	Friable	No Asbestos Detected

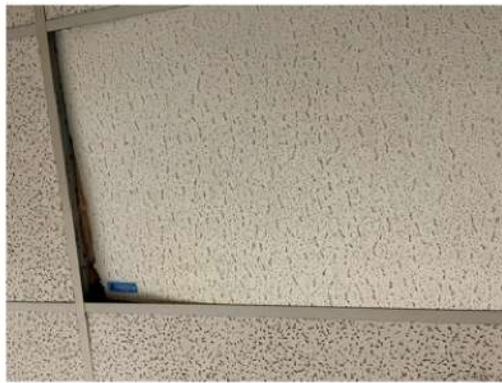
Photo 08- Sample# 7388-07-21-08, No Asbestos Detected in Ceiling Tile

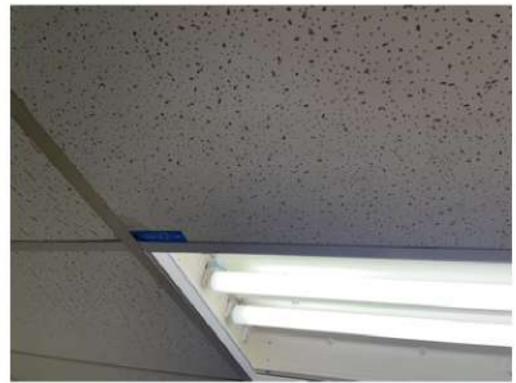
Photo 09- Sample# 7388-07-21-09, No Asbestos Detected in Ceiling Tile

Helix Sample No. Lab Sample No.	Amount	Layer	Description/Sample Location	Friable or Non-Friable	PLM Result (% Asbestos)
7388-07-21-09 25047487-009	80 SF	1	2' x 4' Ceiling Tile, Random Gouges and Holes/ 1st Floor, West Addition, Northeast Hallway, South Central Area, On Ceiling, 9' Ht.	Friable	No Asbestos Detected
7388-07-21-10 25047487-010	-	1	2' x 4' Ceiling Tile, Random Gouges and Holes/ 1st Floor, West Addition, East Central Room, North Central Area, On Ceiling, 9' Ht.	Friable	No Asbestos Detected
7388-07-21-11 25047487-011	16 SF	1	2' x 4' Ceiling Tile, Deep Horizontal Fissures and Holes/ 1st Floor, West Addition, South Central Room, East Central Area, On Ceiling, 9' Ht.	Friable	No Asbestos Detected
7388-07-21-12 25047487-012	-	1	2' x 4' Ceiling Tile, Deep Horizontal Fissures and Holes/ 1st Floor, West Addition, East Central Room, West Central Area, On Ceiling, 9' Ht.	Friable	No Asbestos Detected

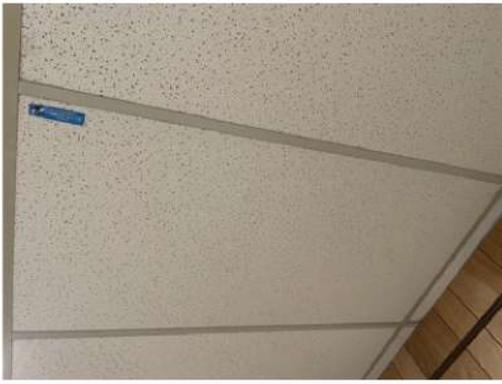
Photo 10- Sample# 7388-07-21-10, No Asbestos Detected in Ceiling Tile

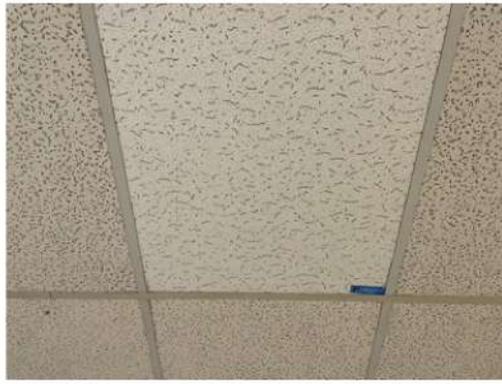
Photo 11- Sample# 7388-07-21-11, No Asbestos Detected in Ceiling Tile

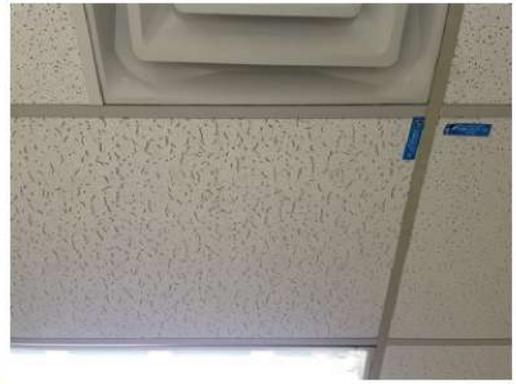
Photo 12- Sample# 7388-07-21-12, No Asbestos Detected in Ceiling Tile

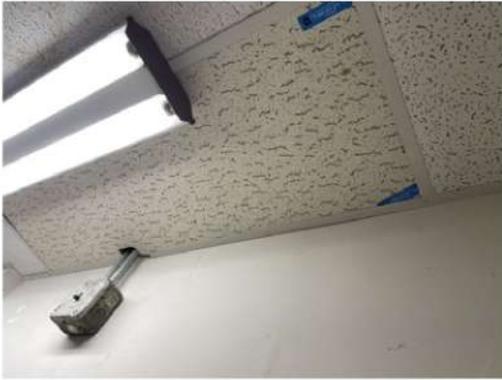
Photo 13- Sample# 7388-07-21-13, No Asbestos Detected in Ceiling Tile

7388-07-21-13 25047487-013	8 SF	1	2' x 4' Ceiling Tile, Deep Longways Fissures and Holes/ 1st Floor, West Addition, Southeast Mechanical Room, Southwest Area, On Ceiling, 9' Ht.	Friable	No Asbestos Detected
7388-07-21-14 25047487-014	-	1	2' x 4' Ceiling Tile, Deep Longways Fissures and Holes/ 1st Floor, West Addition, Southeast Mechanical Room, Southwest Area, On Ceiling, 9' Ht.	Friable	No Asbestos Detected

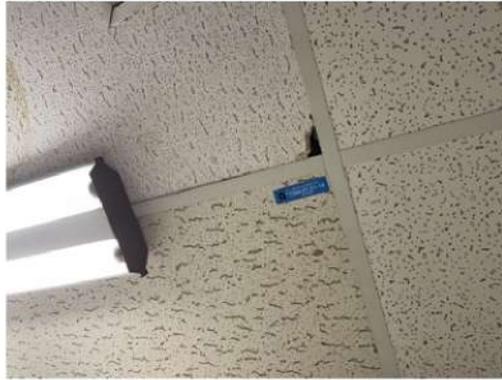
Photo 14- Sample# 7388-07-21-14, No Asbestos Detected in Ceiling Tile

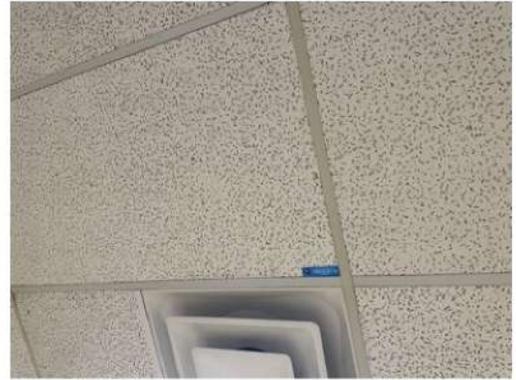
Photo 15- Sample# 7388-07-21-15, No Asbestos Detected in Ceiling Tile

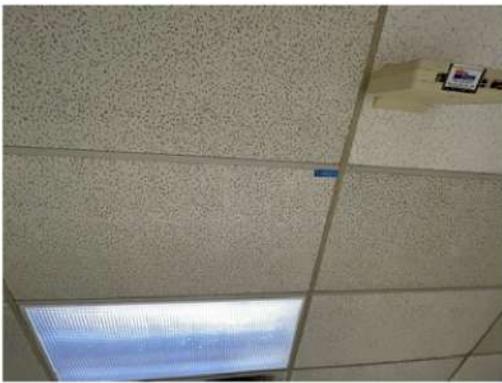
Photo 16- Sample# 7388-07-21-16, No Asbestos Detected in Ceiling Tile

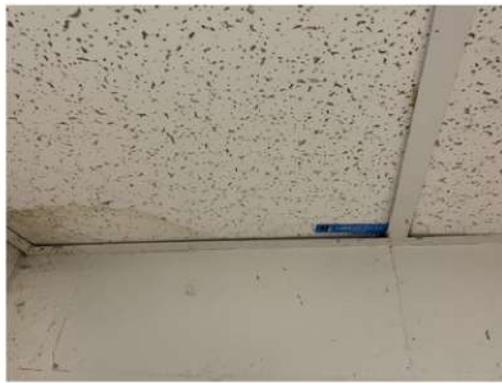
Photo 17- Sample# 7388-07-21-17, No Asbestos Detected in Ceiling Tile

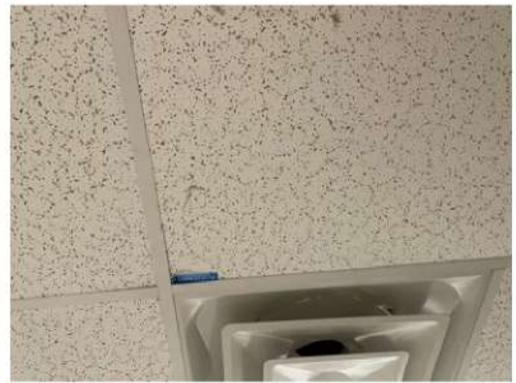
Photo 18- Sample# 7388-07-21-18, No Asbestos Detected in Ceiling Tile

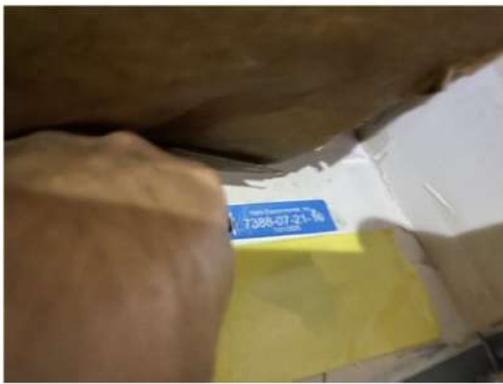
Photo 19- Sample# 7388-07-21-19, No Asbestos Detected in Drywall and Joint Compound

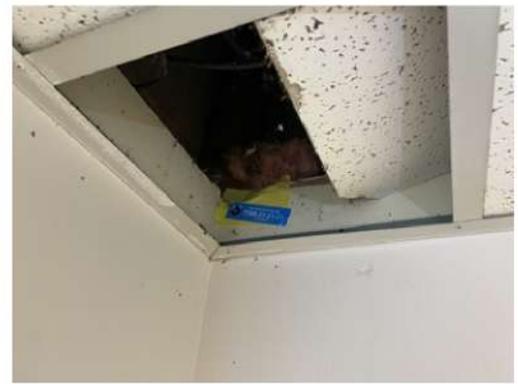
Photo 20- Sample# 7388-07-21-20, No Asbestos Detected in Drywall and Joint Compound

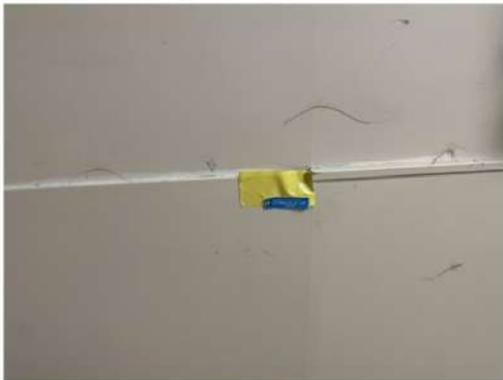
Photo 21- Sample# 7388-07-21-21, No Asbestos Detected in Drywall and Joint Compound

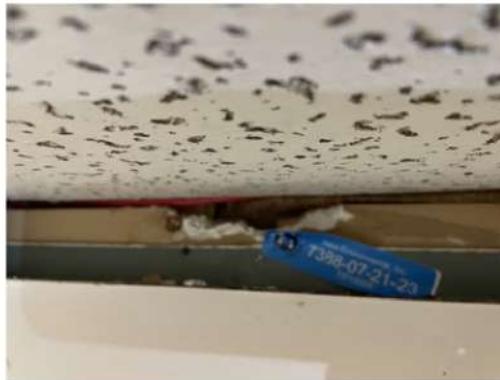
Photo 22- Sample# 7388-07-21-22, No Asbestos Detected in Drywall and Joint Compound

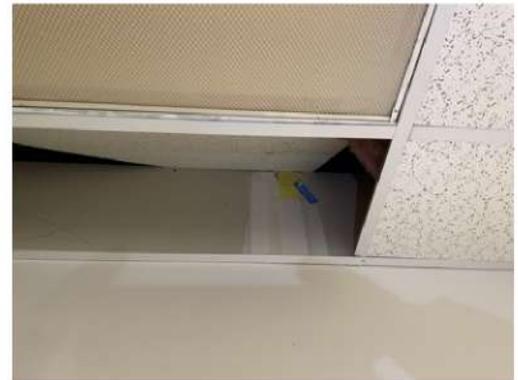
Photo 23- Sample# 7388-07-21-23, No Asbestos Detected in Drywall and Joint Compound

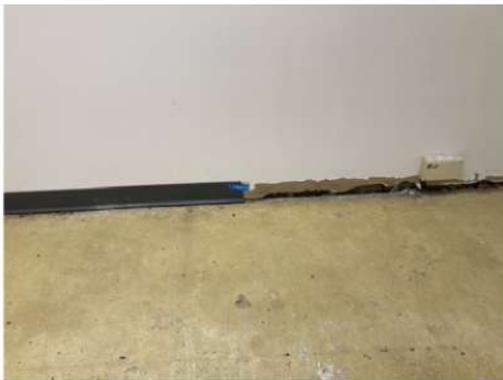
Photo 24- Sample# 7388-07-21-24, No Asbestos Detected in Drywall and Joint Compound

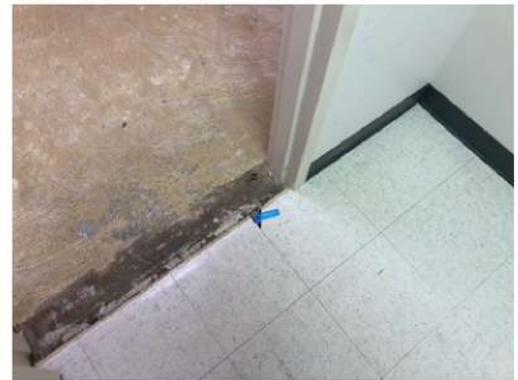
Photo 26- Sample# 7388-07-21-26, No Asbestos Detected in 12"x12" Ivory Mottled Floor Tile and Mastic

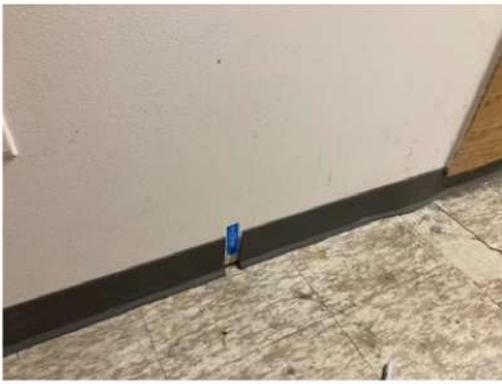
Photo 27- Sample# 7388-07-21-27, No Asbestos Detected in 12"x12" Ivory Mottled Floor Tile and Mastic

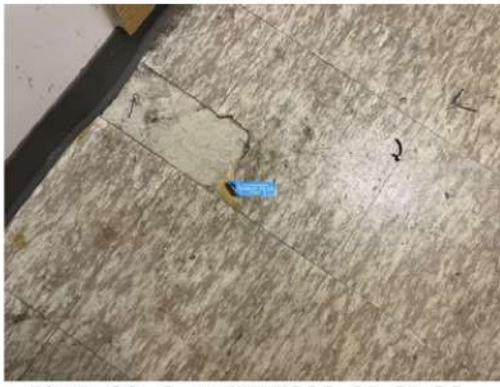
Photo 28- Sample# 7388-07-21-28, No Asbestos Detected in Cove Base and Mastic

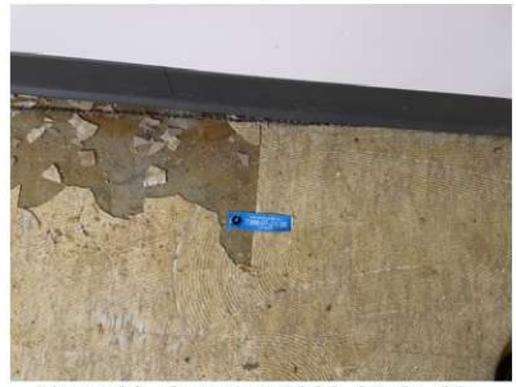
Photo 29- Sample# 7388-07-21-29, 0.6% Chrysotile Asbestos Detected in Grey Mottled Floor Tile, No Asbestos Detected in Mastic

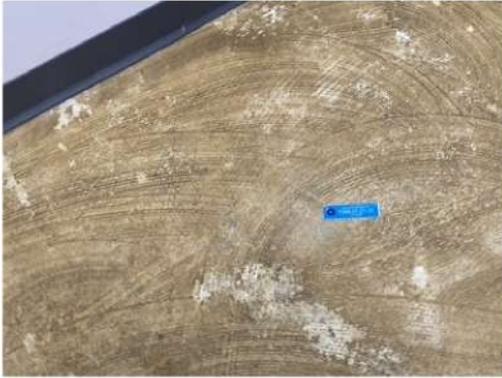
Photo 30- Sample# 7388-07-21-30, 0.6% Chrysotile Asbestos Detected in Grey Mottled Floor Tile, No Asbestos Detected in Mastic

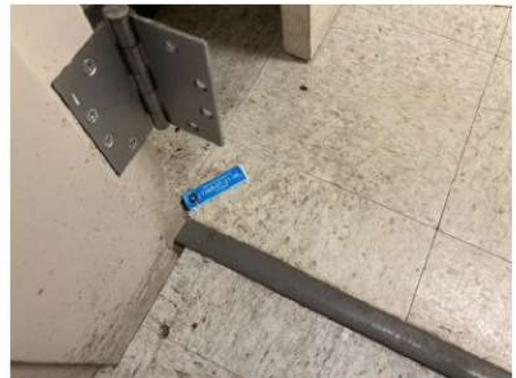
Photo 35- Sample# 7388-07-21-35, No Asbestos Detected in 12"x12" Ivory Mottled Floor Tile and Mastic

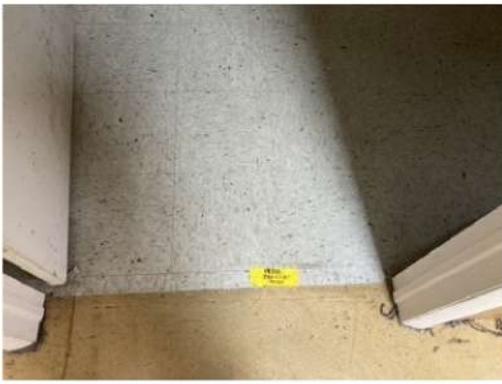
Photo 36- Sample# 7388-07-21-36, No Asbestos Detected in 12"x12" Ivory Mottled Floor Tile and Mastic

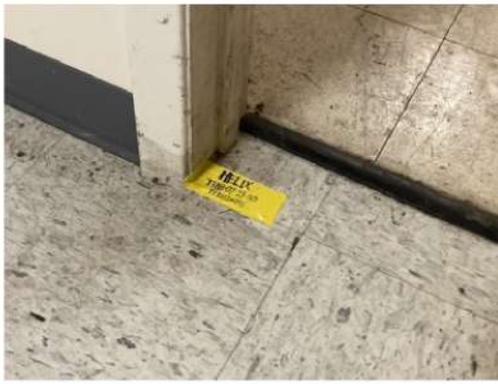
Photo 37- Sample# 7388-07-21-37, No Asbestos Detected in 12"x12" Grey Mottled Floor Tile and Mastic

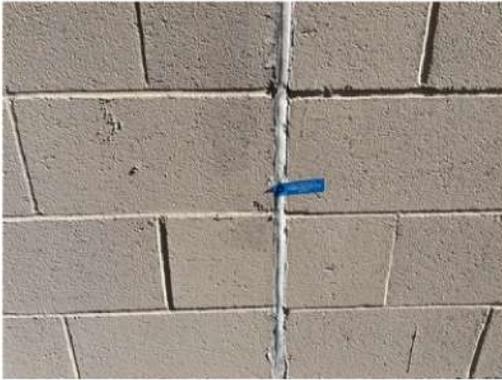
Photo 39- Sample# 7388-08-08-03, No Asbestos Detected in Light Grey Expansion Joint Caulk

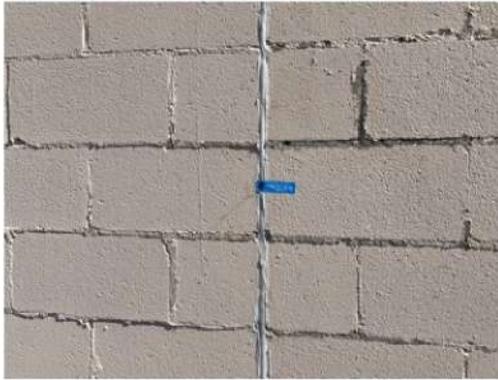
Photo 40- Sample# 7388-08-08-04, No Asbestos Detected in Light Grey Expansion Joint Caulk

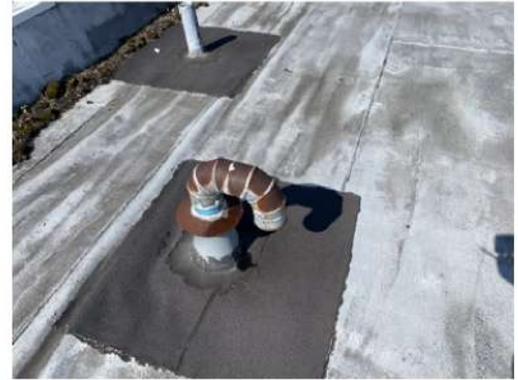
Photo 41- Sample# 7388-08-08-05, No Asbestos Detected in Light Grey Expansion Joint Caulk

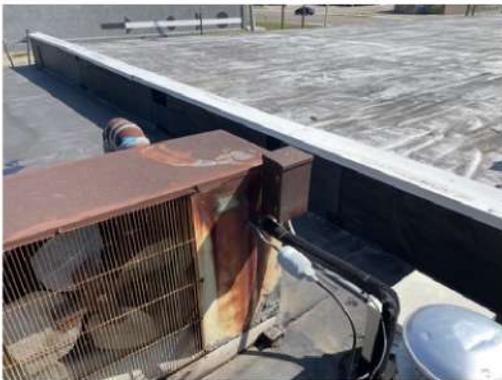
Photo 42- Sample# 7388-08-08-06, No Asbestos Detected in Light Grey Duct Caulk

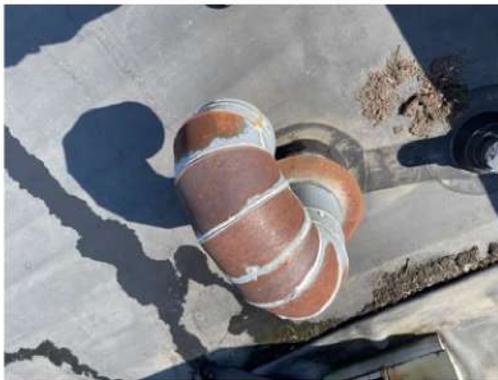
Photo 43- Sample# 7388-08-08-07, No Asbestos Detected in Light Grey Duct Caulk

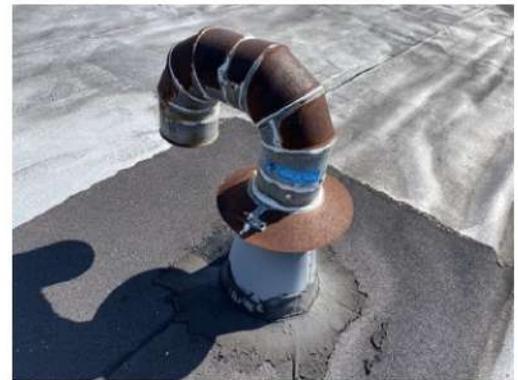
Photo 44- Sample# 7388-08-08-08, No Asbestos Detected in Light Grey Duct Caulk

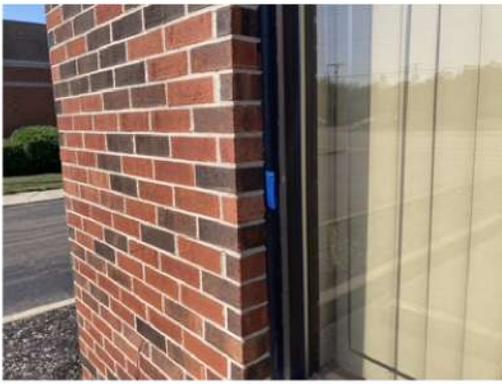
Photo 45- Sample# 7388-08-08-09, No Asbestos Detected in Light Grey Duct Caulk

HELIX SAMPLE ID NUMBER	AMOUNT	REPRESENTATIVE SAMPLE LOCATION	MATERIAL DESCRIPTION	FRAGILE/ NON	CONDITION	COMMENTS
7388-08-08-01		W. Addn, North Caster Door Frame	Exterior Caulk	N	G	
7388-08-08-02		W. Addn, North Caster Door Frame	Exterior Caulk	N	G	
7388-08-08-03	24 LF	Exterior, South side of room between Buildings 5-14.	Light grey Expansion joint caulk	N	G	36 LF total
7388-08-08-04		Exterior, south side, West Addition, Cedar, 3 HI.	Light grey Expansion joint caulk	N	G	
7388-08-08-05	24 LP	Exterior, South side, East Bldg, Cedar, 3 HI.	Light grey Expansion joint caulk	N	G	
7388-08-08-06	2 SF	Exterior, East Building Area, on Exhaust out, 1.5 HI.	Light grey Duct Caulk	N	F	
7388-08-08-07	4 SF	Exterior, West Addition Roof, on Exhaust out, 2 HI.	Light grey Duct Caulk	N	F	
7388-08-08-08		Exterior, West Addition, Roof, S E cantaltery on Exhaust out, 2 HI.	Light grey Duct Caulk	N	F	
7388-08-08-09		Exterior, East Bldg, roof, SE Area on Exhaust Duct	Light grey Duct Caulk	N	F

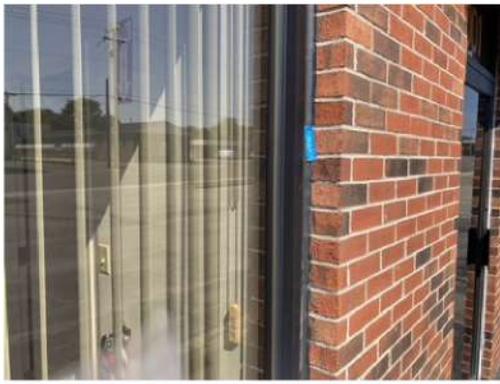
Photo 46- Sample# 7388-08-08-12, No Asbestos Detected in Exterior Dark Brown Caulk

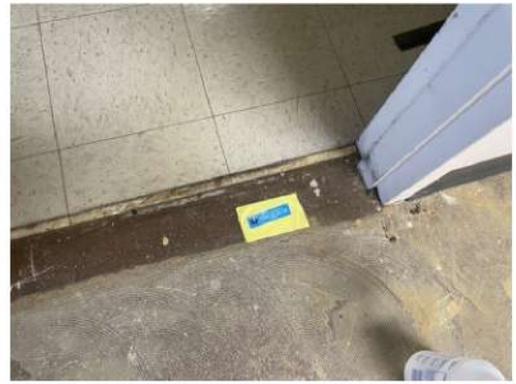
Photo 47- Sample# 7388-08-08-13, No Asbestos Detected in Exterior Dark Brown Caulk

HELIX SAMPLE ID NUMBER	AMOUNT	REPRESENTATIVE SAMPLE LOCATION	MATERIAL DESCRIPTION	FRAGILE/ NON	CONDITION	COMMENTS
7386-08-08-13	2	East Side, N Windows, N Side	Exterior Bank Brown Caulk	N	G	
7386-08-08-14	500 SF	West Addition, 1st Fl. S. Central Room, NE of Main Entrance to NWS Restroom.	Brown concrete coating	N	F	
7386-08-08-15	1	West Addition, 1st Fl. S. Central Room SE of Main Entrance to Mechanical Room.	Brown concrete coating	N	F	
7386-08-08-16	3 SF	East Addition, 1st Fl. S. Central Room, West of Main Electrical Service	grey fire protection plaster	N	F	
7386-08-08-17	1	East Addition, 1st Fl. S. Central Room, West of Main Electrical Service	grey fire protection plaster	N	F	
7386-08-08-18		Exterior East Bldg, East Side N. Area, At Doorway, N. Side	Grey Exterior Caulk	N	F	
7386-08-08-19	120 SF	East Bldg, 1st Fl. NE Room (doorway) S. Central Room	Thrust Mortar	N	G	
7386-08-08-20	1	East Bldg, 1st Fl. NE Room (doorway) S. Central Room	Thrust Mortar	N	G

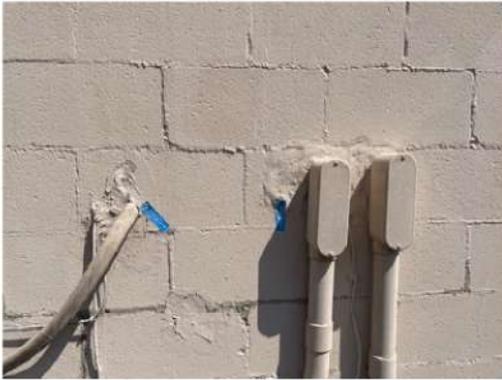
Photo 48- Sample# 7388-08-08-14, No Asbestos Detected in Brown Concrete Coating

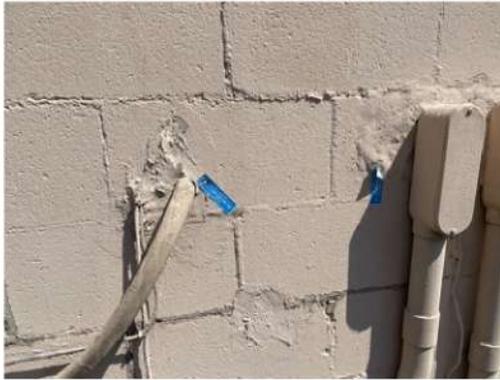
Photo 49- Sample# 7388-08-08-16, No Asbestos Detected in Grey Pipe Penetration Plaster

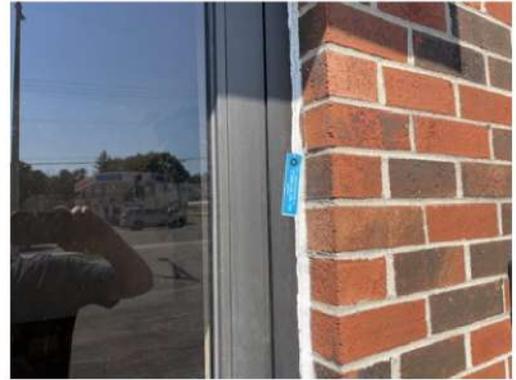
Photo 50- Sample# 7388-08-08-17, No Asbestos Detected in Grey Pipe Penetration Plaster

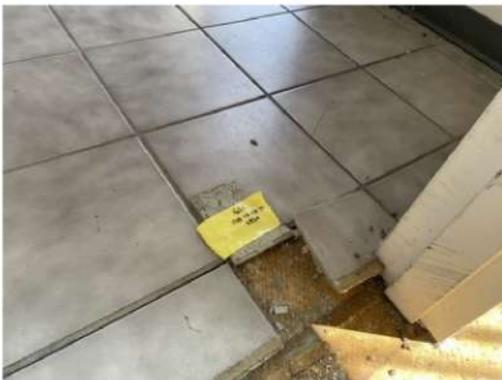
Photo 51- Sample# 7388-08-08-18, No Asbestos Detected in Exterior Dark Brown and Grey Caulk

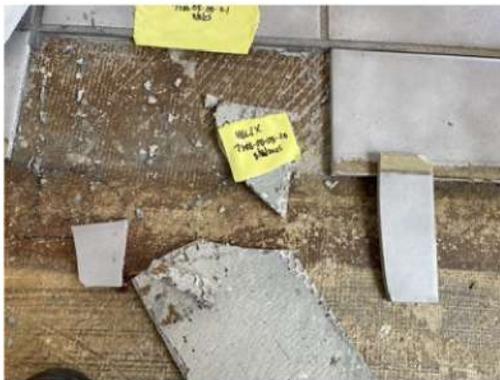
Photo 52- Sample# 7388-08-08-19, No Asbestos Detected in Thinset Mortar

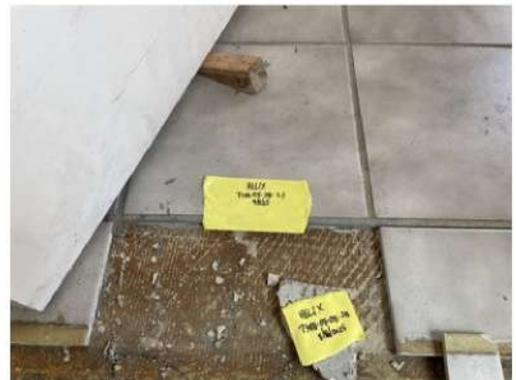
Photo 53- Sample# 7388-08-08-20, No Asbestos Detected in Thinset Mortar

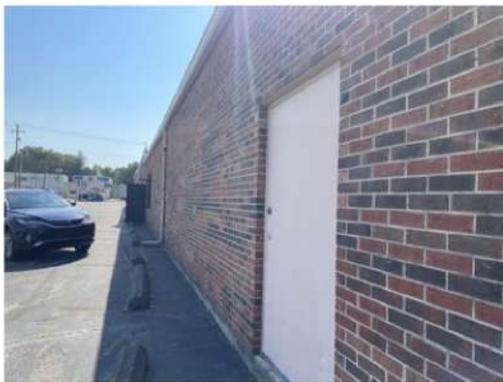
Photo 55- Exterior, North Side, Two Solid Metal Fire Doors, Assumed to Contain Asbestos

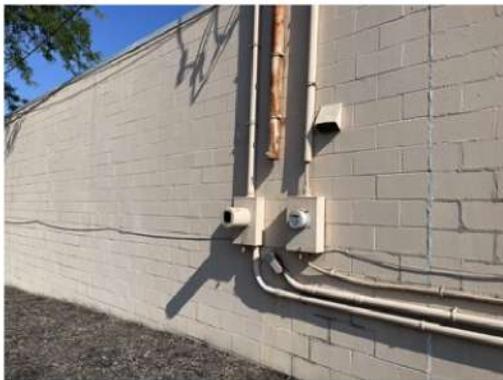
Photo 61- 1st Floor, South Side, West Central Area, All Electrical Insulators in Electric Meters are Assumed to Contain Asbestos

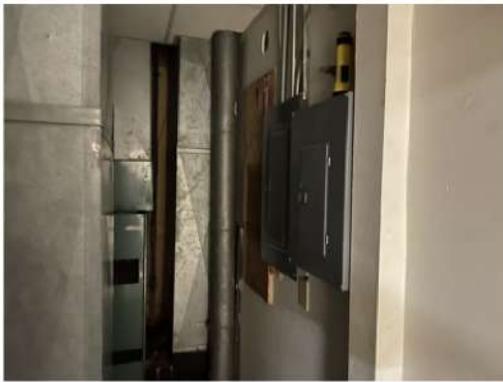
Photo 63- 1st Floor, East Building, SW Mechanical Room, South Wall, All Electrical Insulators are Assumed in Circuit Breakers to Contain Asbestos

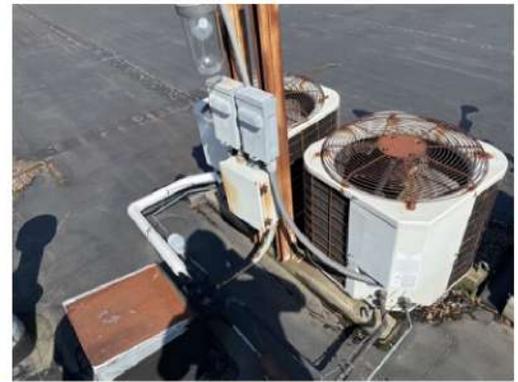
Photo 65- Roof, East Building, SW Area, All Electrical Insulators in Safety Switches are Assumed to Contain Asbestos

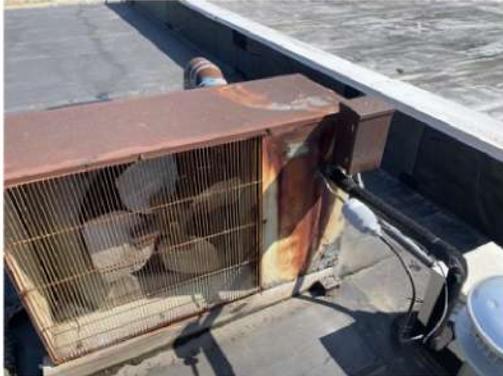
Photo 66- Roof, West Addition, SE Area, All Electrical Insulators in Safety Switches are Assumed to Contain Asbestos

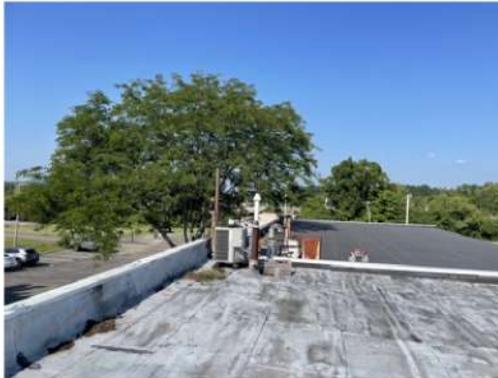
Photo 67- Roof, West Addition, SE Area, All Electrical Insulators in Safety Switches are Assumed to Contain Asbestos

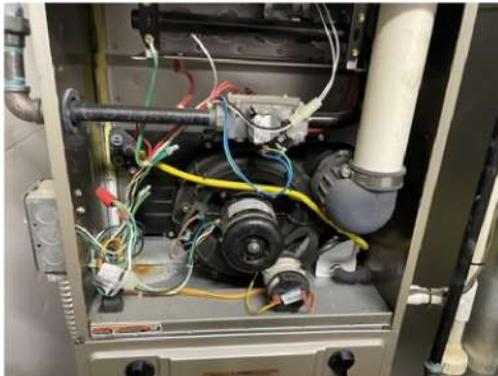
Photo 70- West Addition, SE Mech. Room, West Furnace, Fiberglass Insulation, Working Furnace, Could not Dismantle

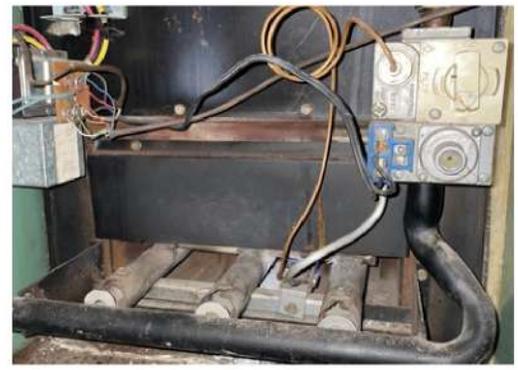
Photo 71- West Addition, SE Mech. Room, Center Furnace, Fiberglass Insulation, Working Furnace, Could not Dismantle

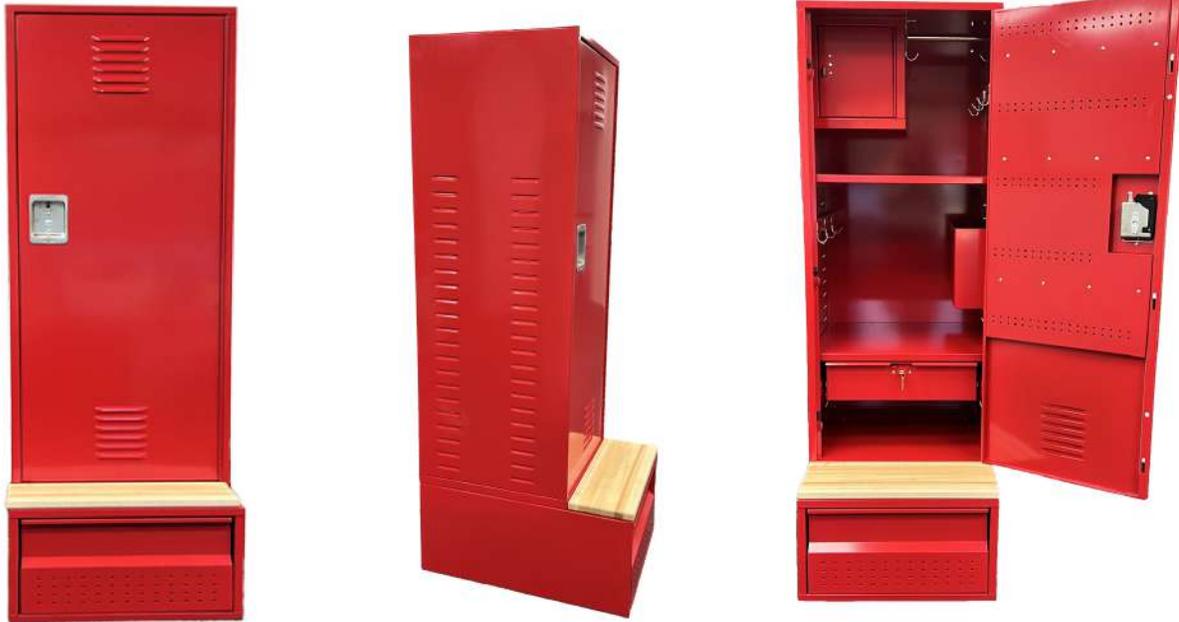
This all-welded gear locker is designed for ultimate strength and versatility, featuring a double-panel door for added security, a built-in lockable security box, and weapons drawers with fully adjustable shelving. Additional hooks provide extra hanging space, while the integrated foot locker and built-in bench enhance functionality. Perfect for fire departments, police stations, and tactical storage needs.
