DATE: February 16, 2026
PROJECT: Harrison Township District 10
Sheriff Substation Renovation

ADDENDUM NO. 1

Analysis Report
prepared for
Helix Environmental Inc

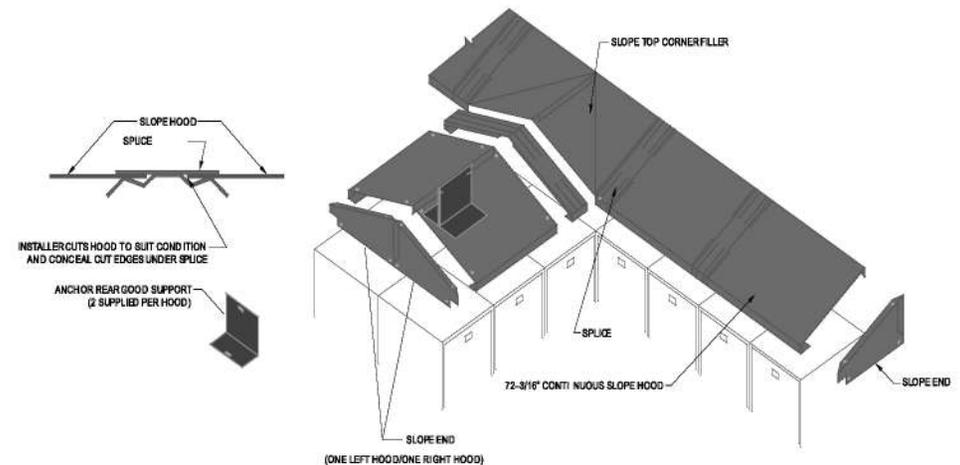
CONTINUOUS SLOPE HOODS

Continuous Slope Hoods fit on top of flat top lockers. They can be used on new lockers, or on a retrofit basis. All hoods are furnished in 72" lengths and must be cut to length during installation. Intermediate splices, ends and rear supports (2 per hood) complete the installation, and must be ordered separately.

Slope Hoods are available in the following width, depths and heights: 72x12x5, 72x15x6, 72x18x7, 72x21x8, and 72x24x9.

Slope Ends and Hood Splice available in the following depths and heights: 12x5, 15x6, 18x7, 21x8 and 24x9.

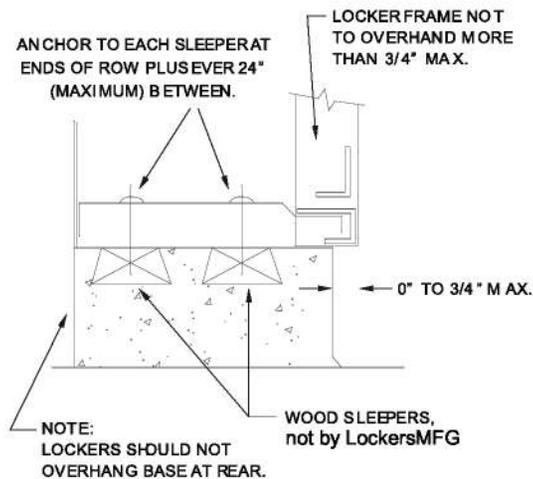
SIDE VIEW OF BASE & ANCHORS

Recess Trim is 3" wide and bridges the gap between lockers and the wall and/or soffits when the lockers are recessed into a wall. Lockers must be anchored to base (base and wood to be completed by a general contractor.)

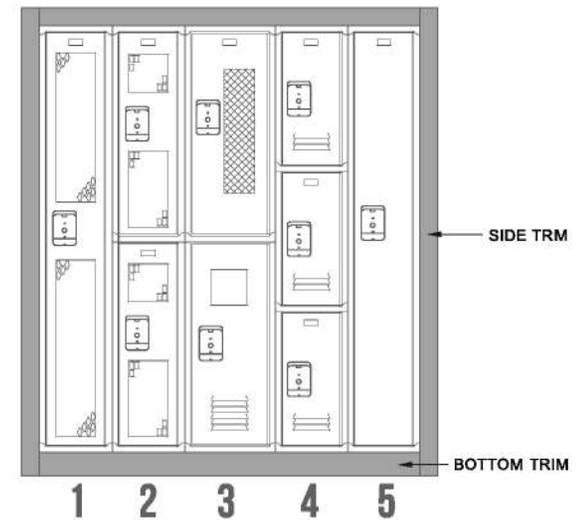
FRONT VIEW OF LOCKER WITH RECESSED TRIM

1. Competitive 1 - Tier with Diamond Perforations
2. Durable 2 - Tier with Visual Perforations
3. Fire Extinguisher / Waste Bin
4. Durable 3 - Tier with Louvers
5. Durable Plus 1 - Tier with Solid Doors

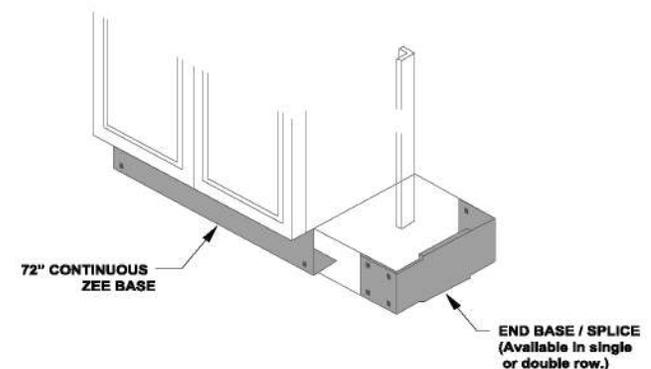
ZEE BASES

Zee bases raise lockers without 4" legs off the floor when there is no concrete or wood base. They provide a toe space in the front and a concealed flange for floor anchoring at the rear. A special 4" high rear leg can be ordered to simplify installation. Also available for 6" high zee bases.

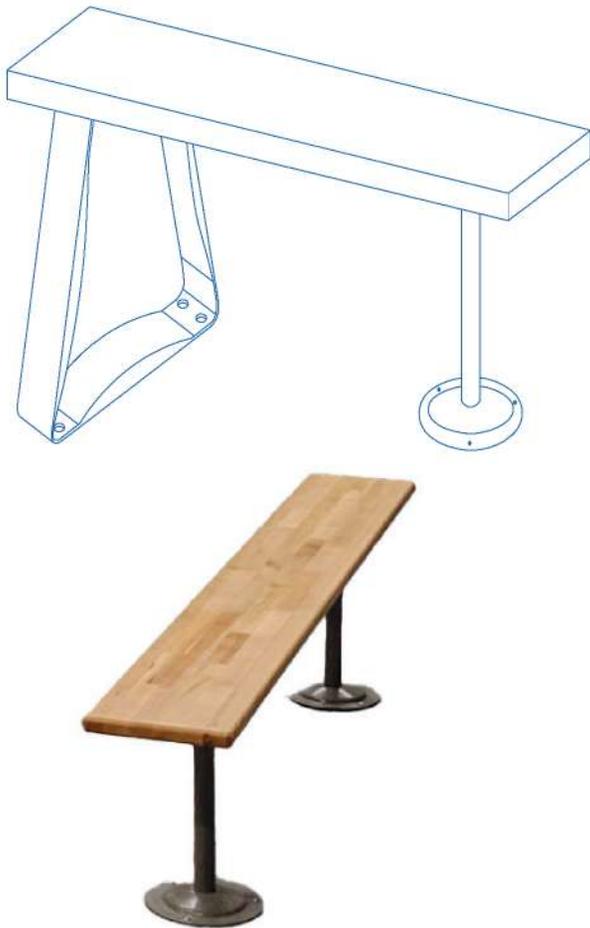
Elevating both comfort and organization, our locker benches seamlessly integrate into any floor plan. These benches provide the perfect blend of durability and aesthetic appeal. With painted or stainless steel pedestals for sturdy support, they are an essential addition to any locker room.

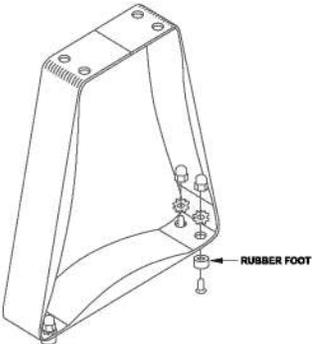
STAINLESS STEEL PEDESTAL

Featuring a 14" wide base, this pedestal offers versatility for freestanding use. Holes at the bottom enable optional floor anchoring or the attachment of non-skid bumpers (refer to the section below for details). Hardware is included for fastening to the bench top. *Stainless steel is typically not painted.

- H. Heavy Duty Bench Pedestals: Steel tubing with 10-gauge (0.1345-inch) steel flanges welded to each end, 16-1/4" high, and finish to match lockers.
- I. Stainless-Steel Free-Standing Bench Pedestal: 2" diameter brushed 16-gauge (0.0598-inch) stainless steel formed into a trapezoid, 14" wide bottom with two 5/16" diameter holes, top flange with four 5/16" diameter holes for fastening to bench.

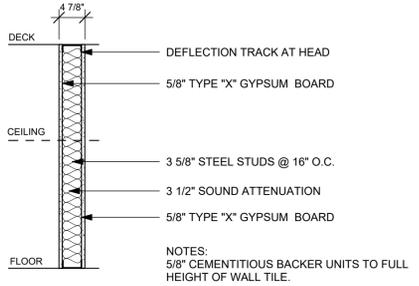
<p>DEFLECTION TRACK AT HEAD 5/8" TYPE "X" GYPSUM BOARD 3 5/8" STEEL STUDS @ 16" O.C. 3 1/2" SOUND ATTENUATION 5/8" TYPE "X" GYPSUM BOARD</p> <p>NOTES: 5/8" CEMENTITIOUS BACKER UNITS TO FULL HEIGHT OF WALL TILE.</p>	M1	7 5/8"	2 HR. UL: U905

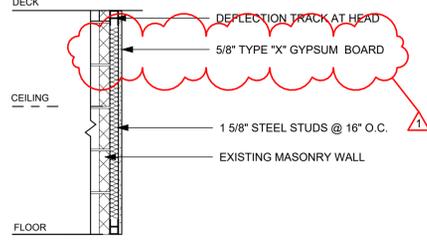
<p>DEFLECTION TRACK AT HEAD BRACE TO DECK AT 48" O.C. 5/8" TYPE "X" GYPSUM BOARD 3 5/8" STEEL STUDS @ 16" O.C. 3 1/2" SOUND ATTENUATION 5/8" TYPE "X" GYPSUM BOARD</p>	A6	1 5/8"

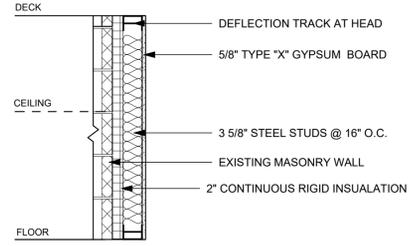
A4	3 5/8"

<p>DEFLECTION TRACK AT HEAD 5/8" TYPE "X" GYPSUM BOARD 3 5/8" STEEL STUDS @ 16" O.C. EXISTING MASONRY WALL 2" CONTINUOUS RIGID INSULATION</p>					<p>GENERAL NOTES</p> <p>A. MOISTURE/MOLD RESISTANT GYPSUM BOARD SHALL BE USED BEHIND ALL SINKS, SERVICE SINKS AND SHOWER AREAS. EXTEND MINIMUM 24" BEYOND PLUMBING FIXTURES.</p> <p>B. PROVIDE & INSTALL DEFLECTION TRACK AT ALL INTERIOR WALLS THAT EXTEND TO DECK.</p> <p>C. UL TEST NUMBERS FOR INTERIOR PARTITIONS WILL VARY DEPENDING ON THE MANUFACTURER OF COMPONENTS ACTUALLY USED. MAINTAIN RATING AND ADVISE IF WALL THICKNESS WILL CHANGE.</p> <p>D. DRYWALL CONTRACTOR TO PAINT WALL RATINGS LABELS AT MAXIMUM 12 FEET O.C. ON ALL FIRE RATED PARTITIONS. LABEL TO BE PAINTED ABOVE CEILING WITH A STENCIL MIN. OF 4 INCHES IN HEIGHT, BLACK COLOR.</p> <p>E. FIRE RATED WALLS AND SMOKE PARTITIONS ARE TO BE CONSTRUCTED TIGHT TO STRUCTURE, PIPING AND OTHER PENETRATIONS. ALL PENETRATIONS AND PERIMETER OF WALLS TO BE FIRE CAULKED.</p> <p>F. STEEL STUD PARTITIONS SHALL BE BRACED TO STRUCTURE ABOVE.</p> <p>G. REFER TO FLOOR PLANS FOR LOCATIONS OF INTERIOR PARTITION TYPES.</p> <p>H. REFER TO SHEET AX.X FOR TYPICAL INTERIOR PARTITIONS DETAILS.</p> <p>I. ALL PARTITIONS SCHEDULED RECEIVE WALL TILE SHALL HAVE CEMENTITIOUS BACKER UNIT TO FULL HEIGHT OF WALL TILE.</p> <p>J. ALL PENETRATIONS IN FIRE RATED PARTITIONS SHALL BE FIRESTOPPED, WHETHER THEY ARE NEW OR EXISTING. INCLUDING THOSE CREATED BY THE REMOVAL OF AN EXISTING PENETRATING ITEM. FIRESTOPPING SYSTEMS SHALL BE FM OR U.L. LABORATORY APPROVED PRODUCTS.</p> <p>K. APPLY ACOUSTICAL SEALANT AT ENTIRE PERIMETER OF ALL GYPSUM BOARD PARTITIONS.</p> <p>L. AT ALL STC-RATED ACOUSTICAL / SOUND CONTROL TYPE PARTITIONS APPLY ACOUSTICAL SEALANT AT PERIMETER OF PARTITION AND AROUND ELECTRICAL RECEPTACLES, PIPES AND DUCT PENETRATIONS. ACOUSTICAL SEALANT SHALL BE APPLIED TO BOTH FACES OF PARTITION.</p> <p>M. EXISTING BUILDING FLOOR TO DECK HEIGHTS FOR AREAS OF WORK: - FIRST FLOOR TO ROOF ROOMS 101-118: F.V. VARIABLE - DECK SLOPES SOUTH TO NORTH - FIRST FLOOR TO ROOF ROOMS 119-140: F.V. VARIABLE - DECK SLOPES SOUTH TO NORTH</p>

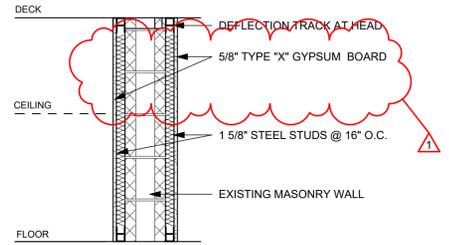
A5	1 5/8"

<p>DEFLECTION TRACK AT HEAD 5/8" TYPE "X" GYPSUM BOARD 1 5/8" STEEL STUDS @ 16" O.C. EXISTING MASONRY WALL</p>

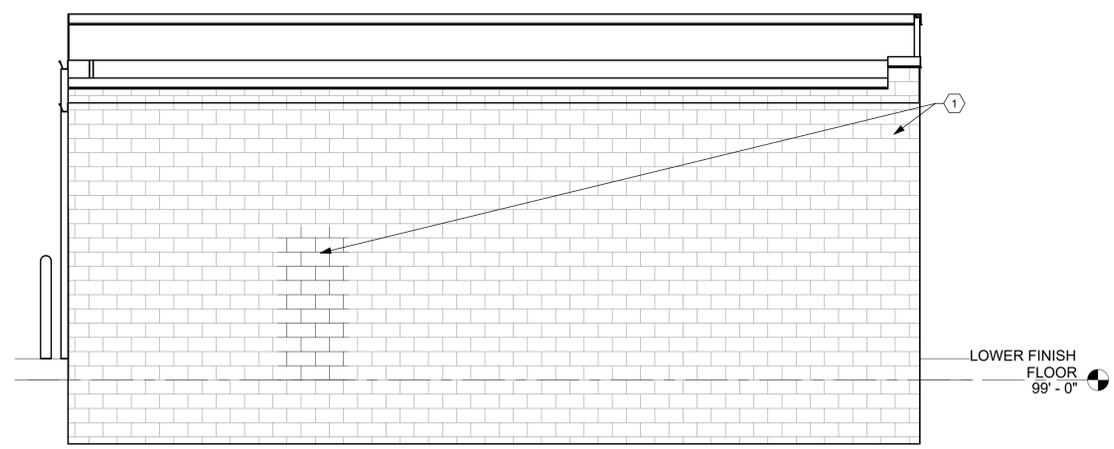
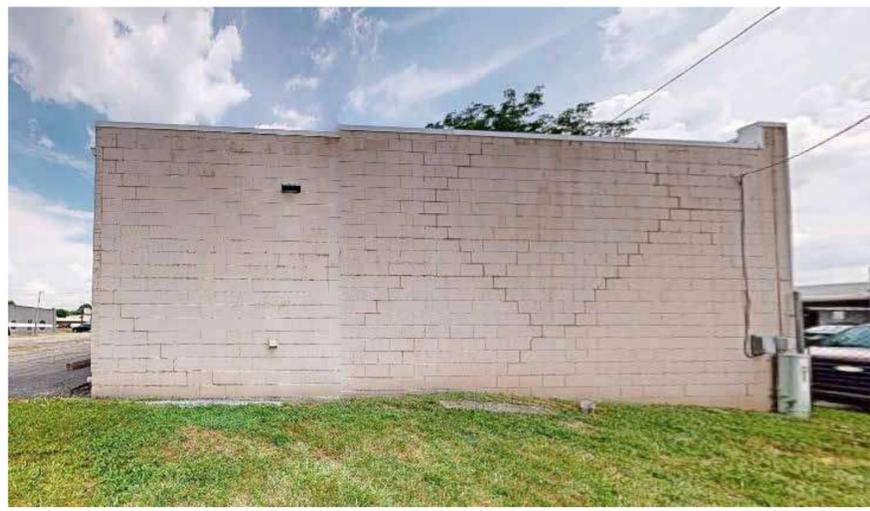
C1 EXTERIOR ELEVATION - WEST REPAIR
1/4" = 1'-0"

- ⓪ INDICATES CONSTRUCTION NOTE.
- 1 TUCKPOINT AND REPAINT ENTIRE EXISTING WALL AFTER DOOR INSTALLATION.
 - 2 REPAIR EXISTING FOUNDATION TO MATCH EXISTING EXTERIOR WALL TYPE. REFER TO STRUCTURAL DRAWINGS.
 - 3 REMOVE EXISTING DOOR AND INFILL TO MATCH EXISTING EXTERIOR WALL TYPE.
 - 4 TUCKPOINT EXISTING WALL. PROVIDE ALLOWANCE FOR 200 SF. REPAINT ENTIRE WALL.

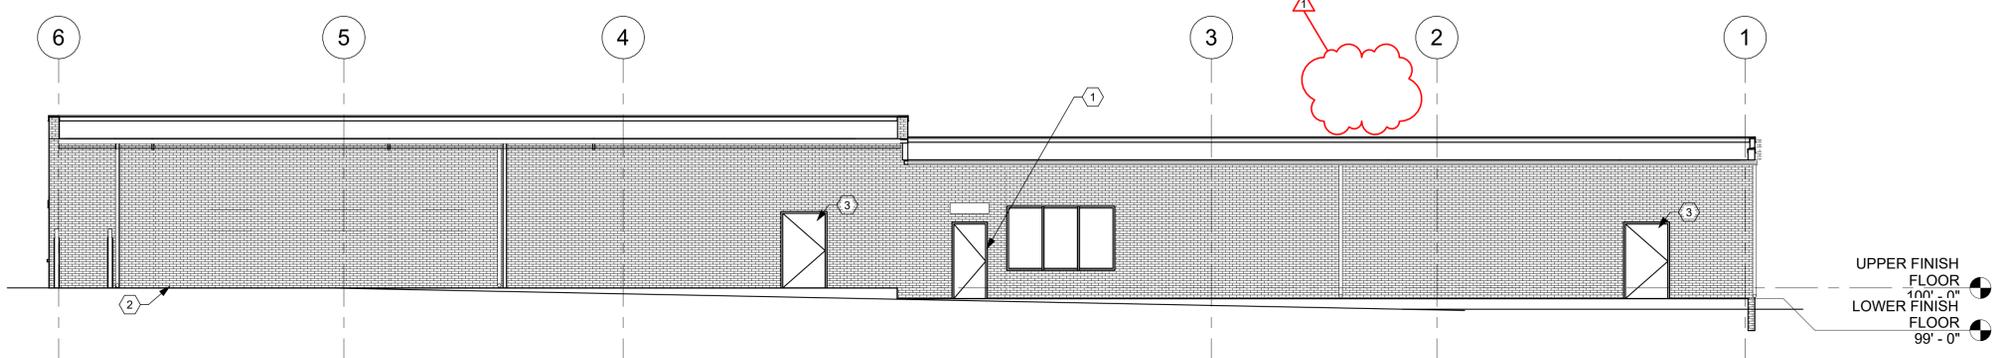
D1 EXTERIOR ELEVATION - NORTH REPAIR
1/8" = 1'-0"

- EXISTING GUTTERS AND DOWNSPOUTS TO REMAIN REPAIR AS NEEDED. MAINTAIN OUTLETS TO FLOW AWAY FROM BUILDING.
- CAULK ALL NEW AND EXISTING WINDOWS, DOORS, PENETRATIONS, AND EXPANSION JOINTS.

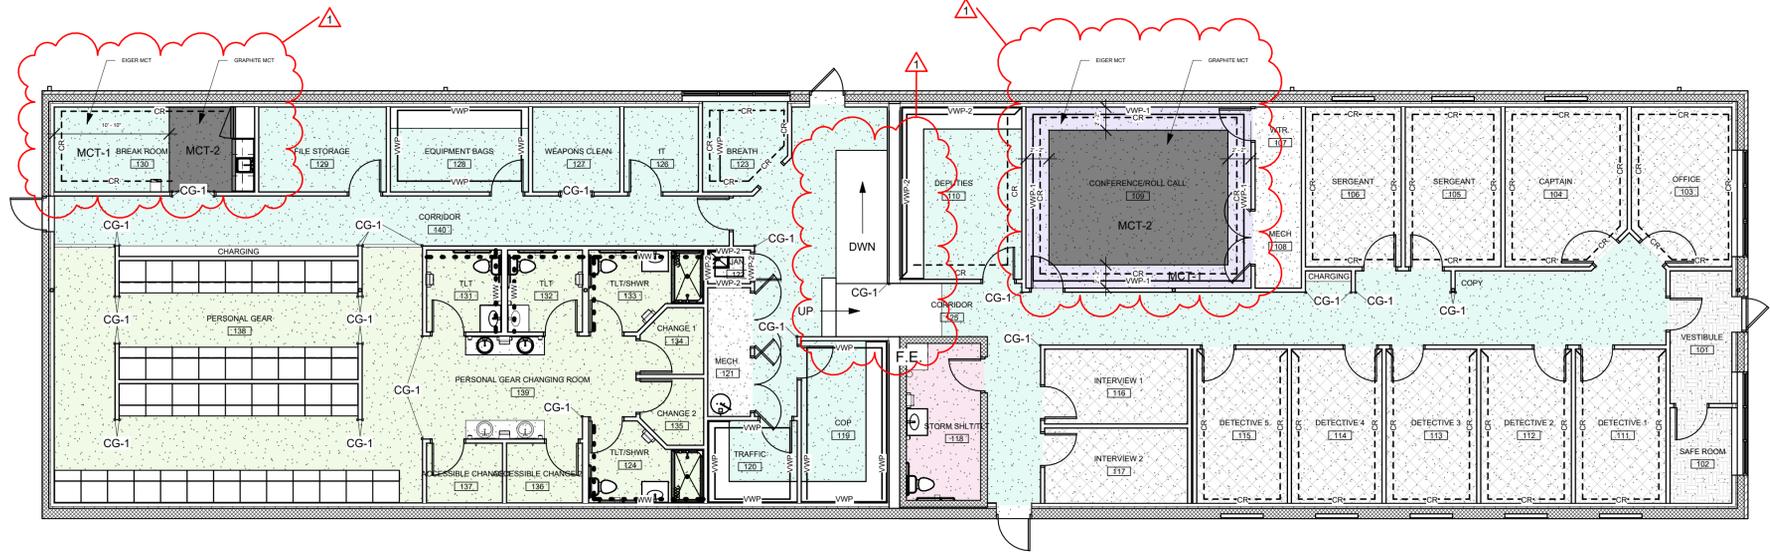
E1 FINISH FLOOR PLAN
1/8" = 1'-0"

- A. REPAIR, LEVEL, AND PREPARE EXISTING CONCRETE FLOOR SLABS TO RECEIVE NEW FLOOR FINISH. REFER TO ARCHITECTURAL ROOM FINISH SCHEDULE AND SPECIFICATIONS FOR ADDITIONAL INFORMATION.
- B. USE MCT-1, EIGER FOR RAMP AND STAIR AT LEVEL CHANGE BETWEEN CORRIDORS 125 AND 140. ALL EDGES OF MCT-1 TO BE PROTECTED WITH FLEXCO, LAP TYPE SQUARE STAIR NOSING ALONG OUTER EDGES OF RAMP. NOSING TO BE USED AT STAIR EDGES.

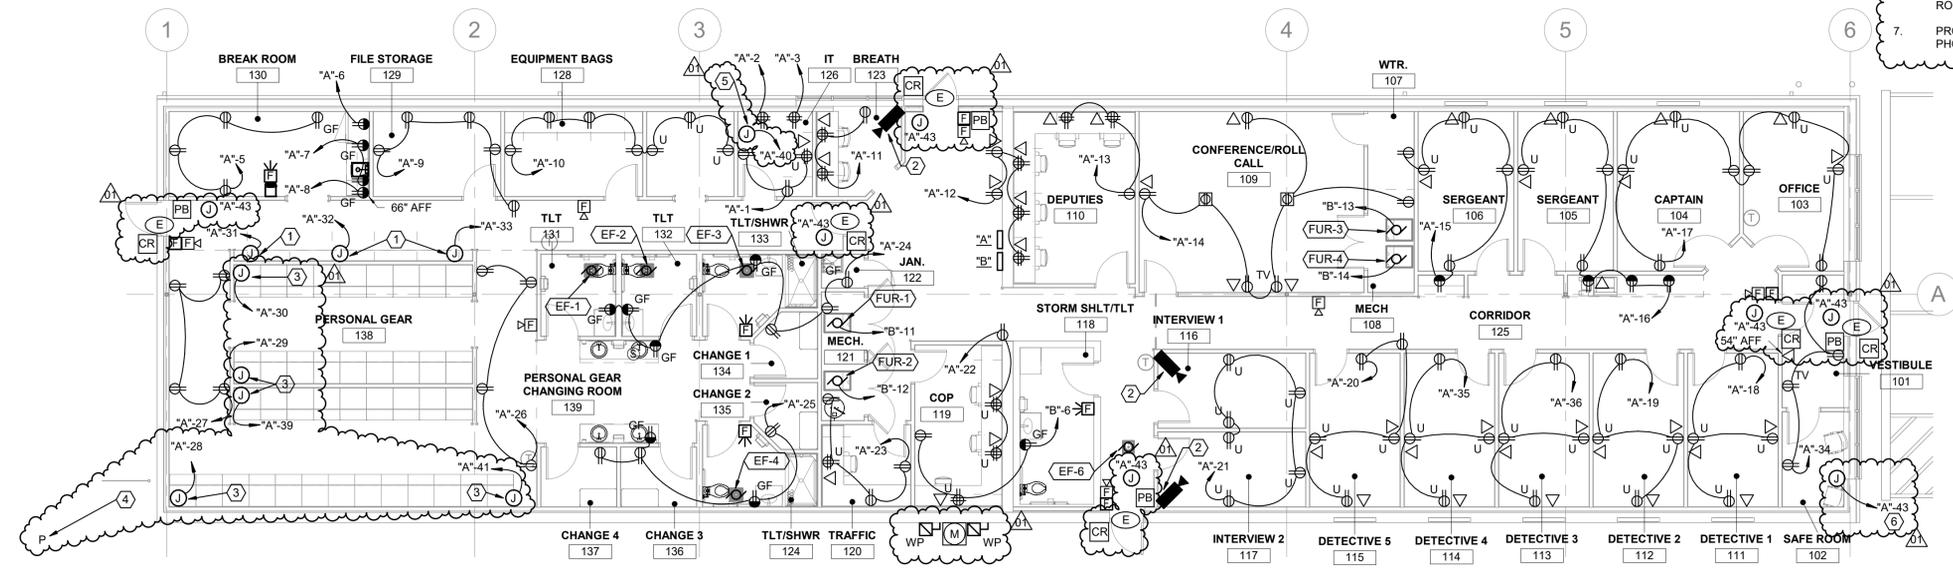
② POWER PLAN NEW WORK
1/8" = 1'-0"

1. PROVIDE 6" STEEL MULTIOUTLET SYSTEM WITH TAMPER RESISTANT RECEPTACLES AT 9" ON CENTER. LEGRAND #WH20GB609 OR EQUAL.
2. SECURITY CAMERAS BY OWNER. ELECTRICAL CONTRACTOR TO COORDINATE WITH IT VENDOR.
3. COORDINATE POWER CONNECTION REQUIREMENTS WITH LOCKER SUPPLIER.
4. EXISTING UTILITY POLE LOCATED APPROXIMATELY 15' WEST OF BUILDING CORNER. TRANSITION FROM OVERHEAD TO UNDERGROUND AT POLE TO NEW METER LOCATION. REFER TO SINGLELINE DIAGRAM FOR REQUIREMENTS.
5. PROVIDE ELECTRICAL CONNECTION TO DOOR ACCESS CONTROL PANEL.
6. PROVIDE POWER CONNECTION TO 911 CALL BOX. COORDINATE EXACT LOCATION AND FINAL ELECTRICAL CHARACTERISTICS PRIOR TO ROUGH IN.
7. PROVIDE LINE VOLTAGE PHOTOCELL WITH MANUAL OVERRIDE SWITCH. PHOTOCELL TO BE MOUNTED TO ROOF PARAPET FACING NORTH.

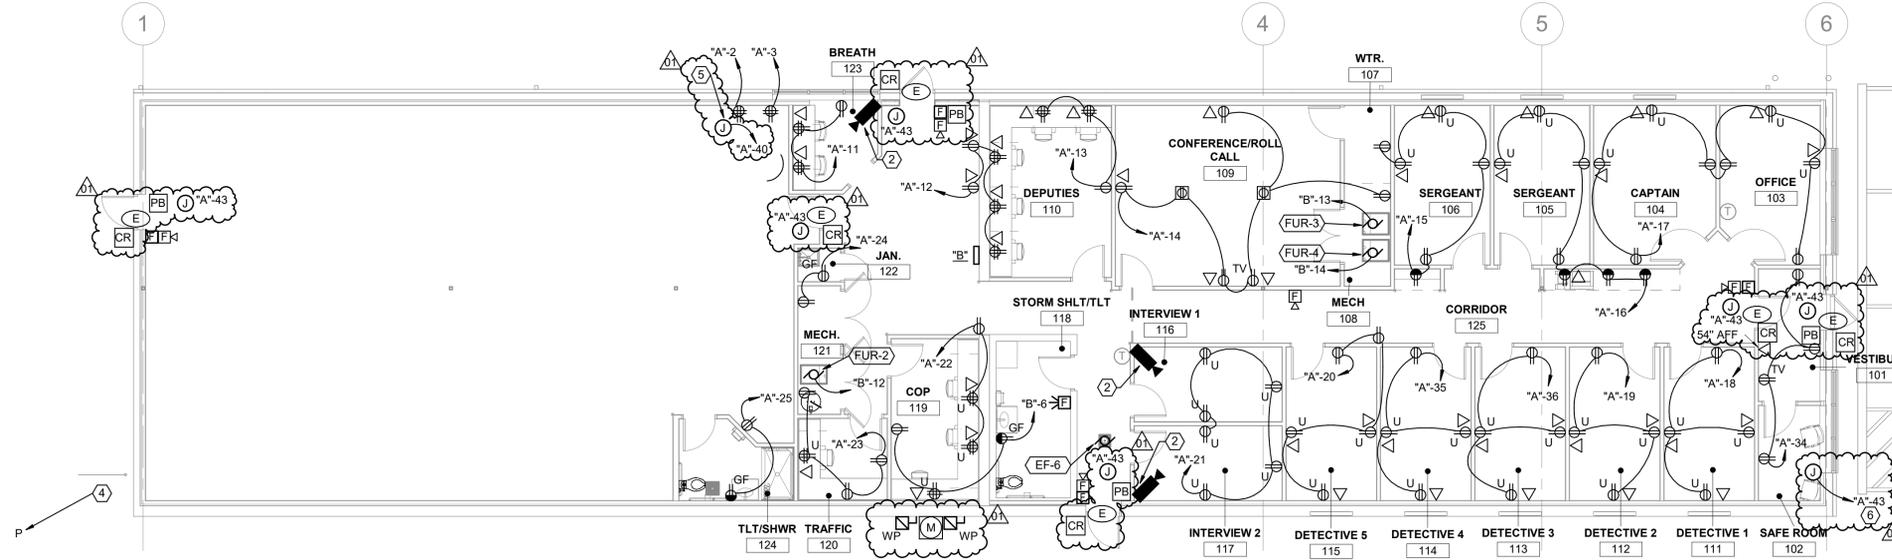
2 POWER PLAN ALTERNATE 1 NEW WORK
1/8" = 1'-0"

1. PROVIDE 6" STEEL MULTIOUTLET SYSTEM WITH TAMPER RESISTANT RECEPTACLES AT 9" ON CENTER. LEGRAND #WH20GB609 OR EQUAL.
2. SECURITY CAMERAS BY OWNER. ELECTRICAL CONTRACTOR TO COORDINATE WITH IT VENDOR.
3. EC TO PROVIDE TEMPORARY SUPPORT FROM STRUCTURE FOR LIGHTING FIXTURES UNTIL CEILING GRID INSTALLATION.
4. EXISTING UTILITY POLE LOCATED APPROXIMATELY 15' WEST OF BUILDING CORNER. TRANSITION FROM OVERHEAD TO UNDERGROUND AT POLE TO NEW METER LOCATION. REFER TO SINGLELINE DIAGRAM FOR REQUIREMENTS.

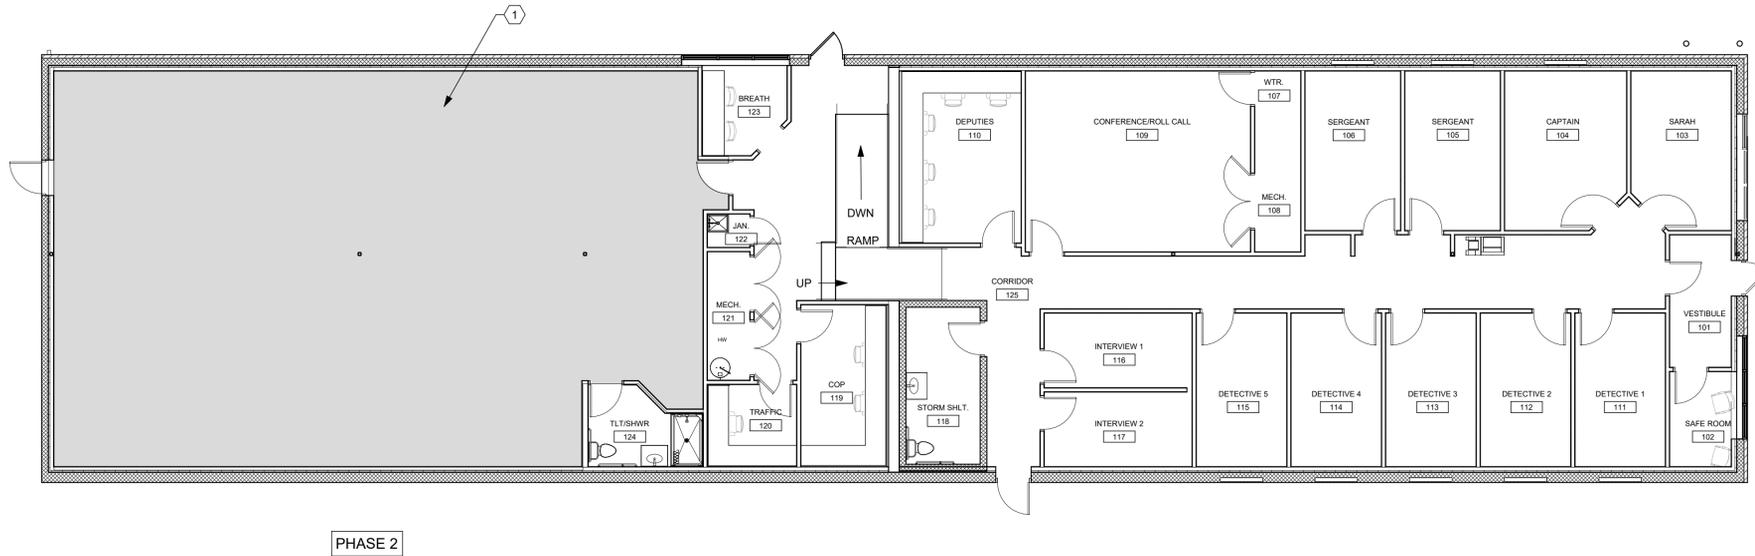
E1 PHASING PLAN
1/8" = 1'-0"

1 PHASE TWO CONSTRUCTION TO CREATE "TRUE SHELL". FLOORS TO BE FINISHED. EGRESS DOOR 140B TO BE INSTALLED. EXTERIOR WALLS TO BE COMPLETED EXCEPT FOR FINISH FACE GYPSUM BOARD.

A. THIS SHEET CONTAINS A GENERAL OVERVIEW OF A PHASING PLAN SCOPE.
 PHASE 1: COMPLETE ENTIRE PROJECT BOTH EAST AND WEST OF THE FLOOR PLAN.
 PHASE 2: SHADED AREA SHOULD NOT TO BE COMPLETED WITH EXCEPTION OF STRUCTURAL REINFORCING (INCLUDING STUDS AND INSULATION), CONCRETE SLAB REPAIR, HVAC TRUNKS, AND NEW EGRESS DOOR 140B.
 B. REFER TO MEP DRAWINGS FOR ADDITIONAL PHASING NOTES.

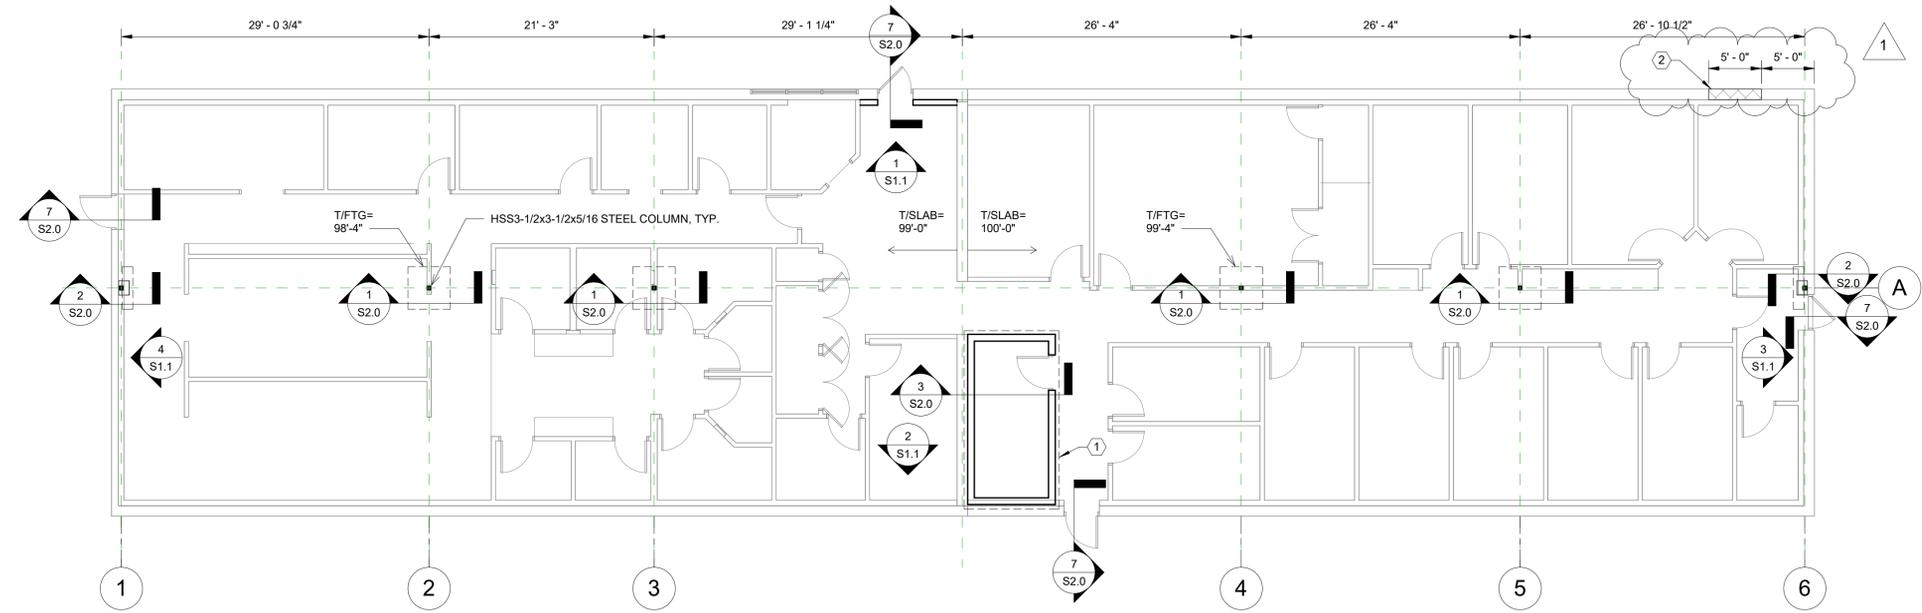
1 FOUNDATION PLAN
1/8" = 1'-0"

- FULLY GROUT ALL EXISTING BELOW-GRADE CMU AND REPLACE ANY DAMAGED BLOCKS.
- CENTER ALL COLUMN FOOTINGS UNDER COLUMN CENTERLINES, U.N.O.

- PROVIDE AN 8" THICKENED SLAB w/ #4 BARS AT 12" O.C. EACH WAY.
- HATCHED AREA DENOTES APPROXIMATE SECTION OF EXISTING STEM WALL WITH BROKEN CMU. EXCAVATE TO THE FOOTING AND REPLACE ALL DAMAGED BLOCKS [GROUT SOLID].
