ADDENDUM NO. #2
December 4, 2025
Fire Station 15 Renovations
(10% MBE PARTICIPATION GOAL)

Answer: *Pre-Renovation Asbestos Inspection* report is attached. Additionally, the *Pre-Renovation Preliminary Lead-Containing Paint Inspection* report is attached as well.

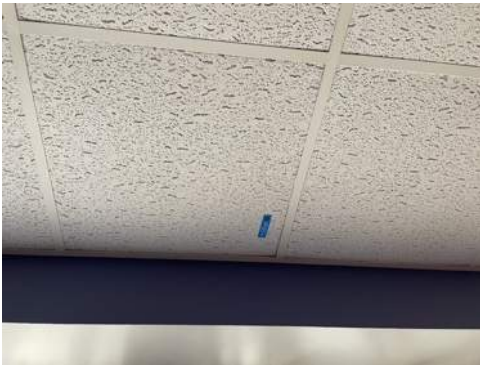
Photo 04- Sample# 7347-03-11-04, No Asbestos Detected in 2' x 2' Ceiling Tile

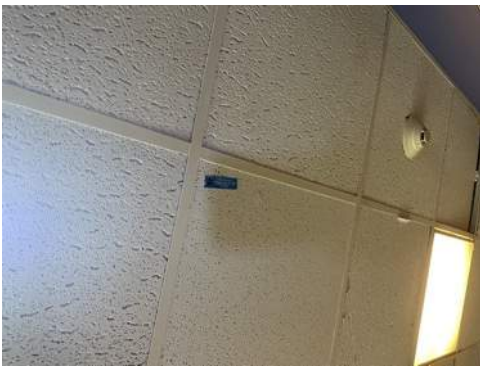
Photo 07- Sample# 7347-03-11-07, No Asbestos Detected in 2' x 2' Ceiling Tile

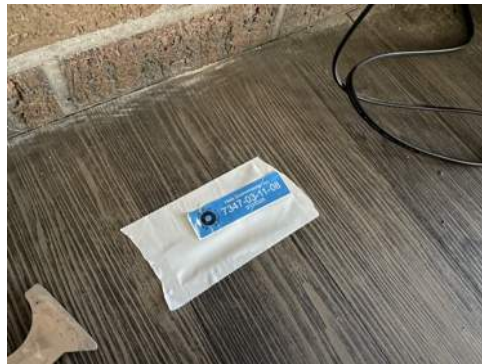
Photo 08- Sample# 7347-03-11-08, No Asbestos Detected in Sheet Flooring and Green Mastic

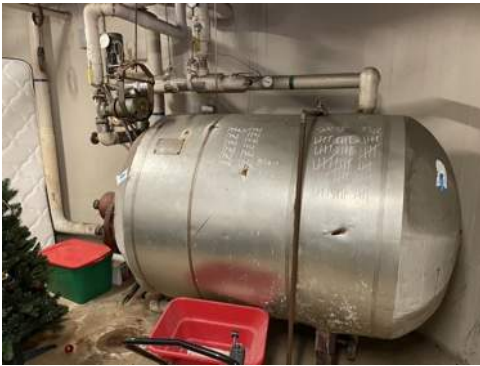
Photo 13- Sample# 7347-03-11-13, 10% Chrysotie Asbestos Detected in Grey Tank Insulation Sealant

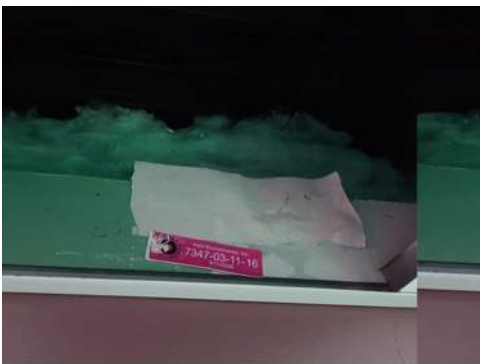
Photo 16- Sample# 7347-03-11-16, No Asbestos Detected in Drywall and Joint Compound

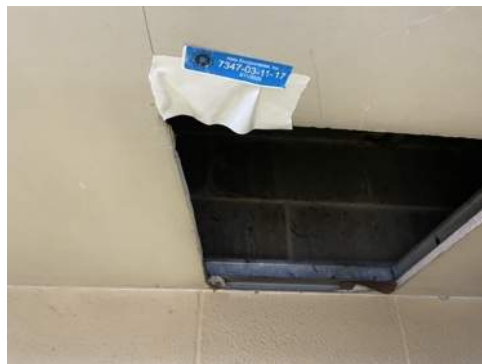
Photo 17- Sample# 7347-03-11-17, No Asbestos Detected in Drywall and Joint Compound

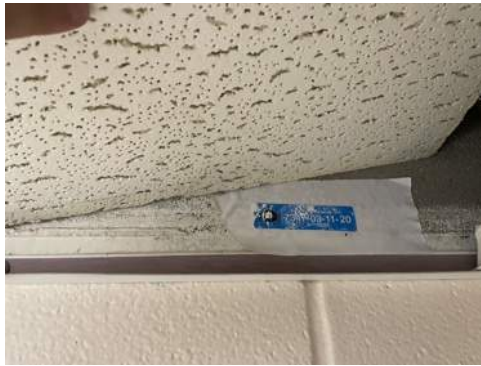
Photo 20- Sample# 7347-03-11-20, No Asbestos Detected in Stucco

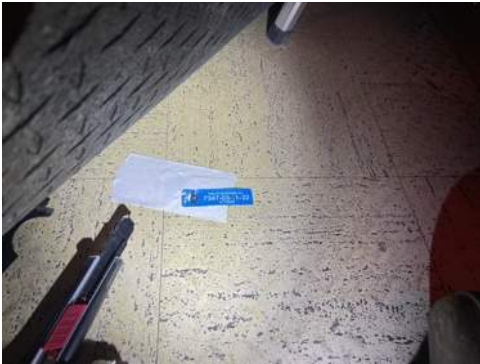
Photo 22- Sample# 7347-03-11-21, 0.4% Chrysotile Asbestos Detected in 12"x12" Grey Streaked Floor Tile, No Asbestos in Black Mastic

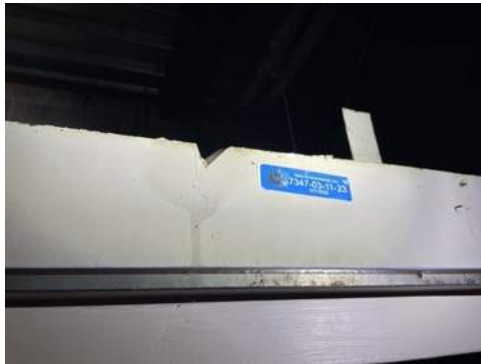
Photo 23- Sample# 7347-03-11-23, No Asbestos Detected in Drywall and Joint Compound

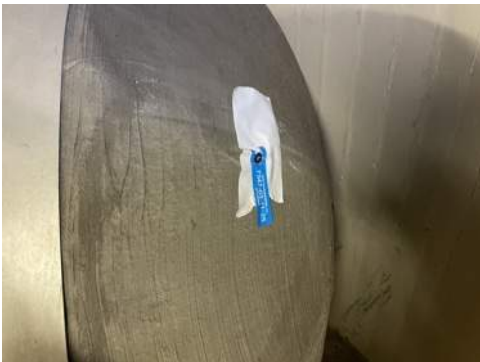
Photo 25- Sample# 7347-03-11-25, 10% Chrysotile Asbestos Detected in Grey Tank Insulation Sealant

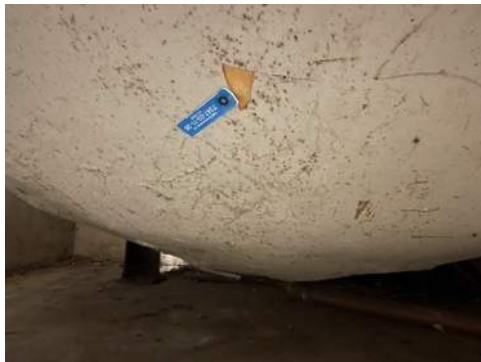
Photo 26- Sample# 7347-03-11-26, 10% Chrysotile Asbestos Detected in Grey Tank Insulation Sealant

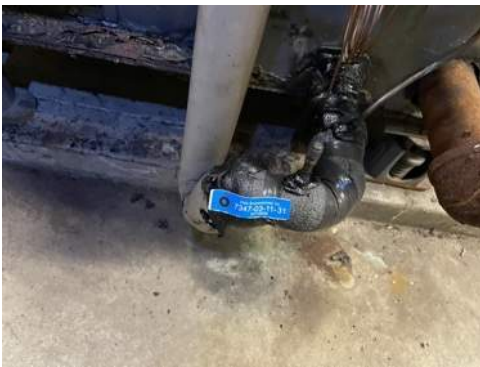
Photo 31- Sample# 7347-03-11-31, No Asbestos Detected in Black Sweat Wrap

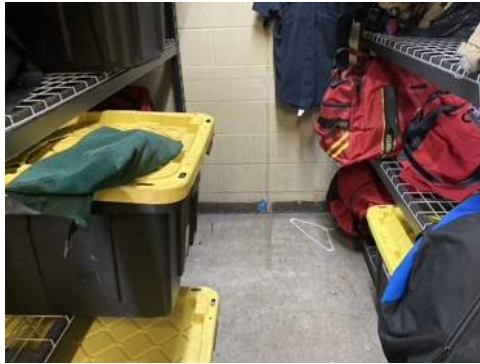
Photo 32- Sample# 7347-03-11-32, No Asbestos Detected in 4" Brown Cove Base and Mastic

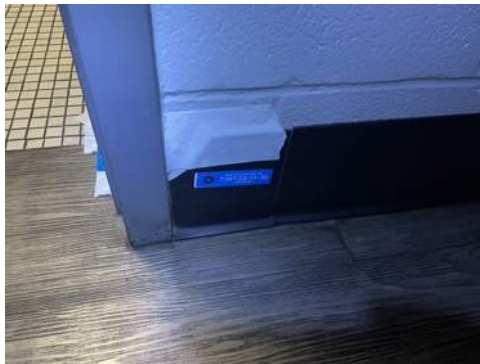
Photo 35- Sample# 7347-03-11-35, No Asbestos Detected in 6" Cove Base and Mastic

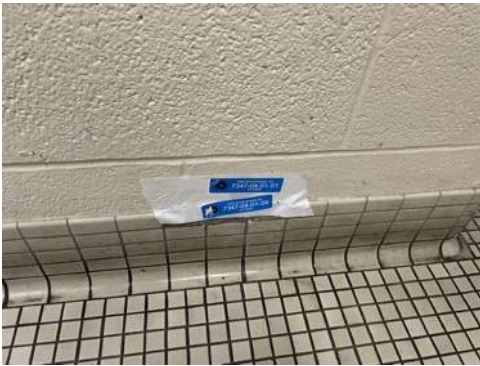
Photo 40- Sample# 7347-04-01-05, No Asbestos Detected in Ceramic Tile, Tan Adhesive, and Grout

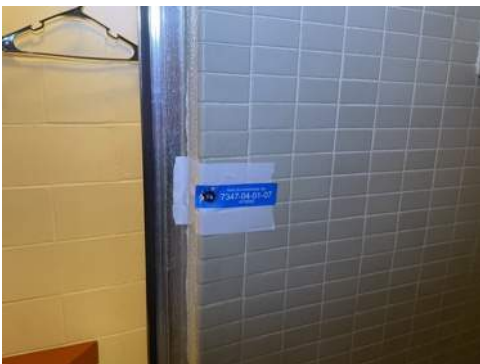
Photo 43- Sample# 7347-04-01-07, No Asbestos Detected in Ceramic Tile, Tan Adhesive, and Grout

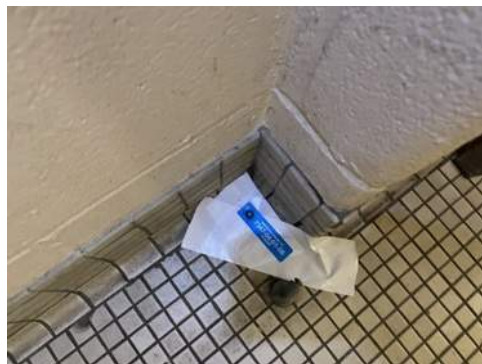
Photo 44- Sample# 7347-04-01-08, No Asbestos Detected in Ceramic Tile, Tan Adhesive, and Grout

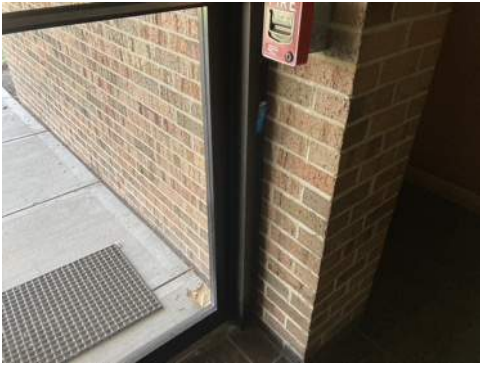
Photo 49- Sample# 7347-04-01-13, No Asbestos Detected in Brown Interior Caulk

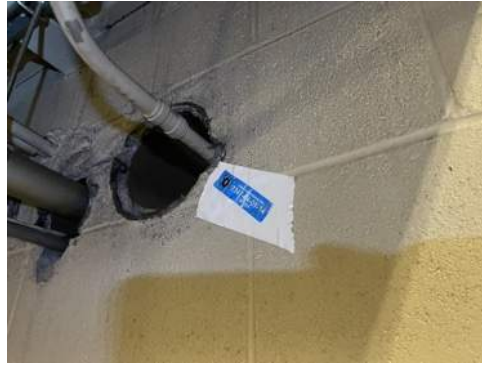
Photo 50- Sample# 7347-04-01-14, 2% Chrysotile Asbestos Detected in Pipe Penetration Caulk

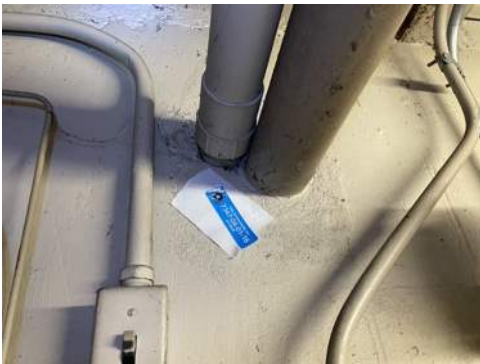
Photo 52- Sample# 7347-04-01-16, No Asbestos Detected in Pipe Penetration Mortar

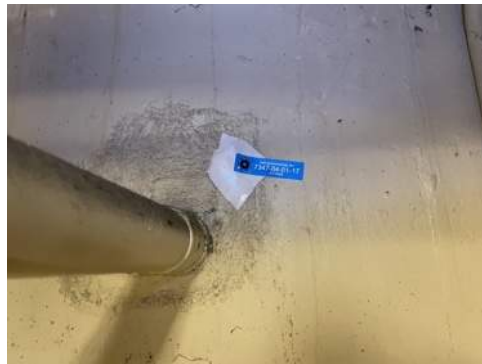
Photo 53- Sample# 7347-04-01-17, No Asbestos Detected in Pipe Penetration Mortar

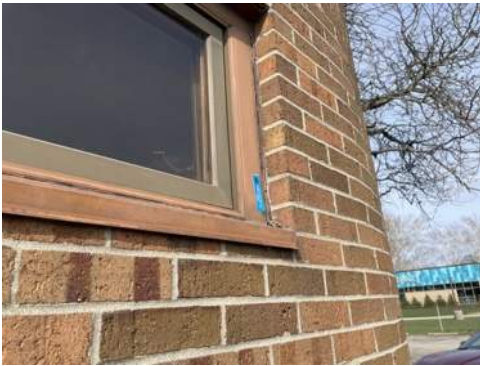
Photo 58- Sample# 7347-04-01-22, No Asbestos Detected in Grey Exterior Caulk

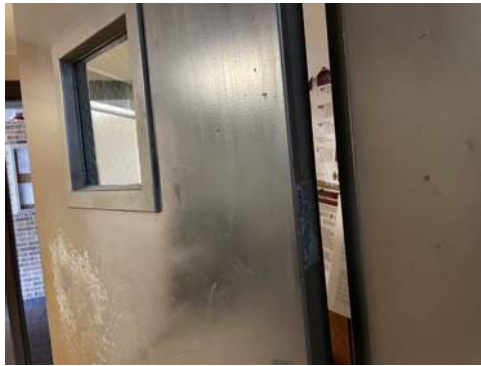
Photo 59- 1st Floor, West Vehicle Bay, Northeast Door, All Fire Doors are Assumed to Contain Asbestos

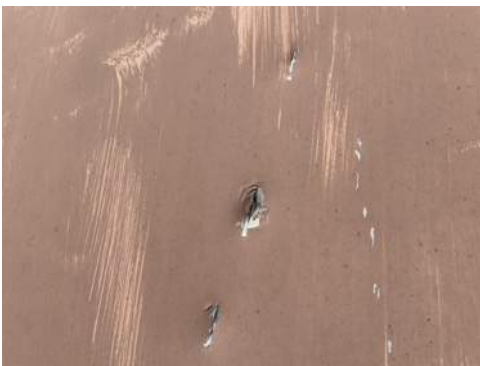
Photo 61- 3rd Floor, Roof Access Door, Visible Insulation, All Insulated Doors are Assumed to Contain Asbestos

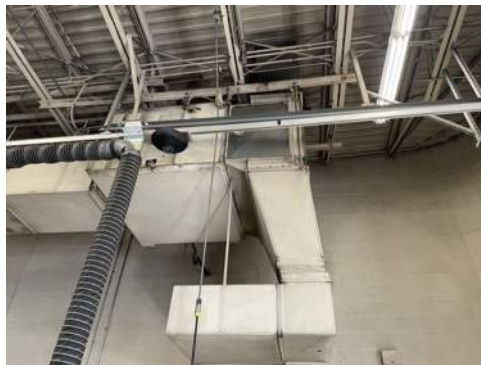
Photo 62- 1st floor, West Vehicle Bay, Southeast Area, All Vibration Isolator Cloths are Assumed to Contain Asbestos, Unless confirmed not to

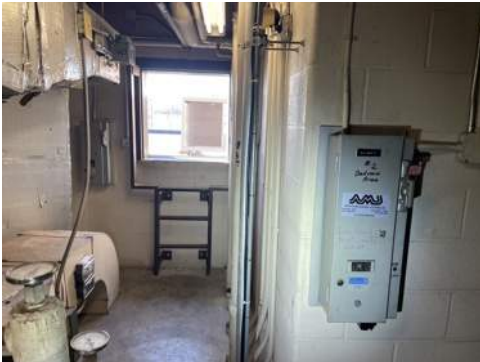
Photo 67- 2nd Floor, Central Tower, SE Area, Safety Switches, All Electrical Insulators are Assumed to Contain Asbestos

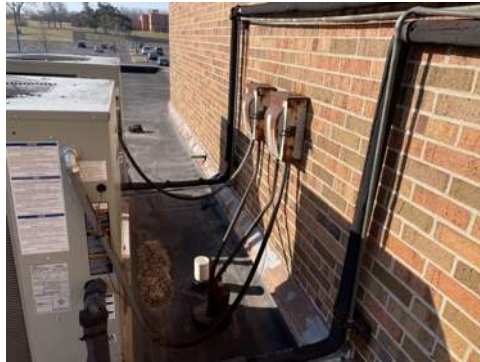
Photo 68- 2nd Floor, Rooftop, S Central Area, Safety Switches, All Electrical Insulators are Assumed to Contain Asbestos

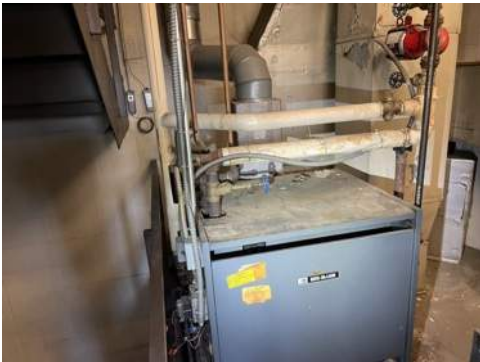
Photo 70- Boiler, Boiler Exhaust Flue is Assumed to Contain Asbestos

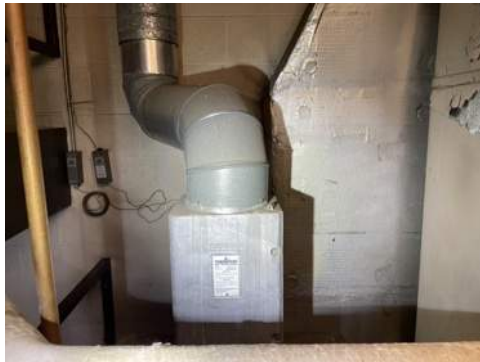
Photo 71- Boiler, Boiler Exhaust Flue is Assumed to Contain Asbestos

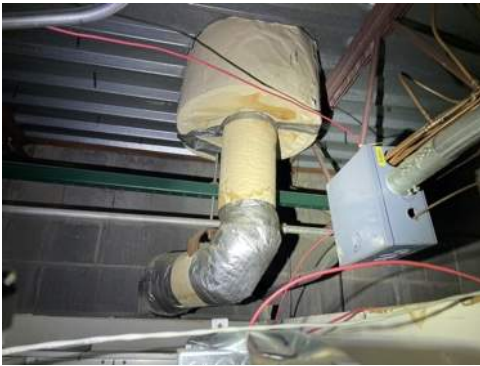
Photo 76- No Visible Hard Pipe Fittings, All Pipe Insulation Sealant is Confirmed to Contain Greater than 1% Asbestos

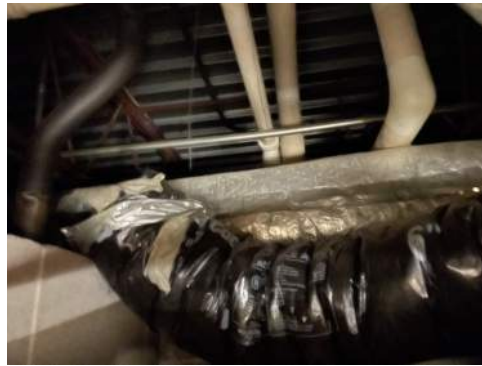
Photo 77- No Visible Hard Pipe Fittings, All Pipe Insulation Sealant is Confirmed to Contain Greater than 1% Asbestos

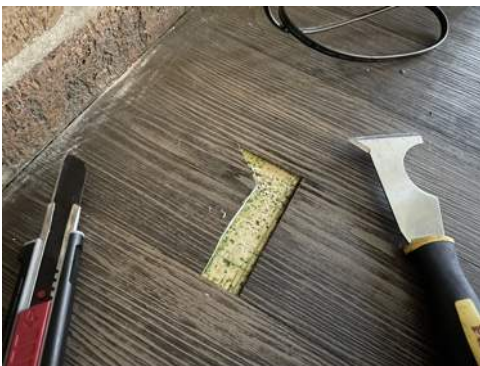
Photo 79- 1st Floor, East Dining Room, Sheet Flooring over <1% Grey 12" x 12" Floor Tile

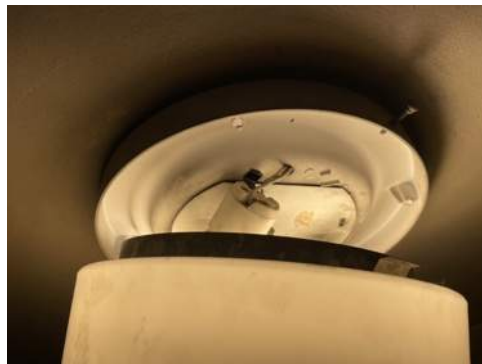
Photo 80- 1st Floor, East Central Janitor's Closet, No Reflector Paper
