**ADDENDUM NO. #2**  
**December 4, 2025**  
**Fire Station 16 Renovations**  
**(10% MBE PARTICIPATION GOAL)**

**RE: Pre-Renovation Asbestos Inspection of Fire Station 16, 4111 Kings Highway,  
Dayton, Ohio, March 10 and 31, 2025.  
Helix Project No. 7348.**

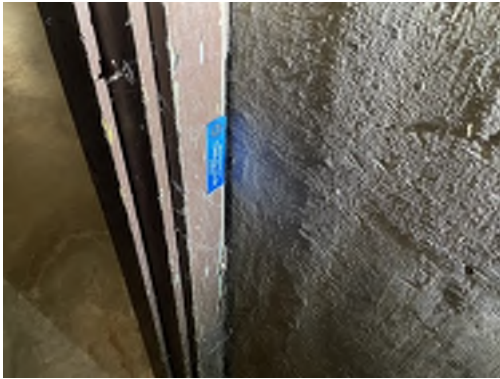
Photo 04- Sample# 7348-03-10-04, 2% Chrysotile Asbestos Detected in Grey Interior Caulk

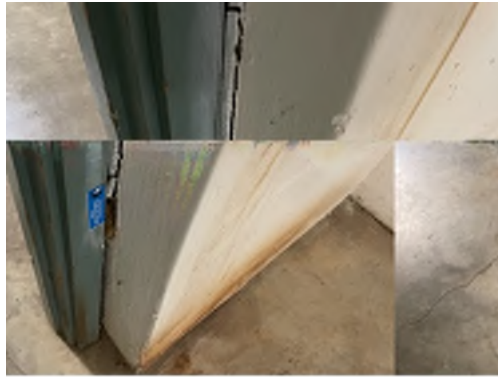
Photo 05- Sample# 7348-03-10-05, 2.5% Chrysotile Asbestos Detected in Grey Interior Caulk

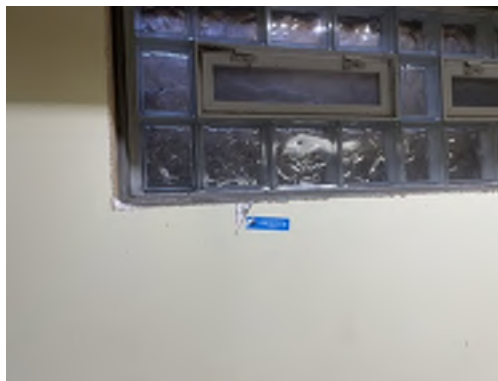
Photo 08- Sample# 7348-03-10-08, No Asbestos Detected in Drywall and Joint Compound

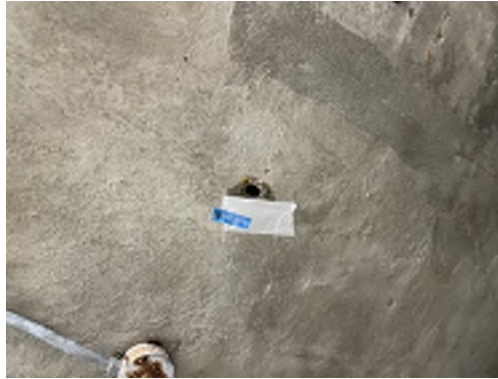
Photo 14- Sample# 7348-03-10-14, No Asbestos Detected in Hard Plaster

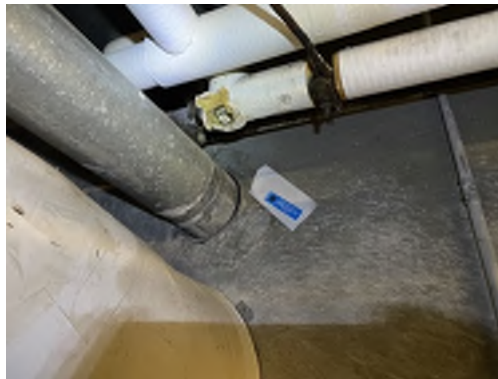
Photo 17- Sample# 7348-03-10-17, No Asbestos Detected in Pipe Penetration Plaster

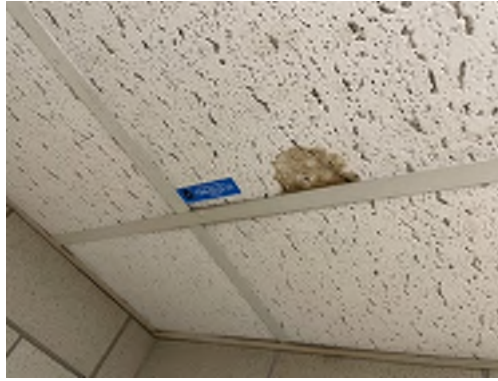
Photo 23- Sample# 7348-03-10-23, No Asbestos Detected in 2' x 2' Ceiling Tile

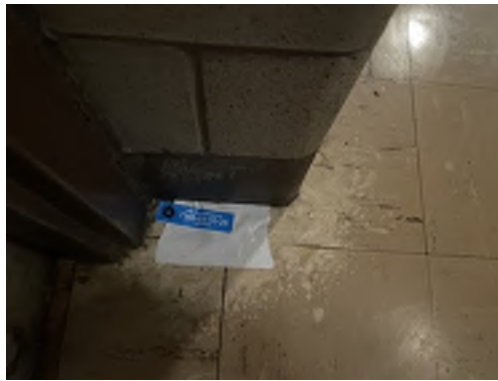
Photo 26- Sample# 7348-03-10-26, 4% Asbestos Detected in 9"x9" Tan Streak Floor Tile, No Asbestos in Black Mastic

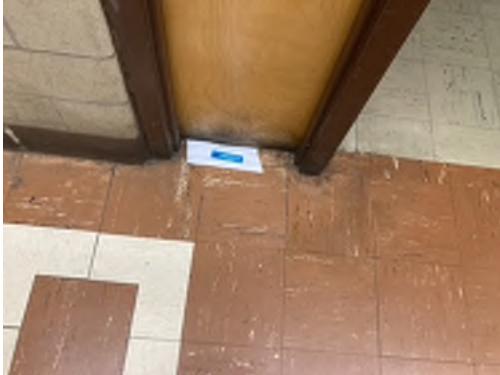
Photo 31- Sample# 7348-03-10-31, 4% Asbestos Detected in 9"x9" Terracotta Streaked Floor Tile, No Asbestos in Black Mastic

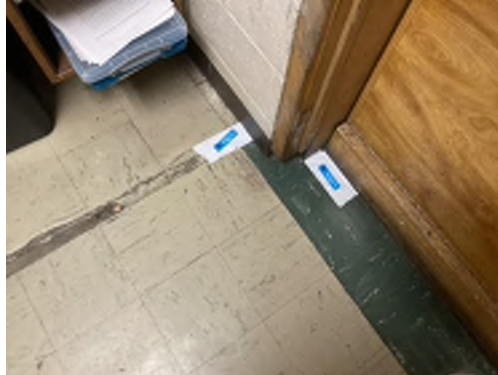
Photo 32- Sample# 7348-03-10-32, 2.2% Asbestos Detected in 9"x9" Grey and Green Streaked Floor Tile, No Asbestos in Black Mastic

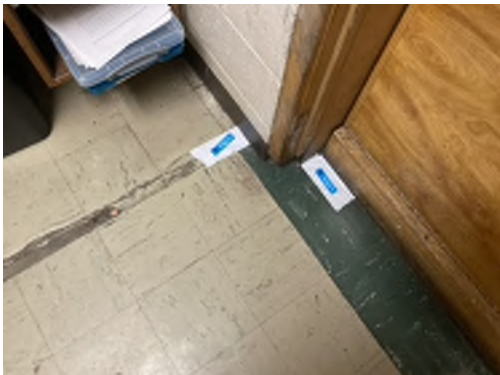
Photo 34- Sample# 7348-03-10-34, 4% Asbestos Detected in 9"x9" Green Streaked Floor Tile, No Asbestos in Black Mastic

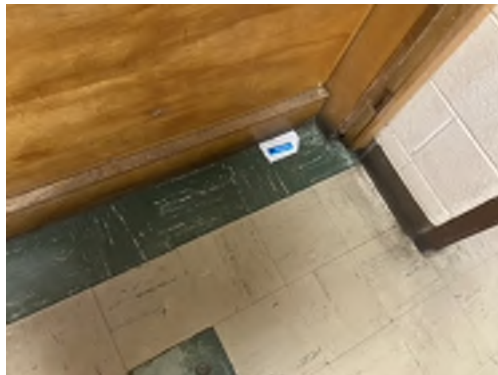
Photo 35- Sample# 7348-03-10-35, 4% Asbestos Detected in 9"x9" Green Streaked Floor Tile, No Asbestos in Black Mastic

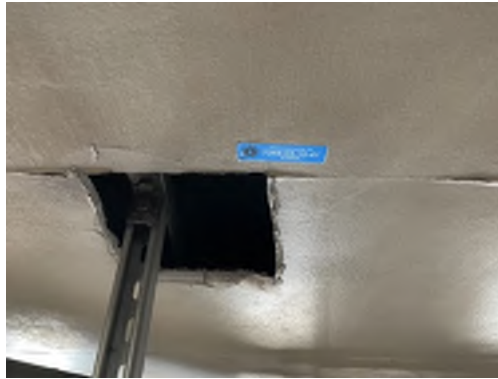
Photo 41- Sample# 7348-03-10-41, No Asbestos Detected in Hard Plaster and Skim Coat

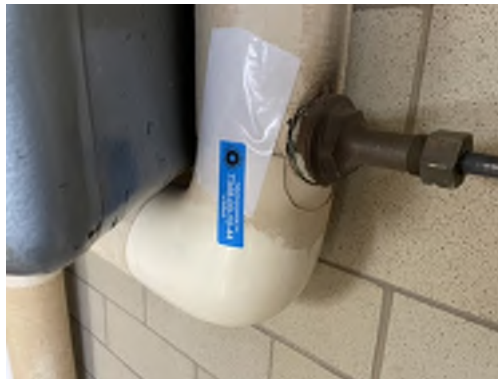
Photo 44- Sample# 7348-03-10-44, No Asbestos Detected in Tan Pipe Insulation Sealant

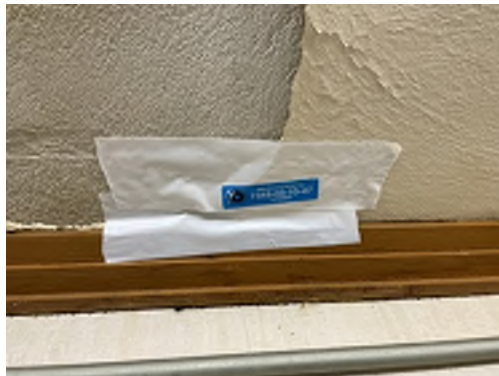
Photo 47- Sample# 7348-03-10-47, No Asbestos Detected in Hard Plaster and Skim Coat

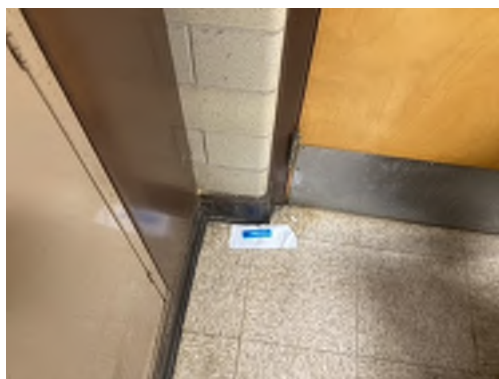
Photo 50- Sample# 7348-03-10-50, No Asbestos Detected in 12"x12" Tan Mottled Floor Tile and Black Mastic

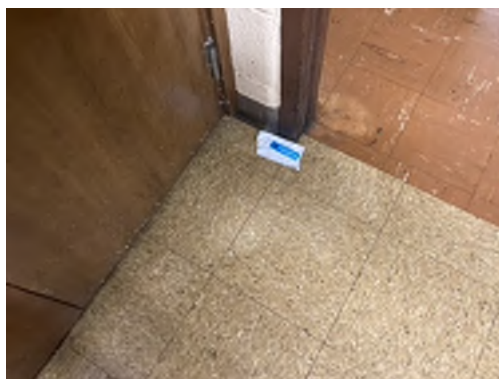
Photo 53- Sample# 7348-03-10-53, No Asbestos Detected in 12"x12" Bronze Mottled Floor Tile and Black Mastic

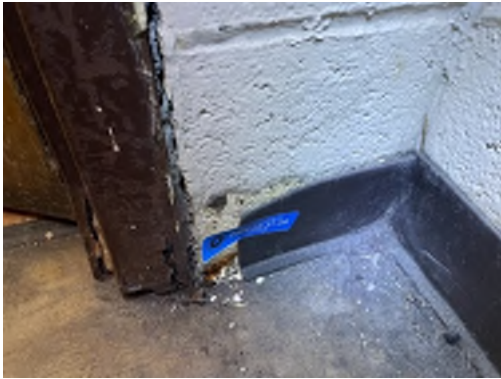
Photo 58- Sample# 7348-03-31-04, No Asbestos Detected in 4" Cove Base and Mastic

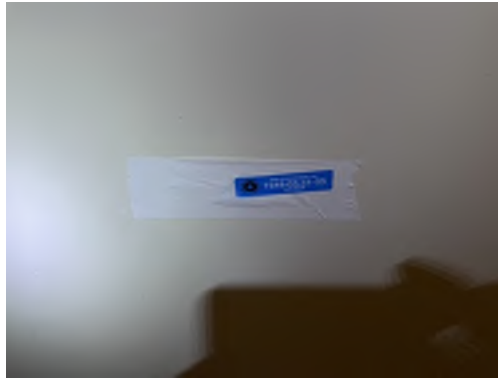
Photo 59- Sample# 7348-03-31-05, No Asbestos Detected in Drywall and Joint Compound

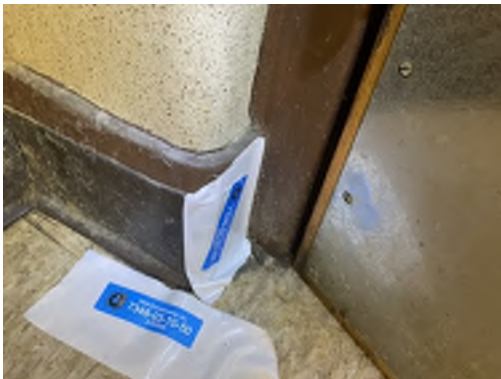
Photo 61- Sample# 7348-03-31-07, No Asbestos Detected in 4" Cove Base and Mastic

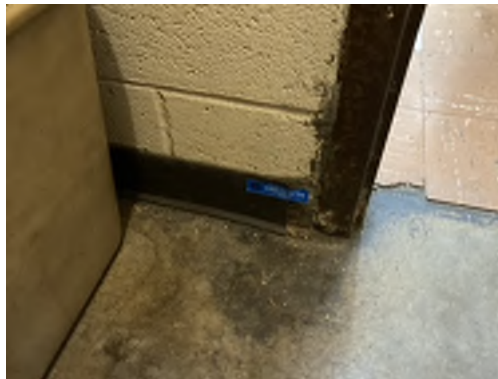
Photo 62- Sample# 7348-03-31-08, No Asbestos Detected in 4" Cove Base and Mastic

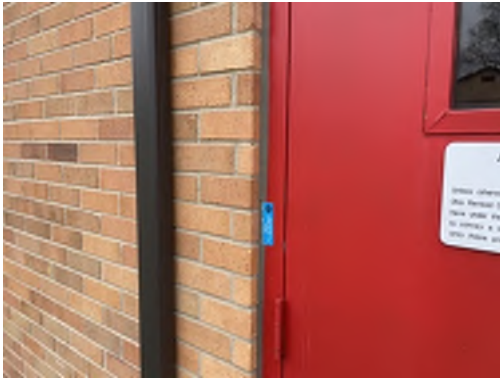
Photo 67- Sample# 7348-03-31-13, No Asbestos Detected in Grey Exterior Caulk

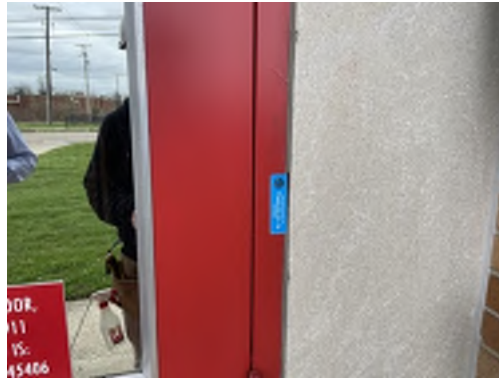
Photo 68- Sample# 7348-03-31-14, No Asbestos Detected in Grey Exterior Caulk

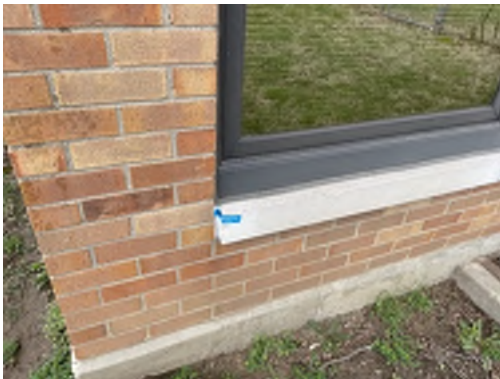
Photo 70- Sample# 7348-03-31-16, No Asbestos Detected in Light Grey Exterior Caulk

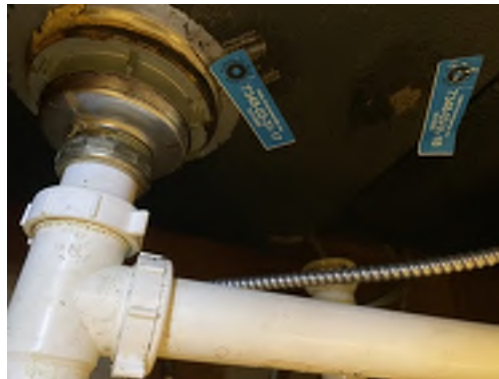
Photo 71- Sample# 7348-03-31-17, No Asbestos Detected in Black Sink Soundproofing

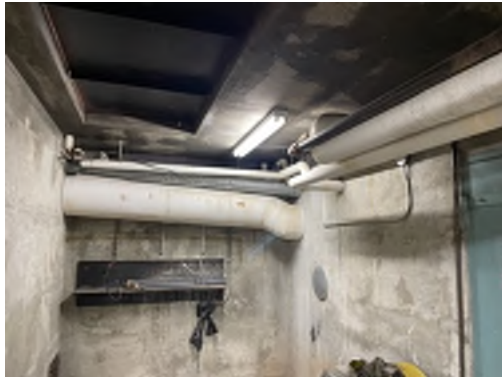
Photo 76- Basement, West Central Hallway, Boiler Flue is Assumed to Contain Asbestos, Under the Metal Jacket

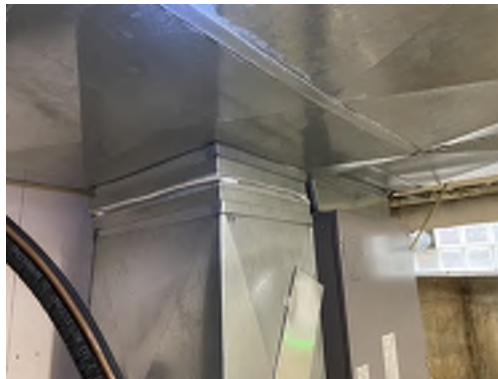
Photo 77- Basement, SW Room, East Area, White Vibration Isolator Cloth is Assumed to Contain Asbestos

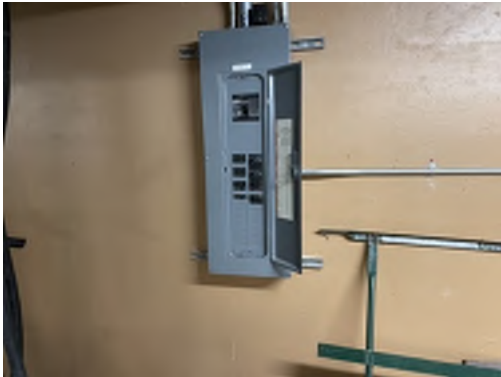
Photo 85- Maintenance Room, South Wall, Circuit Breaker, All Electrical Insulators are Assumed to Contain Asbestos

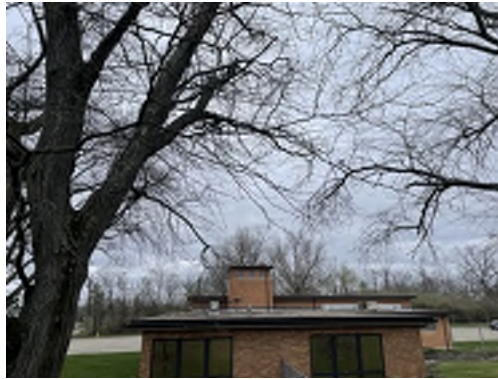
Photo 86- Exterior, Roof, East Side, Safety Switches, All Bituminous Roofing is Assumed to Contain Asbestos

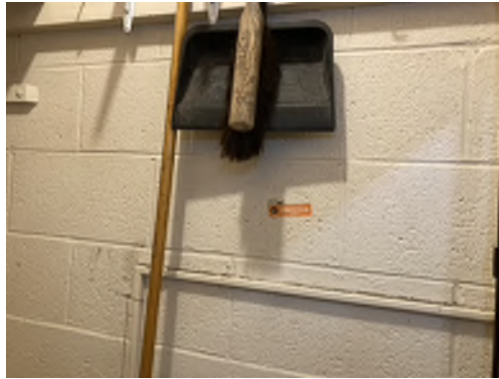
Sample 7348-03-10-64 with no  
detectable lead

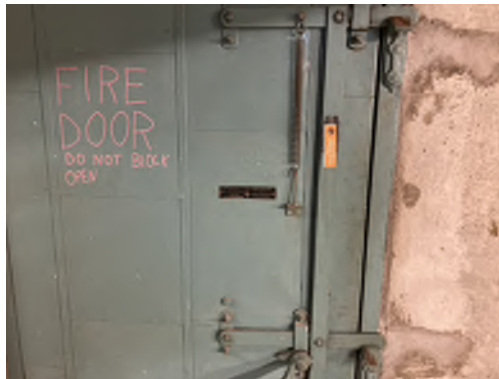
Sample 7348-03-10-69 with  
0.494% lead

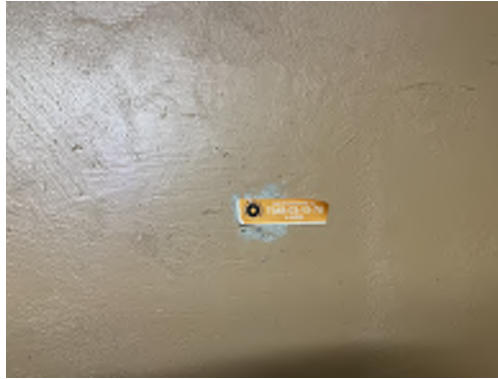
Sample 7348-03-10-75 with no detectable lead

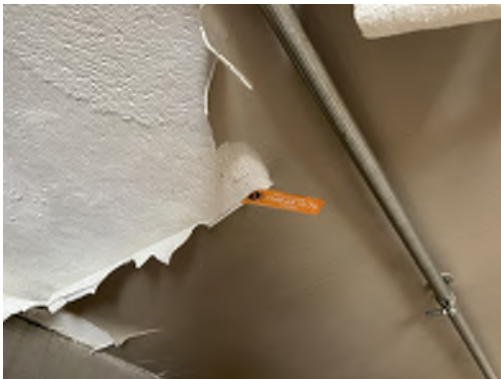
Sample 7348-03-10-77 with 1.707% lead
